The Absence of Low Roller Fairleads in *Titanic's* Forward Well Deck

By Bob Read, D.M.D.

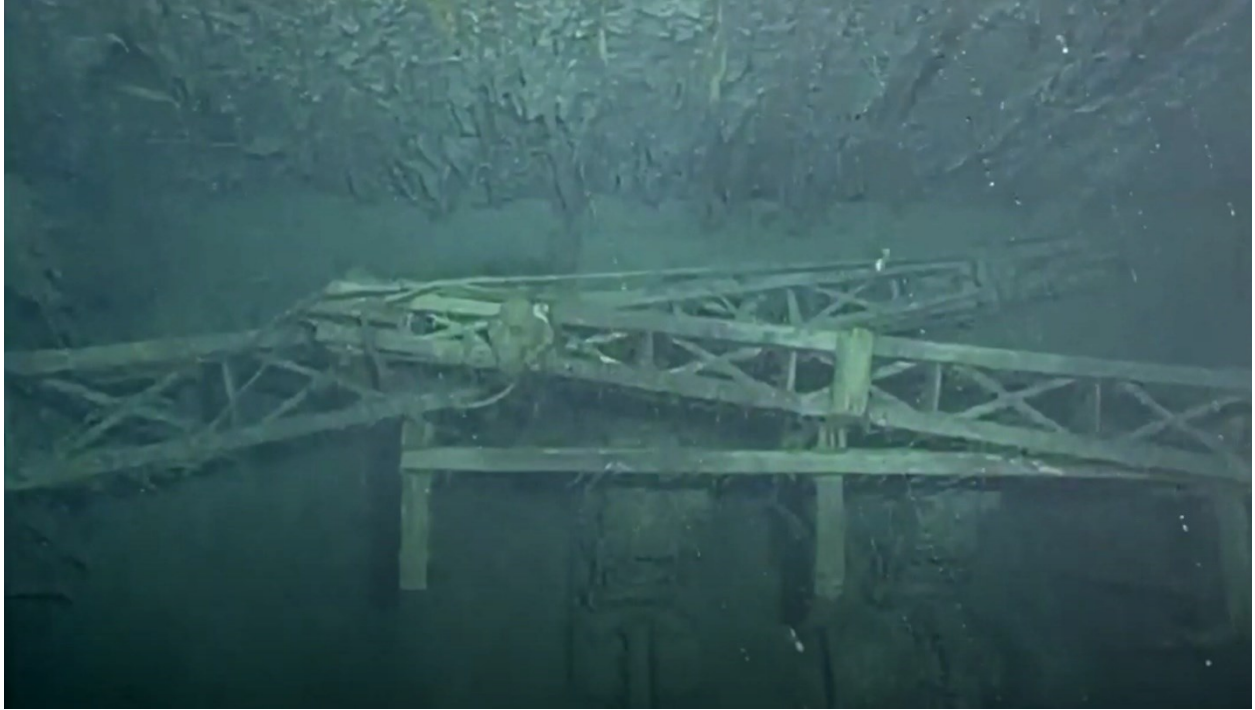
On the *Titanic* wreck the crane jibs have been displaced from their original stowed positions on crutches. Figure 3 shows an overhead view of the area of the jib crutches and where one would expect to see the low roller fairleads if they were present.

Overhead view showing area of crane jibs and jib crutches

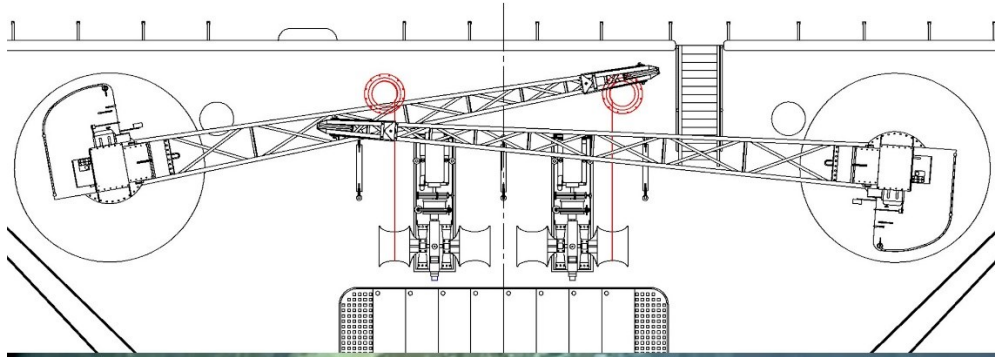
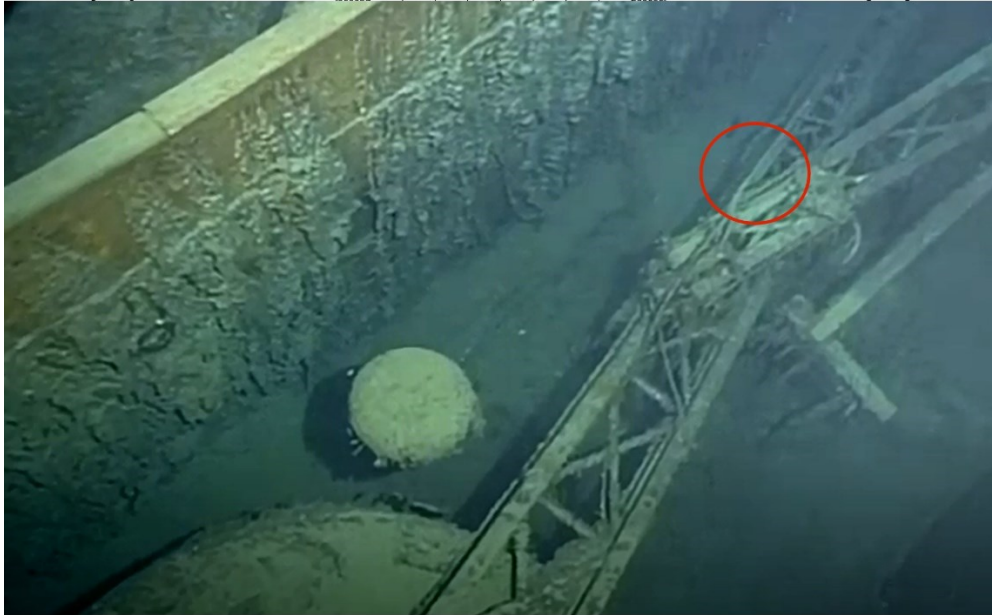
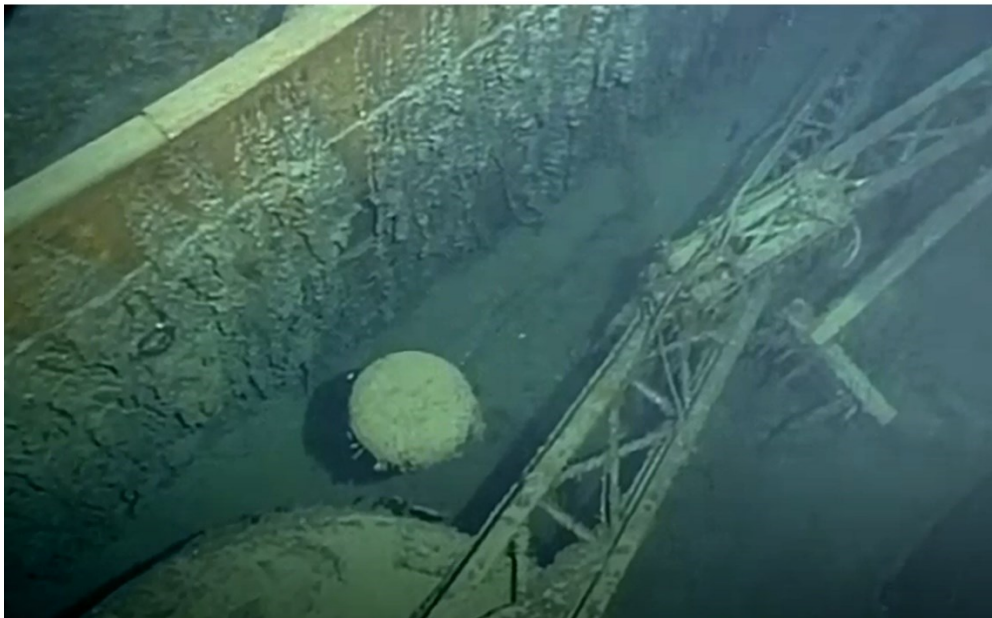
Figure 4

Starboard side showing location where low roller would be expected

These preceding photos demonstrate the *absence* of low roller fairleads in *Titanic's* forward well deck where the *Olympic* plan indicated.

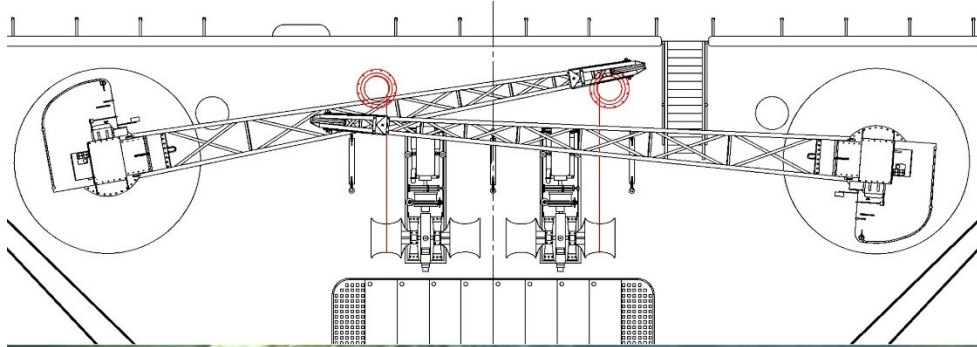
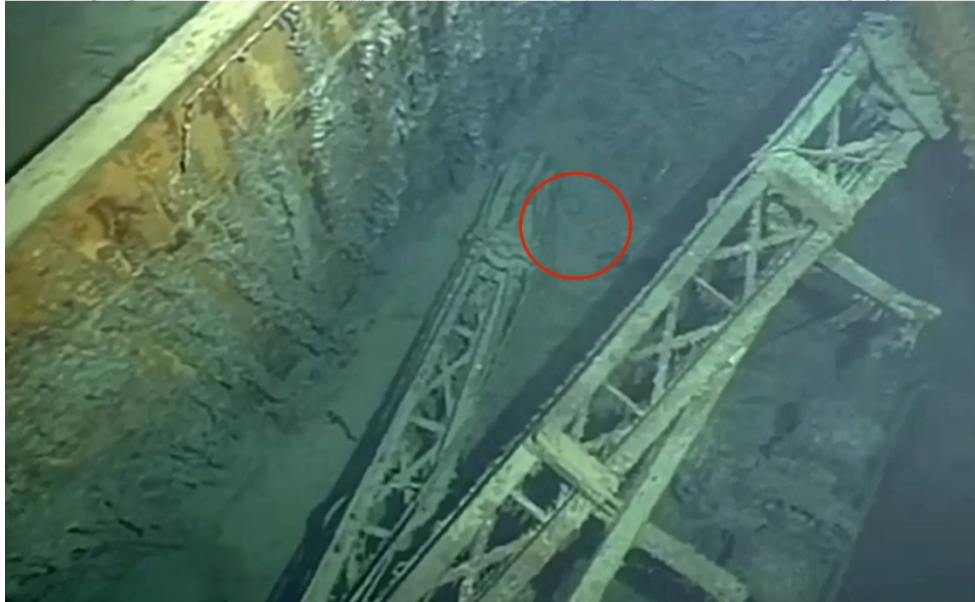
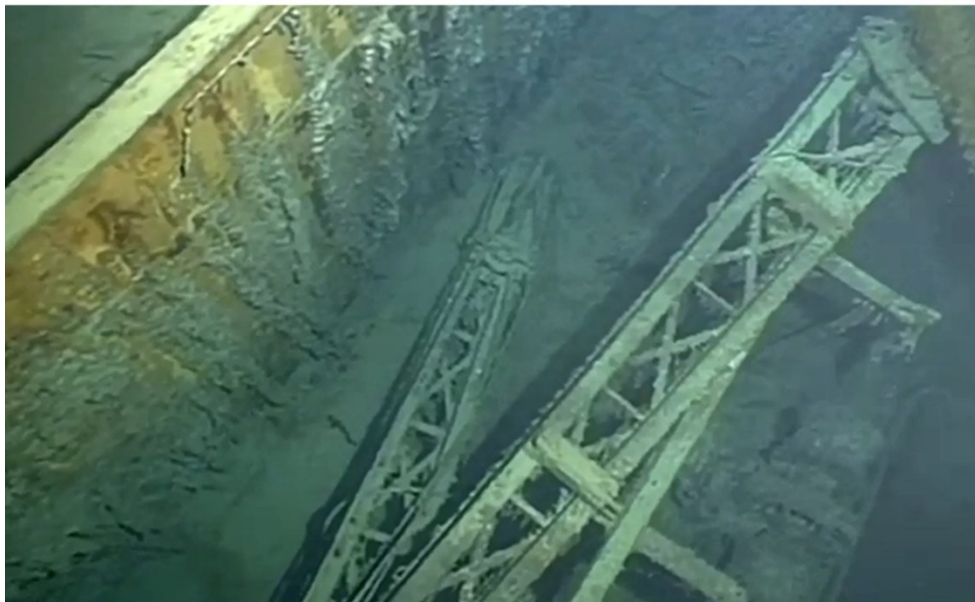
Figure 5

Port side showing location where low roller would be expected
