Why *Titanic's* 1912 Surveyor's Report on Crew Space Accommodation Can't Be Considered Reliable for Ventilators and Skylights

By Bob Read, D.M.D.

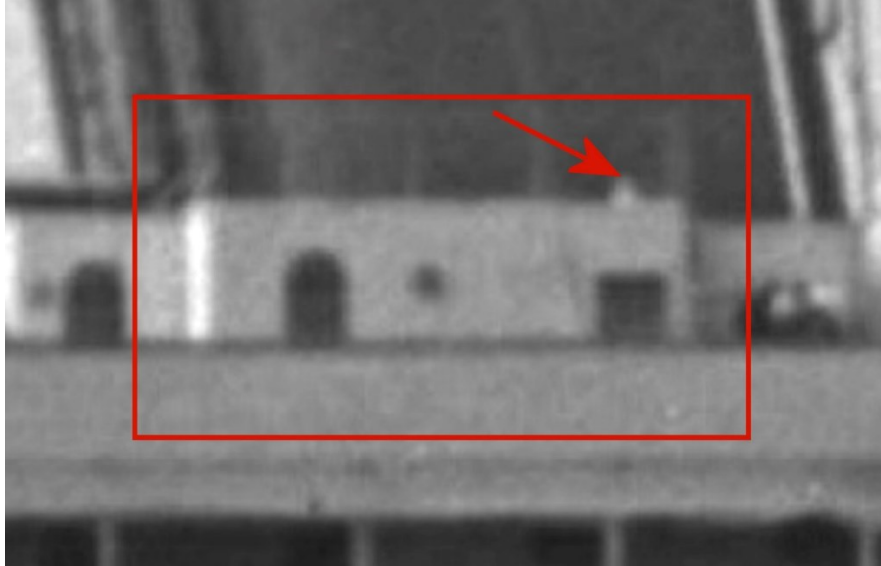
Figure 2

This report entry can easily be refuted by actual photos of *Titanic*. Figures 2 and 3 show two different views of the officers' mess on *Titanic* which is outlined. There is only one mushroom ventilator over the mess which is indicated by an arrow.

Titanic's officers' mess with single mushroom vent indicated

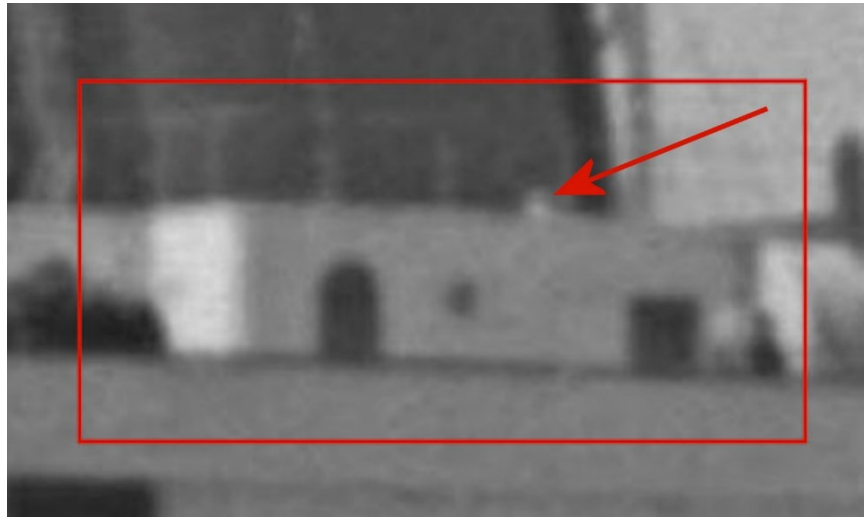
Figure 3

Titanic's officers' mess with single mushroom vent indicated

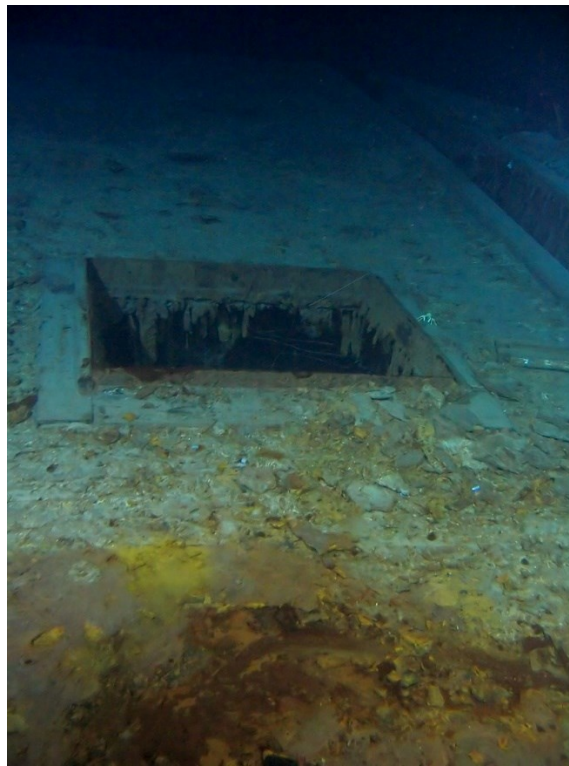
If a mushroom vent for the Marconi operators' bedroom were present, we would see some evidence for it on the starboard side of the skylight. Figure 5 shows the starboard side of the Marconi suite skylight looking to port and there is no evidence of a mushroom vent on the starboard side which would be present if the Survey Report were accurate.

Marconi skylight showing no evidence of mushroom vent on starboard side

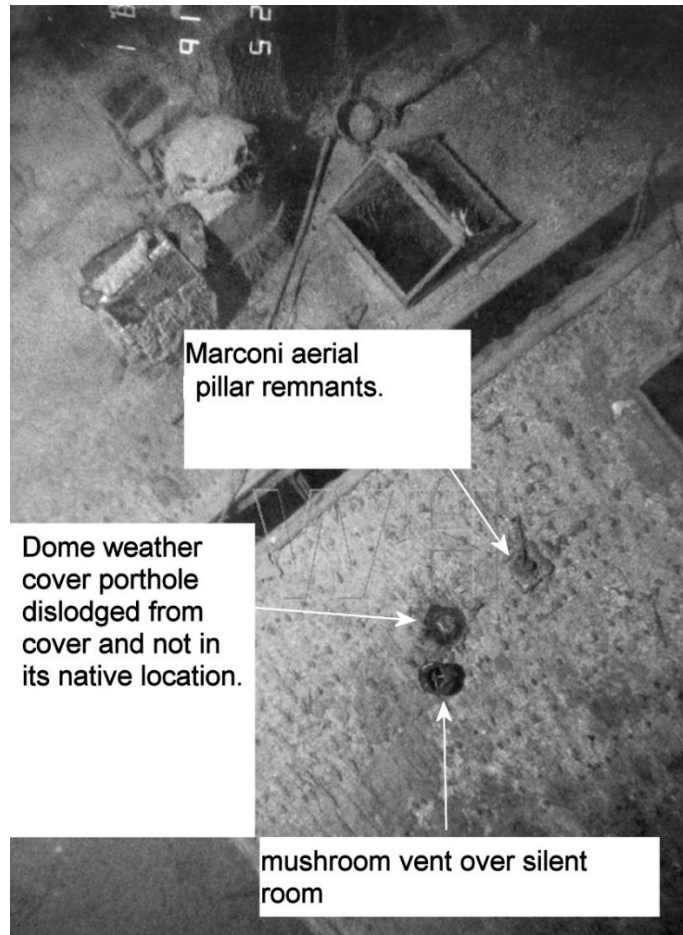
Figure 6

The only mushroom vent over the Marconi suite was over the silent room as is shown in Figure 6.

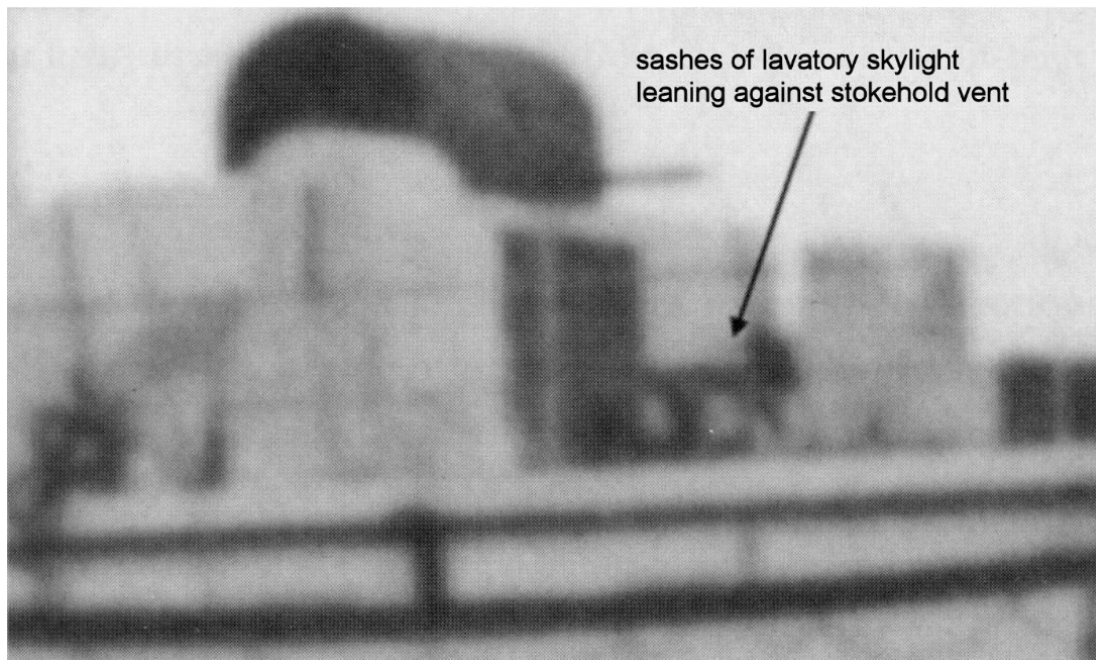
The dimensions of the skylights are given as 5'- 0" X 5 - 5". The part of the entry that appears to be incorrect is that it says that the skylights each have 6 – 15" X 24" panes (3 on each of the two sashes). When this report first surfaced a few years ago, I disputed this skylight pane configuration because there was Titanic fitting-out photo evidence which contradicted it. I argued the case in detail for skylights with two panes per sash in this article: [Titanic's Officers' Quarters Skylights](#). At the time I didn't examine the rest of the report in detail because I thought that the skylight entries might have just been anomalies. With more details being included on plans and paintings which are based on the Surveyor's Report, I decided to take a closer look. As can be seen in the previous examples, the Report has a number of provable errors. Figure 8 shows a sash or sashes for one of the skylights leaning against the stokehold vent aft of #1 funnel. The skylight has not yet been assembled. It can be clearly seen that the skylight sash in the photo has only two panes rather than the three described in the report.

Fitting-out photo of *Titanic* showing two-paned skylight sash
