African Cowl Ventilators on the Roof of *Titanic's* Officers' Quarters?

By Bob Read, D.M.D.

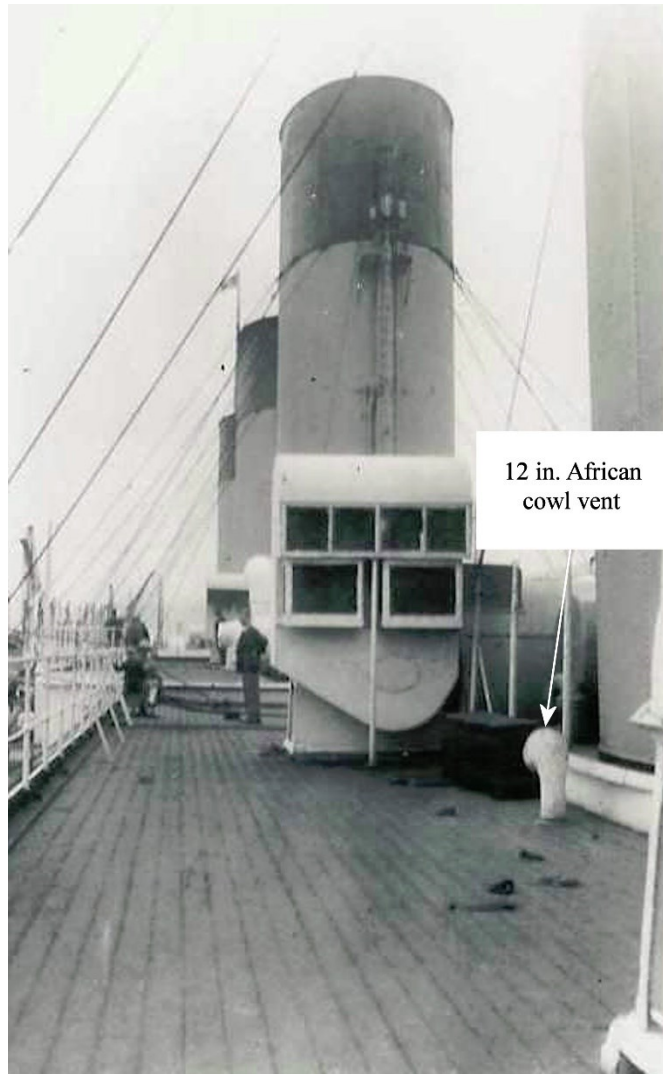
Figure 1

The photo evidence from *Olympic* which is used to support the speculation that these African cowl vents were included on *Titanic* shown in Figure 1. It is unknown exactly when these cowl vents were added to *Olympic* but they weren't a part of her original equipment.

6-inch African cowl vent on *Olympic*

Figure 2 shows a segment from an *Olympic* ventilation plan from 1920. The 6-inch African cowls are shown located port and starboard between frames 62 and 63. This location does not appear to match exactly with the *Olympic* photo in Figure 1. In the photo the cowl appears to be further aft. I would estimate it go be between frames 60-61. For our purposes, either location is acceptable.

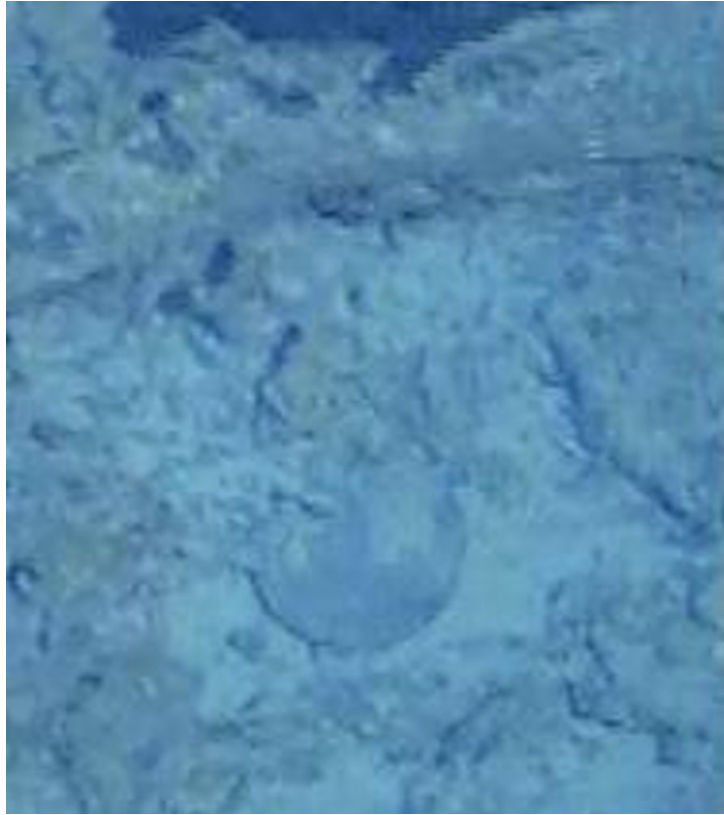
I hesitate somewhat to include this section because it is based on wreck photos that I was privileged to be able to view on the condition that I not share them publicly. These wreck photos are of the areas immediately outboard the port and starboard sides of the boiler casing where funnel #1 was previously located. If there had been an African cowl in these areas, there would be a hole where the ventilator pipe pierced the steel deck. After examining both sides carefully, there was no opening for a ventilation pipe found. Some have pointed to a circular shape in the photos thinking it was a hole through the deck for a ventilator pipe from one of the proposed African cowls. Figure 5 shows this circular object. It is not a hole. It is a circular disc lying on the steel deck.

Circular disc previously thought to be a hole through the deck for a ventilator pipe

High quality wreck photos have shown conclusively that there is no evidence of a hole through the deck for a ventilator on either port or starboard sides of the boiler casing under where funnel #1 was located.
