An Analysis of the Layout of Water Pipes on *Titanic's* Tank Room Roof and Third Funnel Aft Face

By Bob Read, D.M.D.

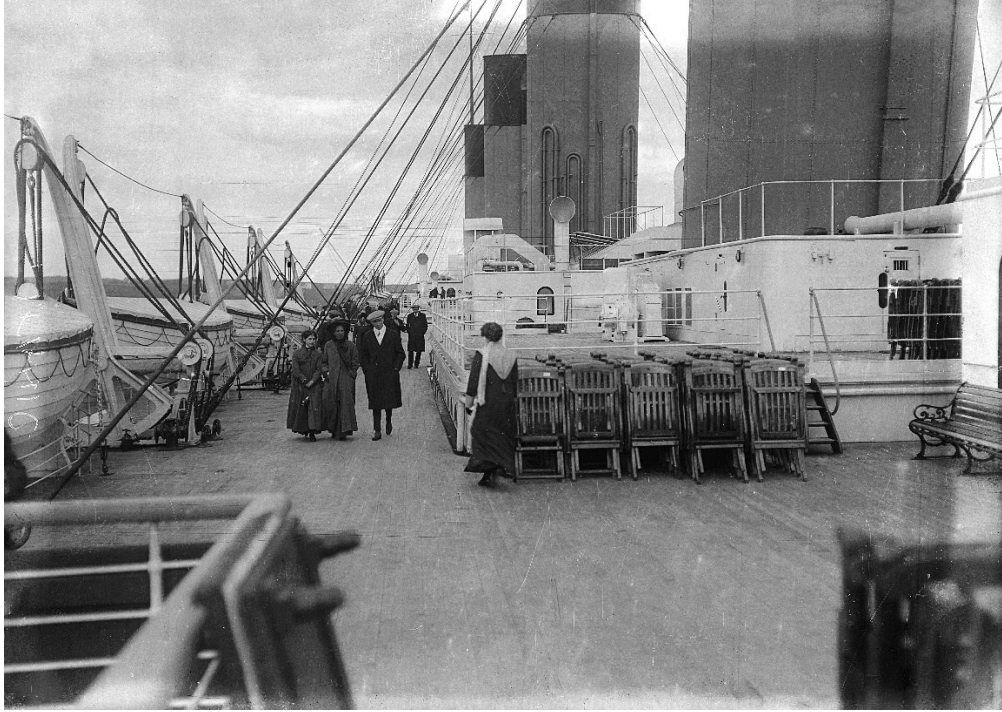
Port side boat deck of *Titanic*

In order to determine the fore and aft positions of the inboard three water pipes on the port tank room roof, the photo shown in Figure 1 must be analyzed by line-of-sight analysis to determine where the end of the pipes pierce the tank room roof. In order to perform this analysis, the location of the camera in the photo must be determined to be able to draw sight lines. So as not to belabor that process, the location of the camera in Figure 1 is shown in Figure 23.

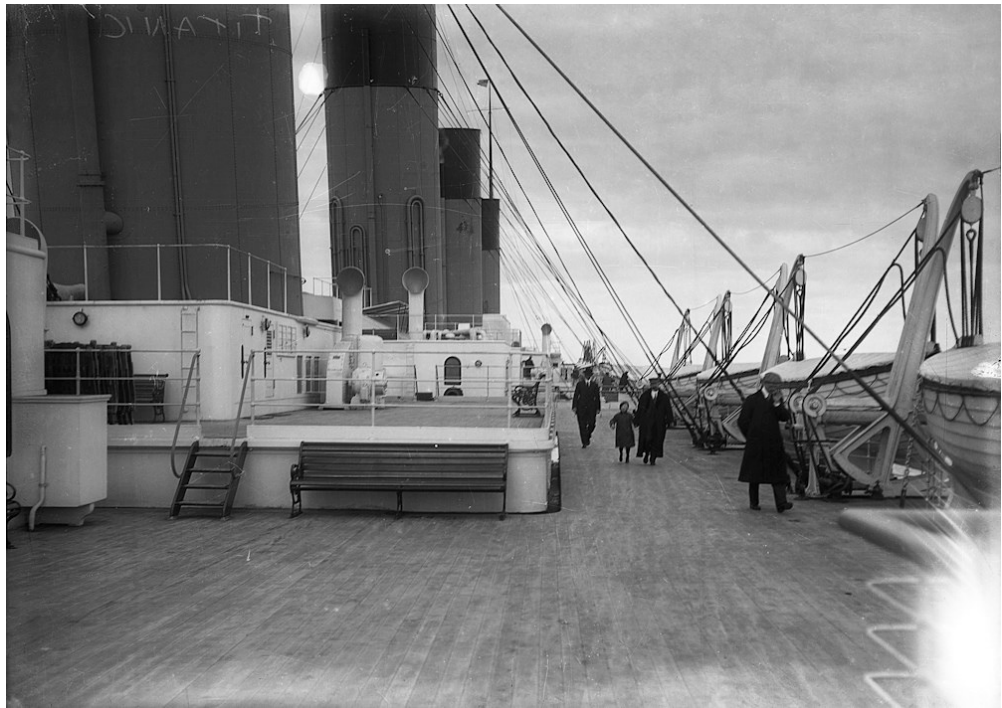
Figure 2

Starboard side boat deck of *Titanic*

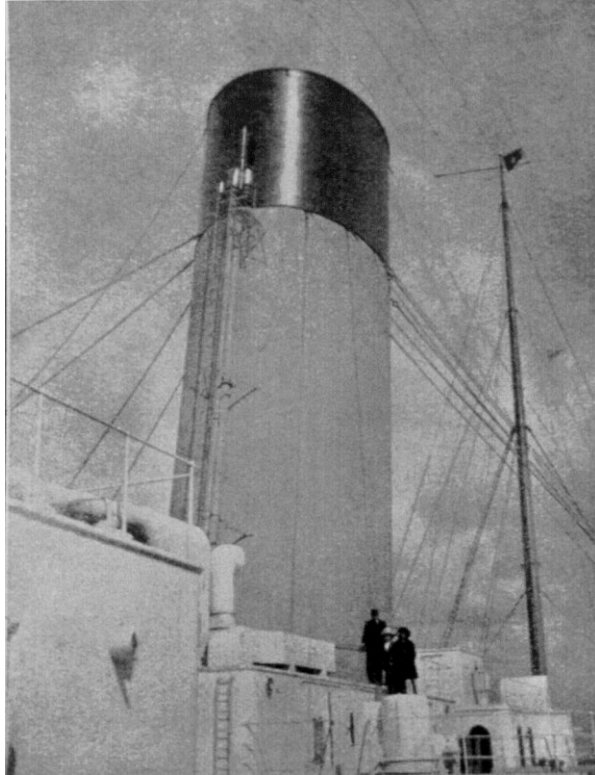
View aft towards *Titanic's* fourth funnel

One of the difficulties in determining the fore and aft positions of the pipes on the port side of the tank room roof is that the best photo of this area is taken from almost directly aft. Fortunately, the Whilems *Titanic* photo shown in Figure 3 shows the fore and aft positions of the outboard two pipes on the port side of the tank room roof. The photo is fairly washed out in this area but it is possible to see where the pipes curve down to pierce the roof as can be seen in Figure 18.

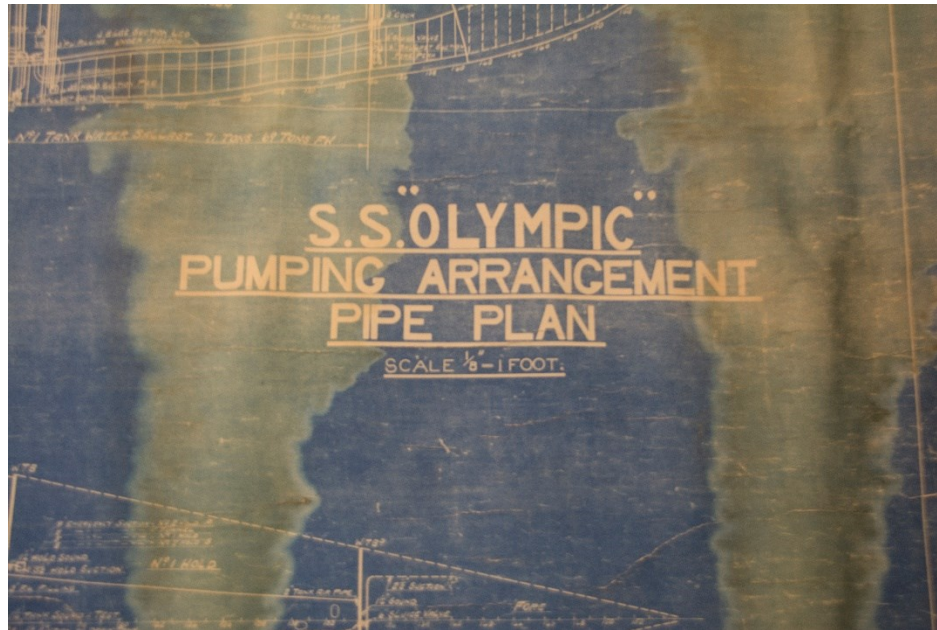
“S.S. Olympic Pumping Arrangement Pipe Plan”

Two particular specialized plans will be used in this analysis. The first is the “S.S. *Olympic* Pumping Arrangement Pipe Plan” as seen in Figure 4 and the “S.S. *Titanic* Pumping Arrangement Pipe Plan” seen in Figure 5. Like the photos, the pertinent sections of these plans will be cropped and enlarged.

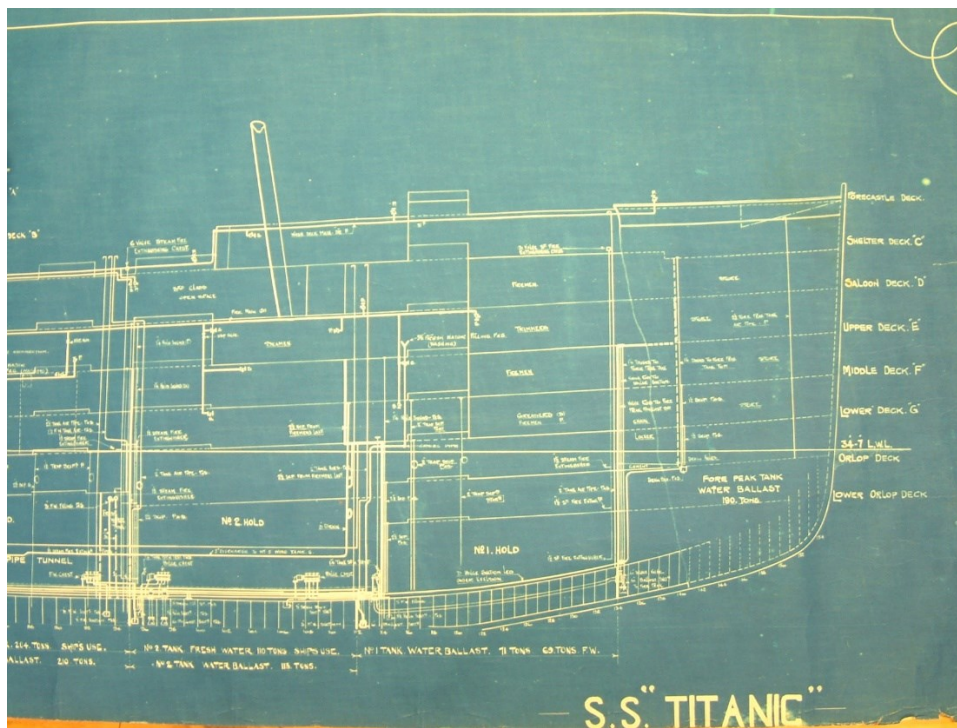
Figure 5

“SS. Titanic Pumping Arrangement and Pipe Plan”

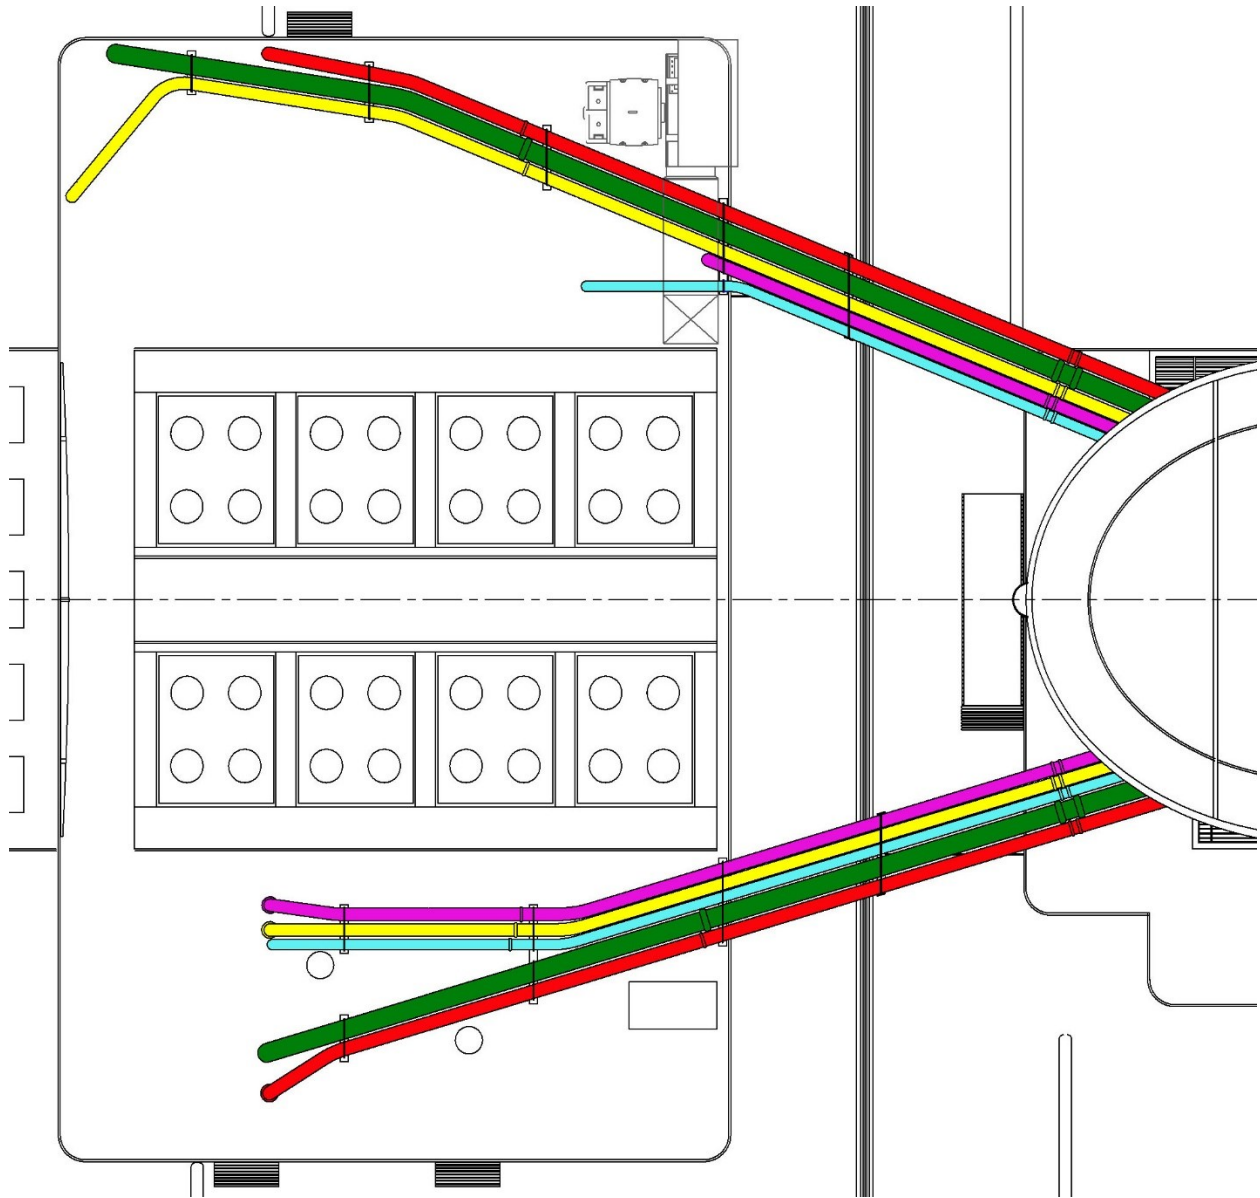
Proposed pipe configuration on tank room roof

Figures 6 & 7 are color-coded to show the different sizes of pipes. Figure 8 is a legend which correlates the colors to the various pipe sizes.

I will be working backward in this article by presenting images of the pipe configurations I am proposing then presenting the various pieces of evidence which I believe confirm this arrangement. Figure 6 shows the proposed pipe configuration on the aft aspect of funnel #3. Figure 7 shows the proposed pipe configuration on the roof of the tank room.

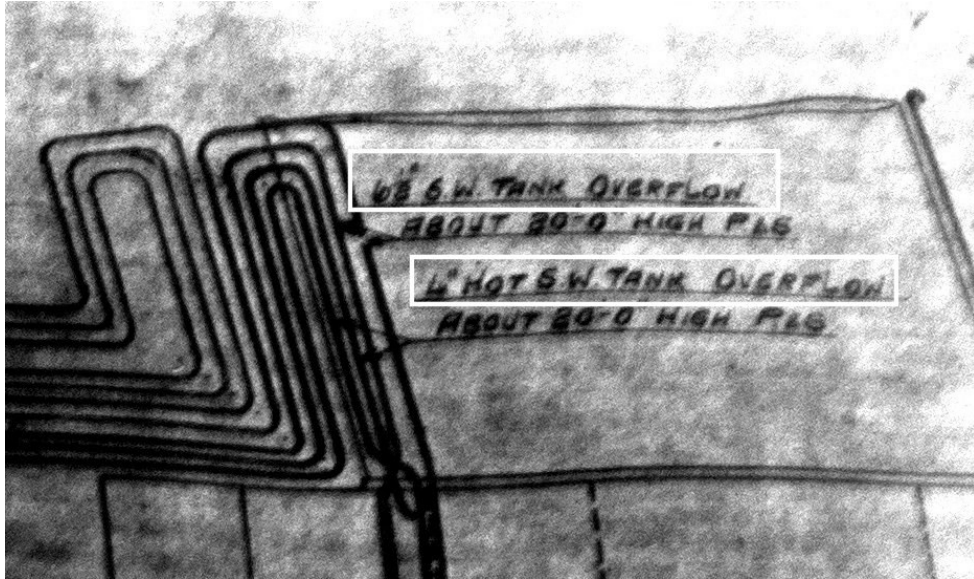
Plan showing sizes of outboard pipe loop pairs (p & s)

The layout of the pipes is not like it is on the ship. The plan's purpose was to provide a working schematic of the pipes much like an electrical circuit diagram. These pipe loop pairs are the largest pipes shown in green and red in Figures 6 & 7. **The pipe sizes in inches are the inside diameters of the pipes.**

The outboard pipe loop pairs (p & s) are identified on the *Olympic* pipe plan. Figure 9 shows a segment of this plan which identifies the sizes of these pipes.

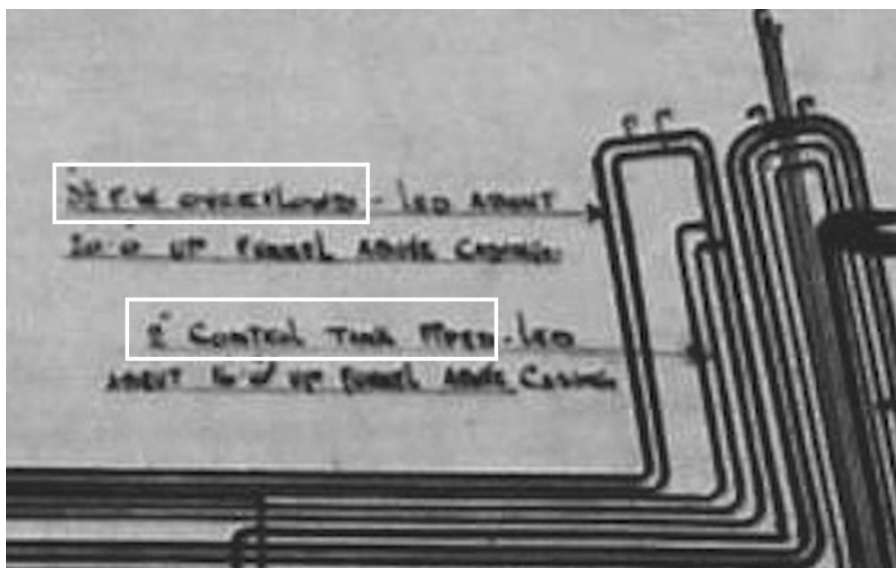
Figure 10

Port inboard pipe loop group

The next pipe loop group is between the outer pipe loop pair and the central steam escape pipe. It is seen on the *Titanic* pipe plan in Figure 10.

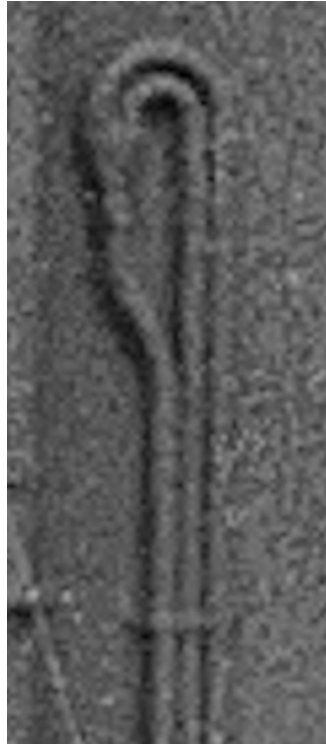
The next group of pipes is somewhat more difficult to identify on the pipe plan with regard to sizes. One has to carefully follow the pipes down to the lower parts of the ship to identify the sizes. This pipe group is the inboard group on the starboard side. It consists of two “J” loop pipe overflows which empty in to a cup-and-drain pipe. The overflow pipes are expansion pipes for hot water systems. This type of pipe arrangement is found on all the other funnels and serves the same purpose. Therefore, we can confirm the size by following the pipes on the other funnels to where the size notation is given. Figure 11 shows this type of expansion pipe and drain configuration.

Expansion pipe loop group

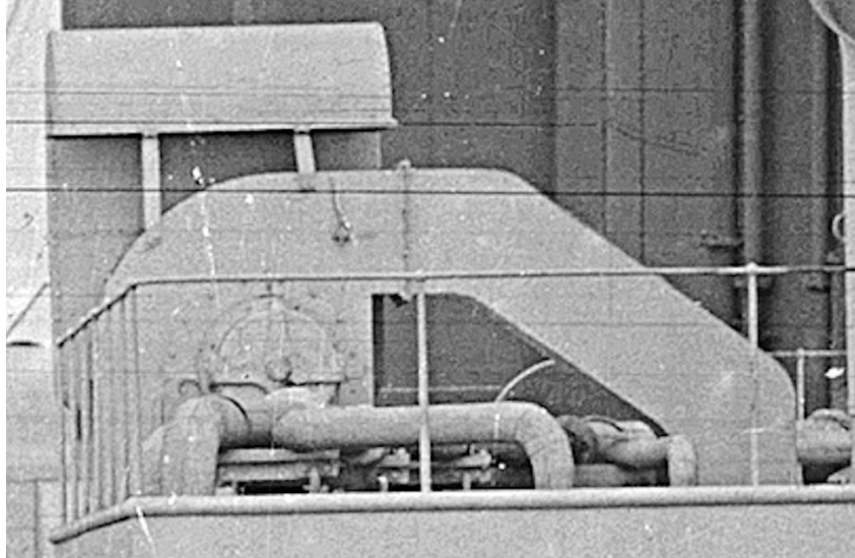
Figure 15

There are a number of structures which establish parameters for the locations of the various pipes on the roof of the tank room. On the port roof of the tank room one of these is 30-inch electric fan sirocco ventilator. This ventilator is a specially configured 30-inch sirocco ventilator. For a long time, this ventilator was misidentified as a 35-inch sirocco ventilator as is seen in many other locations on *Titanic's* weather decks and deck house roofs. This ventilator is shown in Figure 15.

30-inch sirocco ventilator on port tank room roof

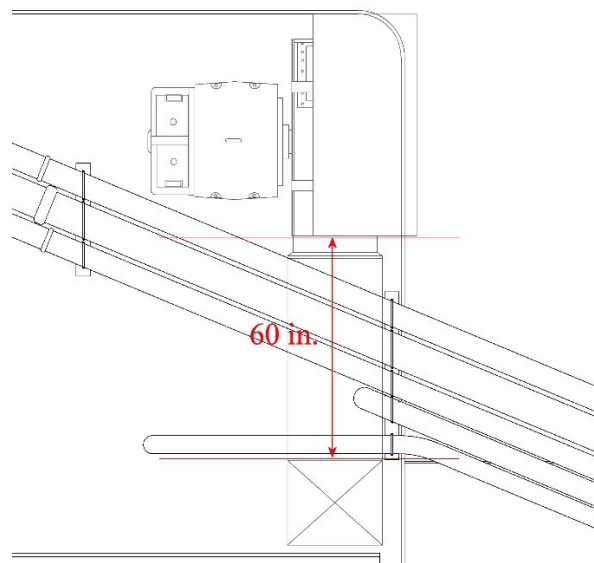
Figure 16

It can be seen that the pipes which travel between the funnel and the port tank room roof must pass between the body of the ventilator and where the output duct pierces the tank room roof. The “window” through which the pipes passed was approximately 60 inches. This dimension can be seen in Figure 16.

Width of window through which pipes pass under 30 in. ventilator

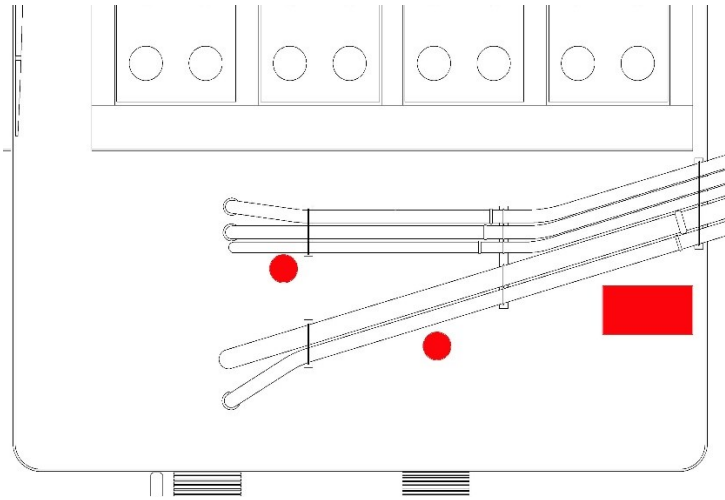
Figure 17

On the starboard tank room there are three natural draft (non-powered) ventilators. The two aft mushroom ventilators were probably installed after the pipes were installed. They had to be centered between roof beams but their athwartship position was not crucial and could be altered to accommodate the pipes. The duct-type ventilator forward needed to be centered athwartship. It was still clear from interfering with the pipes. These three ventilators can be seen in Figure 17.

Natural draft ventilators on starboard tank room roof

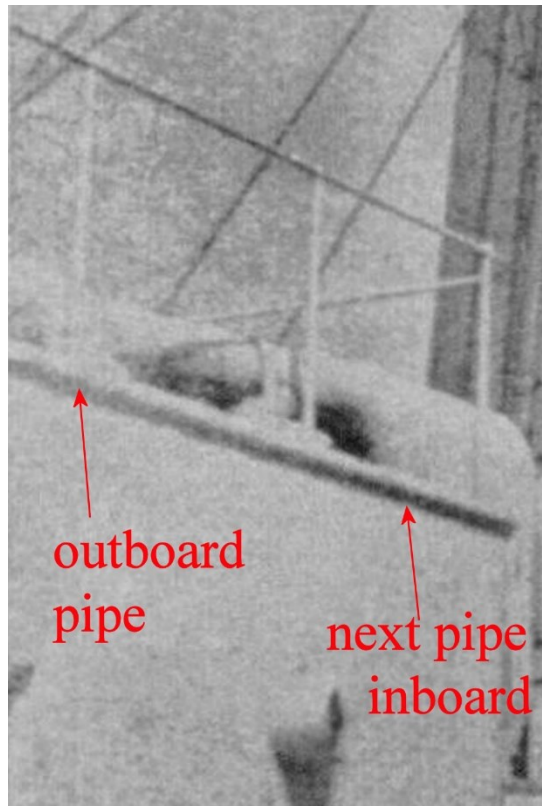
Figure 18

Outboard two pipes on port tank room roof in relation to stanchions

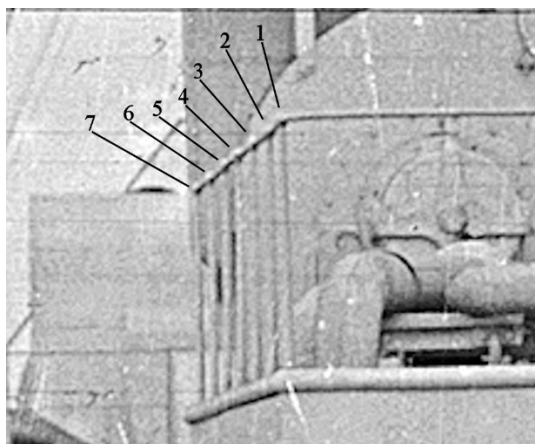
Figure 19

To try to be more precise in locating where the two outboard pipes entered the port tank room roof, the known locations of the port tank room roof railing stanchions are used. There are 7 stanchions on the port side roof as shown in Figure 19.

Port railing stanchions on the tank room roof

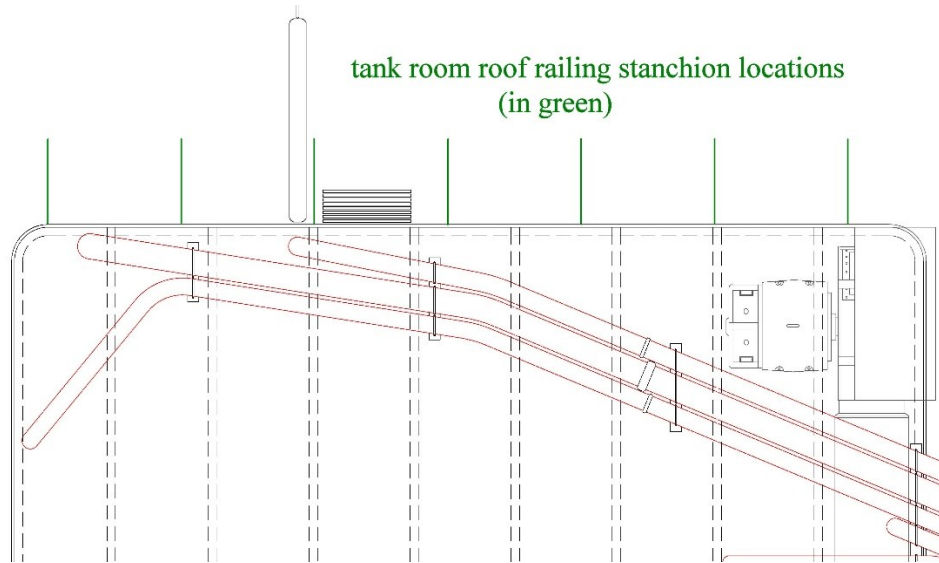
The relationship of the apparent location of the two outboard pipes to the stanchions is also related to the underlying framing of the roof beams as we will see in the next section. Figure 20 shows the location of the two outboard pipes with relation to the tank room roof railing stanchions (in green).

Port side tank room roof railing stanchions (in green)

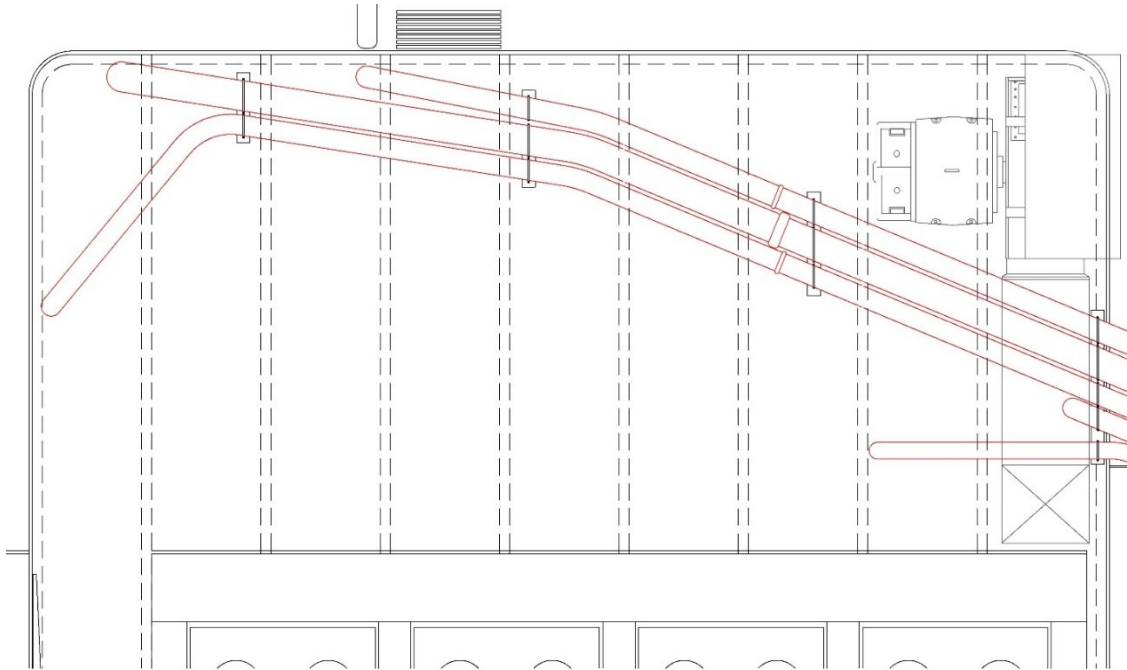
In examining the positions of where the pipes on the tank room roof pass through the roof, it appears that they enter next to roof beams so that the pipes could be securely anchored to them. Figure 21 shows a drawing of the roof of port side the tank room with the underlying beams (dashed). Figure 22 shows the starboard tank room roof with underlying beams (dashed).

Port side tank room roof showing underlying roof beams (dashed)

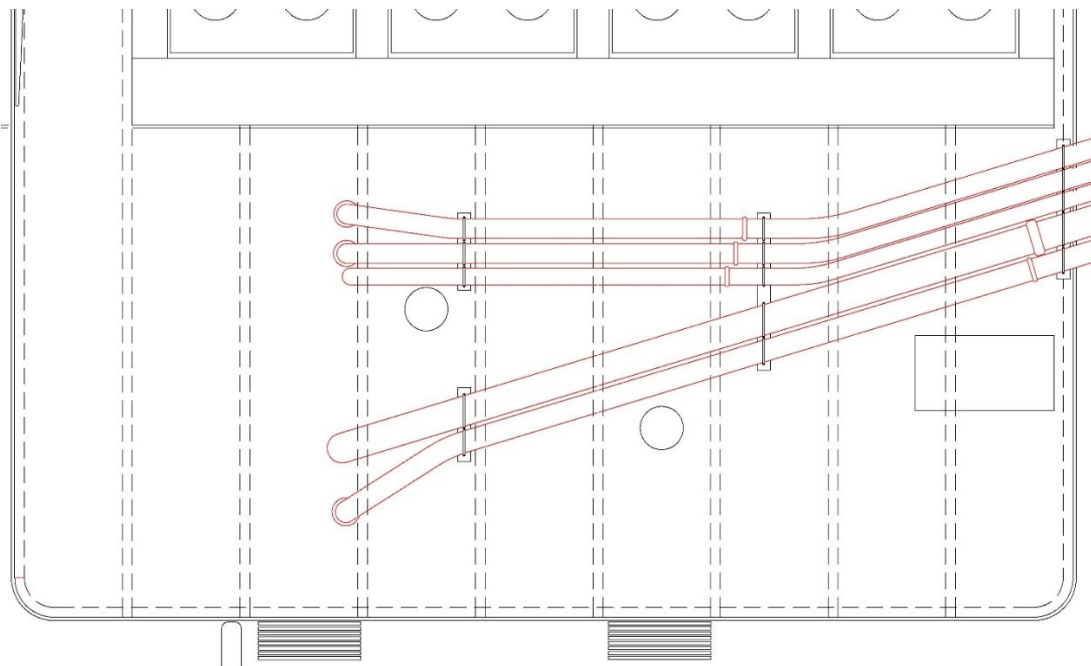
Figure 22

Starboard side roof showing underlying roof beams (dashed)

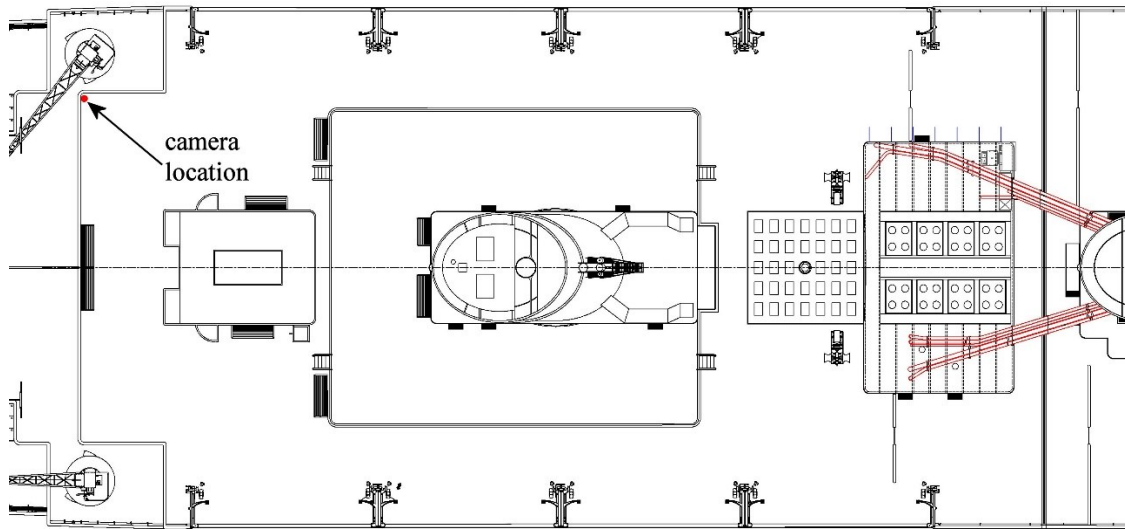
Figure 23

Camera location in Figure 1

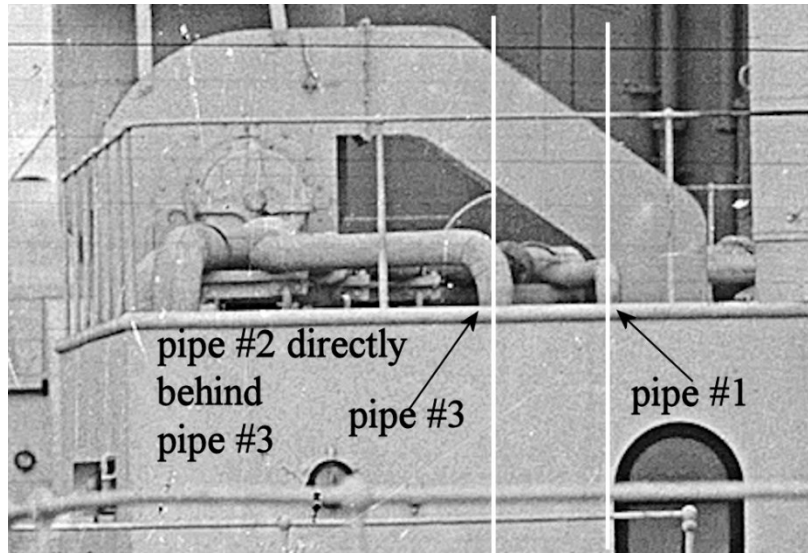
The inboard three pipes will be numbered from inboard to outboard. There are two sight lines which help us to determine the location of the ends of these three pipes. The end of pipe #1 lines up with the inboard aspect of the ventilator duct where it pierces the roof. The ends of pipes #2 and #3 are on the same sight line. Consequently, the end of pipe #3 obscures the end of pipe #2. Figure 24 show a photo view of the lines of sight through the ends of the three inboard pipes.

Inboard three port pipes with lines-of-sight

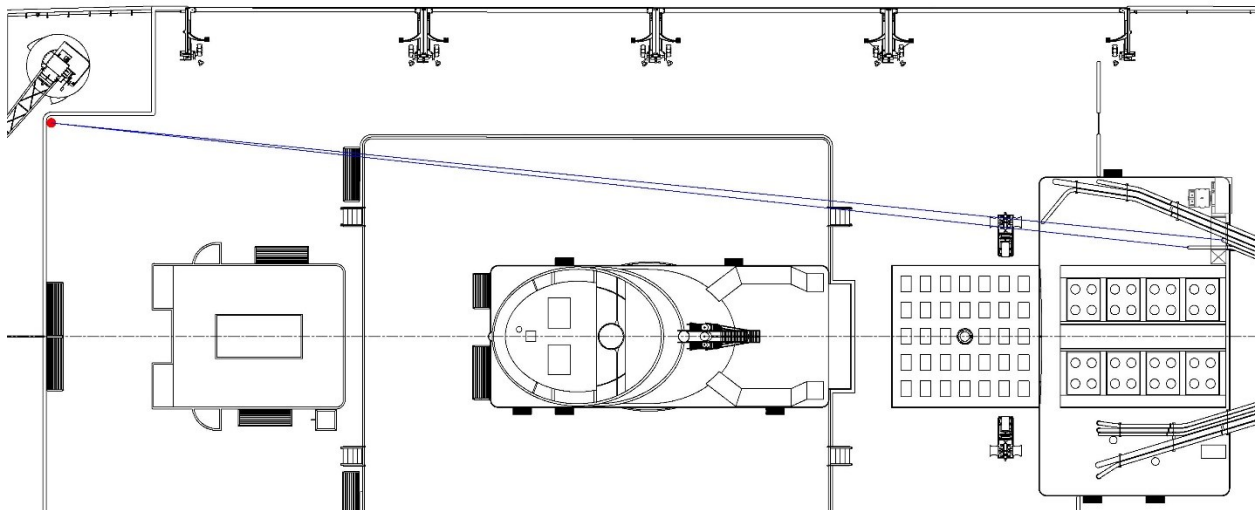
Figure 25 is a plan view drawing of the pipes on the port tank room roof with lines of sight drawn through the inboard three pipe ends.

Plan view of lines of sight through port inboard three pipe ends

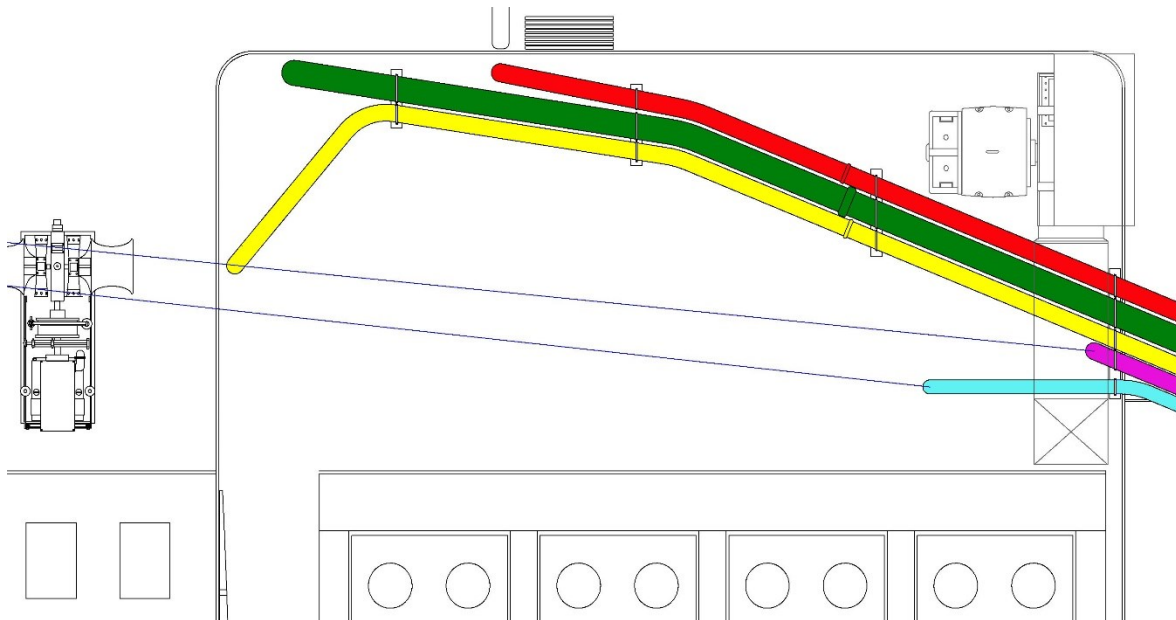
Figure 26 is a closer view of the lines of sight through the inboard three port tank room pipes.

Plan view of lines of sight through port inboard three pipe ends

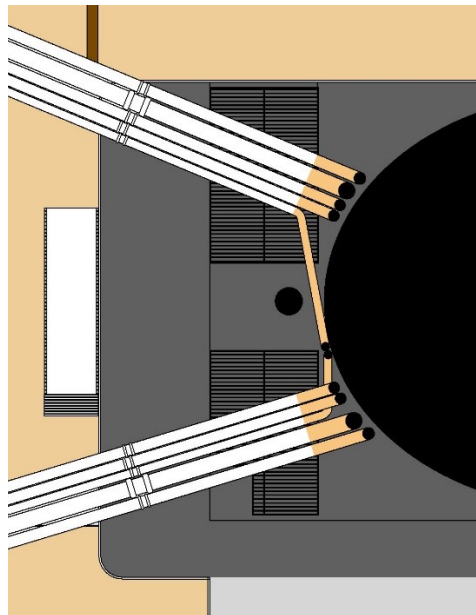
The vertical pipes on the aft face of the third funnel were painted the same White Star Buff as the funnel. The horizontal aspect is a little more difficult. There are very few aspects of the painting of the exterior of *Titanic* which changed between when the ship was presented to her owners on April 2, 1912 until the last photo of her was taken on April 11, 1912. The painting of these third funnel water pipes appears to be an exception. We have photos taken in Belfast which leads one to believe that the buff color proceeded aft to and including the pipe expansion joints of all the pipes. Then we have photos of *Titanic* after she started her voyage which indicate that the separation line between the buff and the white was nearer to the funnel. After much analysis, it appears that *Titanic's* funnels got a fresh coat of paint in Southampton. During this painting it appears that the separation line between buff and white was moved closer to the funnel on both port and starboard sides. Figure 30 show the final position.

Paint separation line location on 3rd funnel water pipes
