Procedures to Launch Collapsible Lifeboats on *Titanic's* Officers' Quarters Roof

By Bob Read, D.M.D.

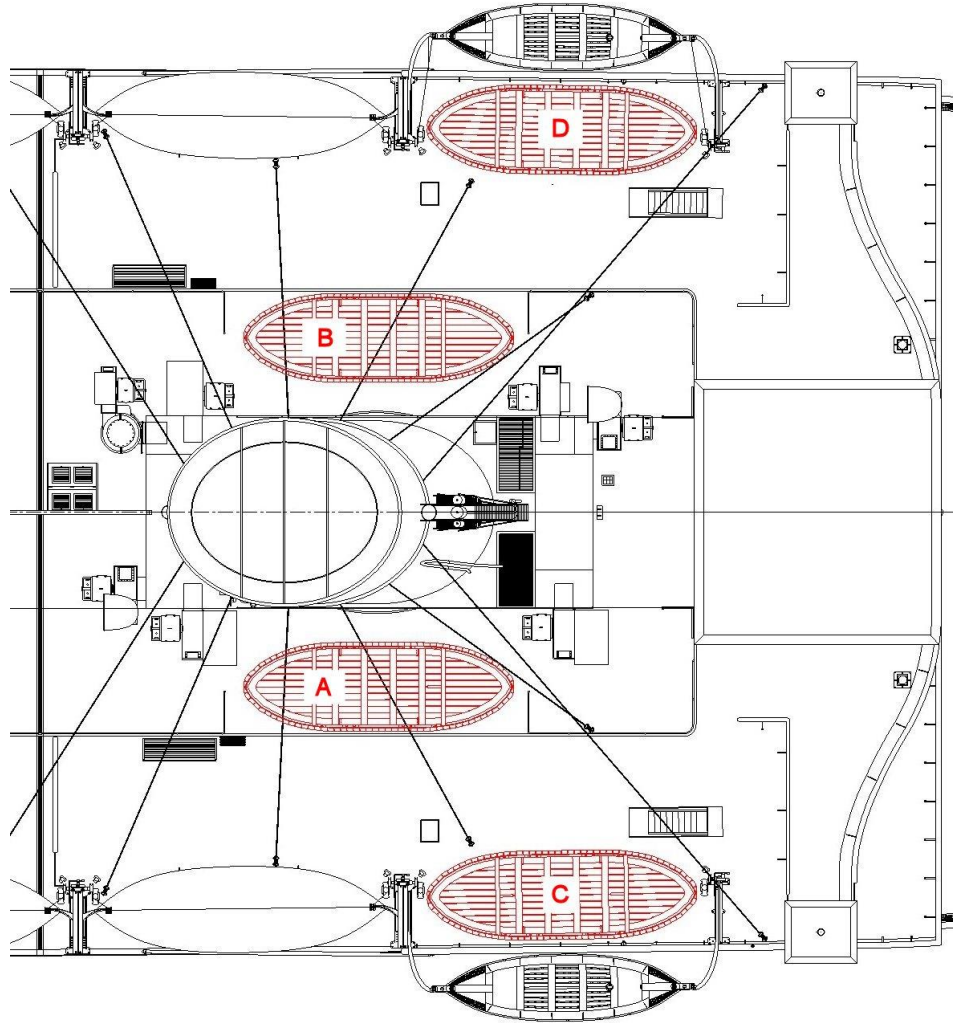
On *Titanic* the four collapsible boats were given letter identifications rather than the number identifications of the wooden lifeboats. The collapsible boats were designated A, B, C and D. Figure 1 shows where these four collapsible boats were stowed.

Stowage of collapsible boats

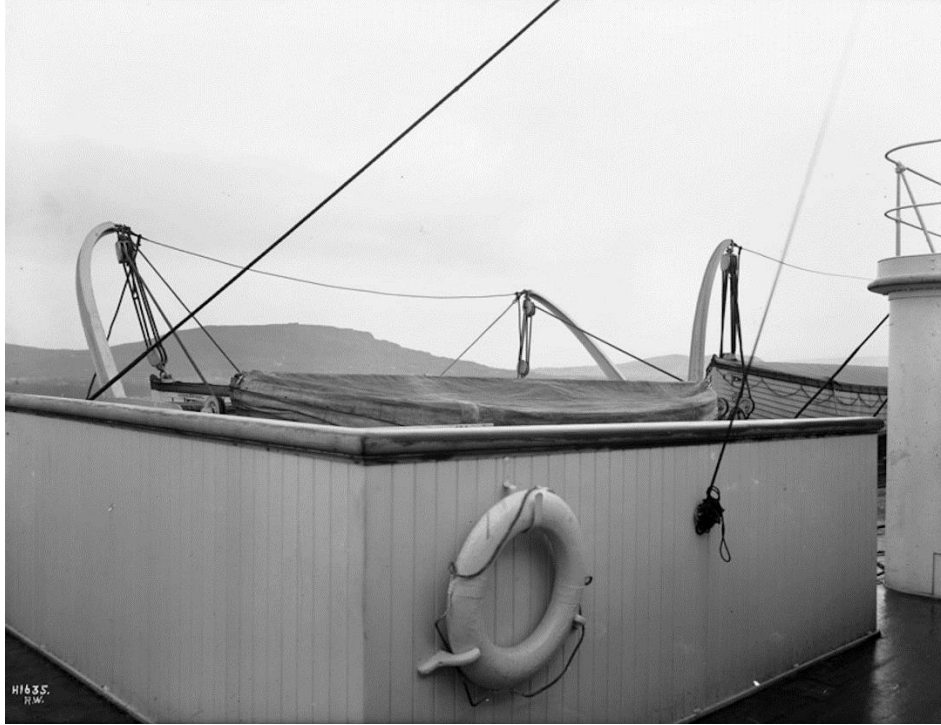
Where *Titanic's* collapsible boats were stowed was different than early *Olympic's*. *Olympic* had boat A stowed atop boat C and boat B stowed atop boat D. In Figure 2 we see how the starboard boats A & C were stowed on *Olympic*.

Starboard collapsible boats stowed on early *Olympic*

What we can see in Figure 2 is that by stowing two collapsible boats atop each other that the two of them are higher than the 4 ft. bulwark by the #1 emergency cutter. The emergency cutters had to be ready and accessible on a moment's notice in case of a man overboard. With the collapsible boats stacked like this on *Olympic*, crew would have to climb over them in order to board the emergency cutter in its outboard position. It is therefore understandable why it was decided to move collapsible boats A and B to a location on the roof of the officers' quarters.

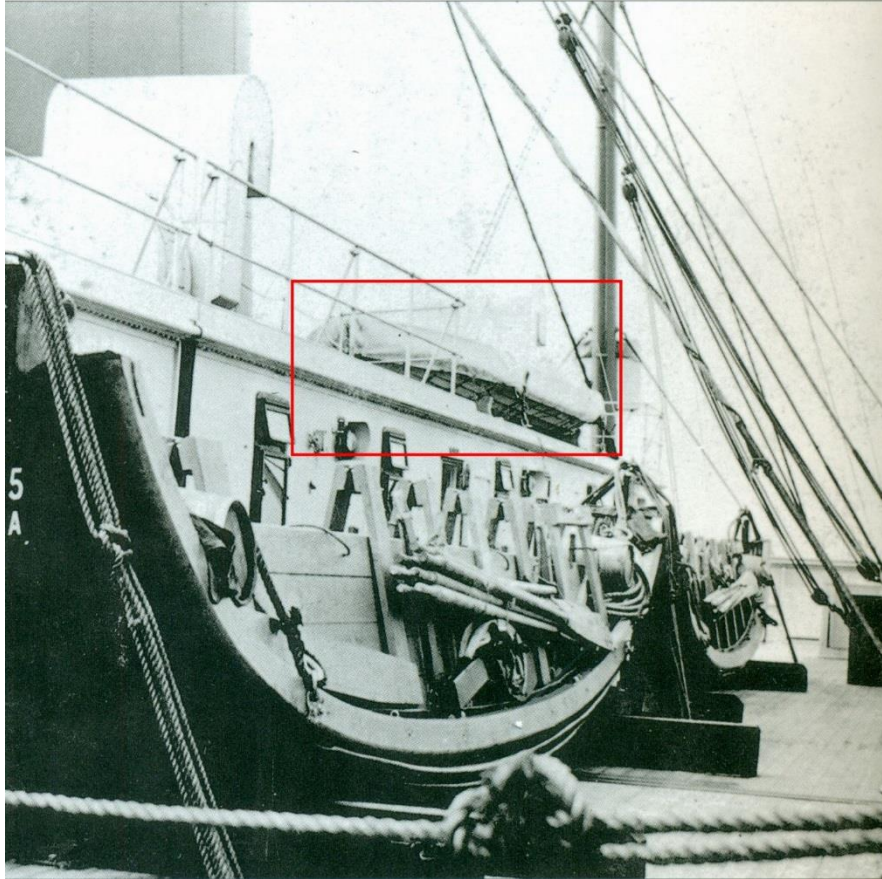
Figure 3 shows collapsible boat A on the roof of *Olympic's* officers' quarters.

Collapsible boat A on roof of *Olympic's* officers' quarters

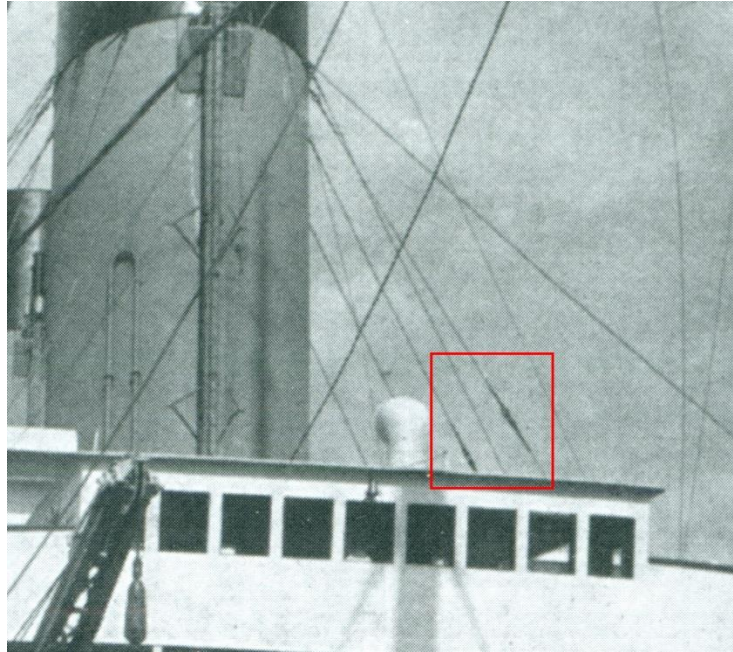
Moving the collapsible boats A and B to *Titanic's* officers' quarters roof required providing some means for lowering the boats to the boat deck. The means which was provided on *Titanic* was the incorporation of round links in shrouds #3 and #4 (as numbered from the forwardmost shroud of funnel #1). These links provided a purchase point for hooks on blocks to be put through the links. Figure 4 shows the port shroud links on *Titanic*.

Port shroud links on *Titanic*

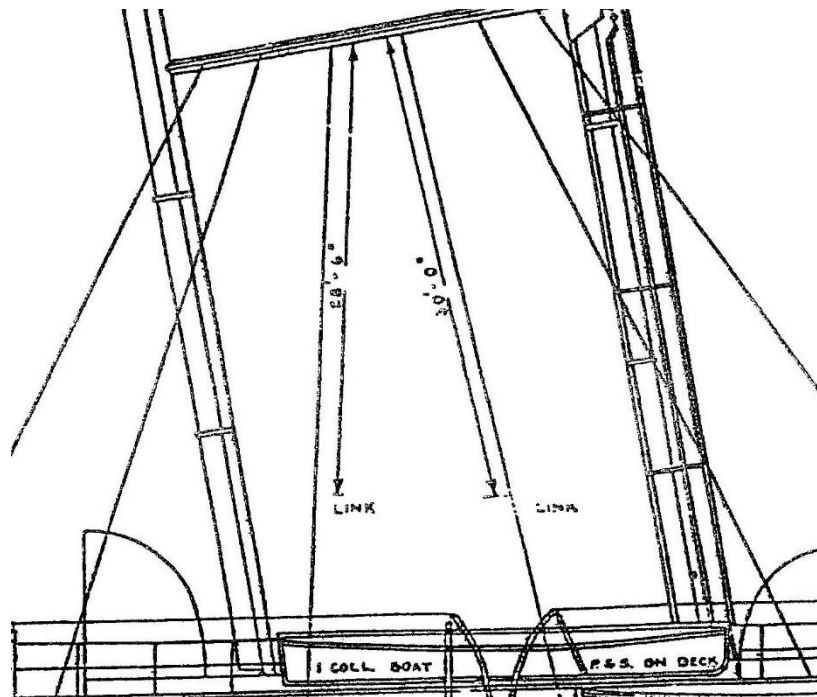
Figure 5 shows the placement of the shroud links on the *Titanic* Rigging Plan.

Shroud links on *Titanic* rigging plan

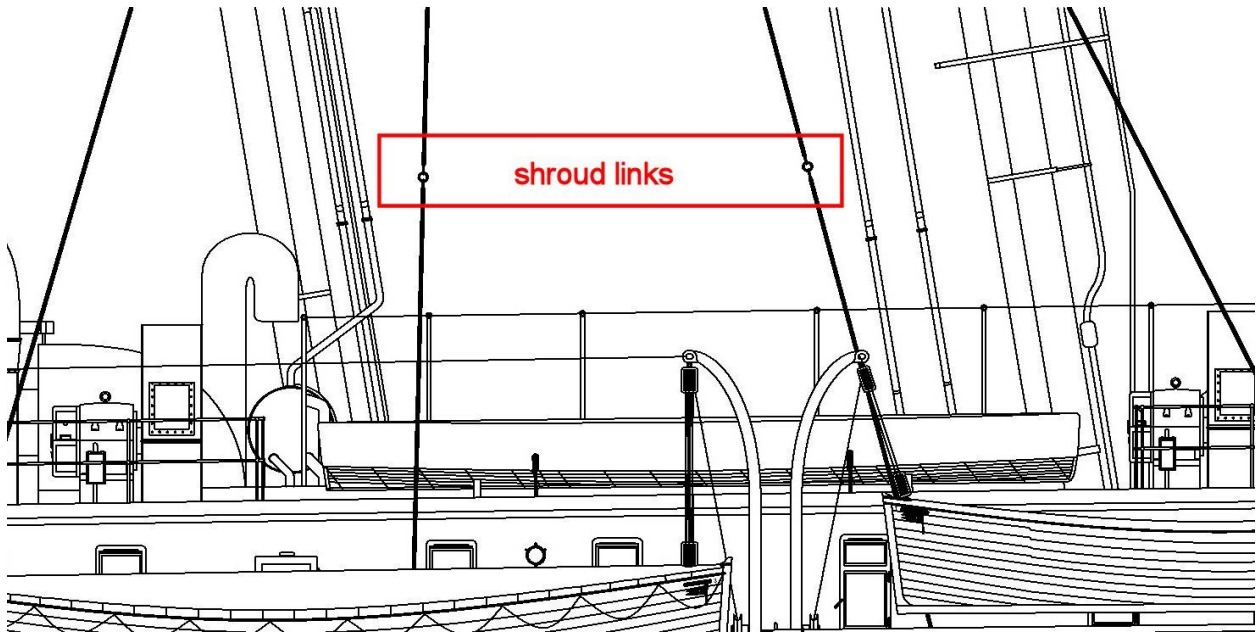
Figure 6

Figures 6 and 7 are drawings showing the location of the shroud links.

Starboard shroud links on *Titanic*

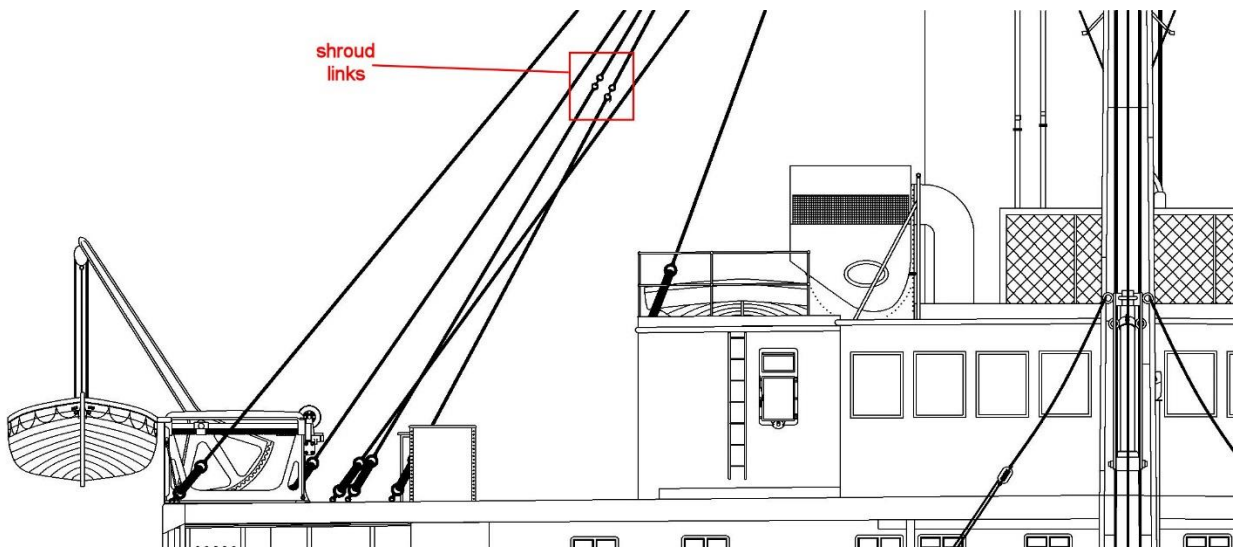
Figure 8

Starboard shroud links on *Titanic*

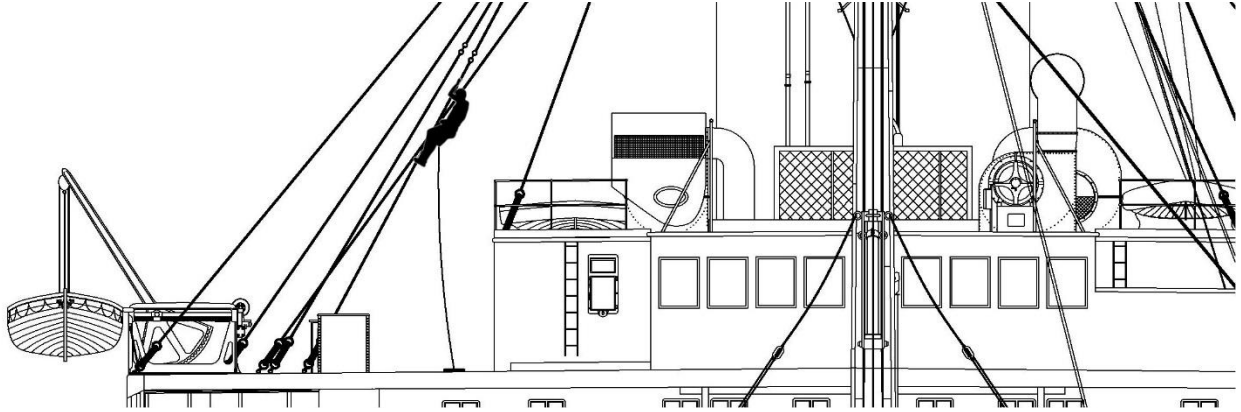
Figure 7

The first task to be accomplished in launching the collapsible boats atop the *Titanic's* officers' quarters is to rig the falls for the boats. This is done by placing treble blocks with hooks through

the eyes of the shroud links. Since there is a 50/50 probability of this needing to be done at night, about the only practical way to do this is for a crewman to climb the shrouds and place the block hook through the link manually. This procedure is shown in Figure 7. In this and other drawings from this perspective, intervening structures have been removed for clarity.

Crewman climbing shroud to rig falls in shroud link

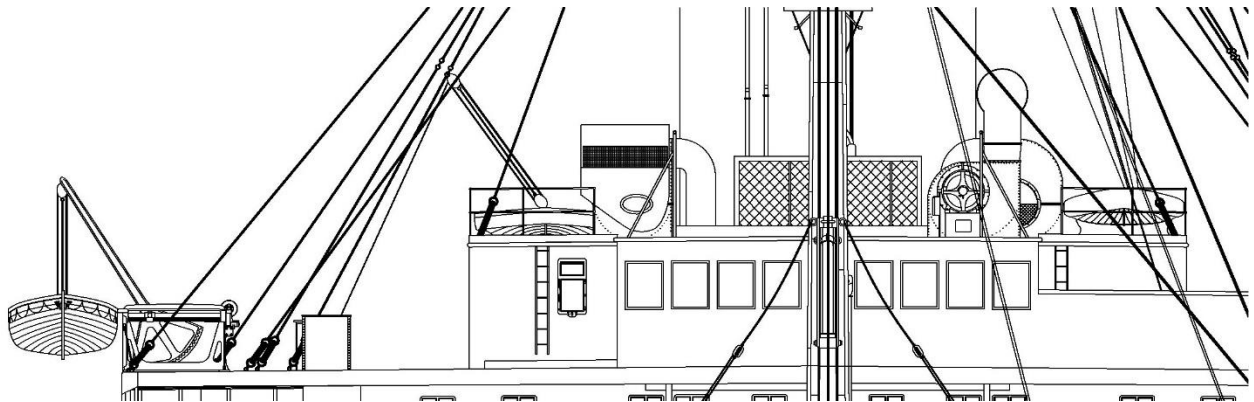
Figure 8 shows the falls rigged to the shroud link and to the collapsible boat.

Falls rigged to collapsible boat

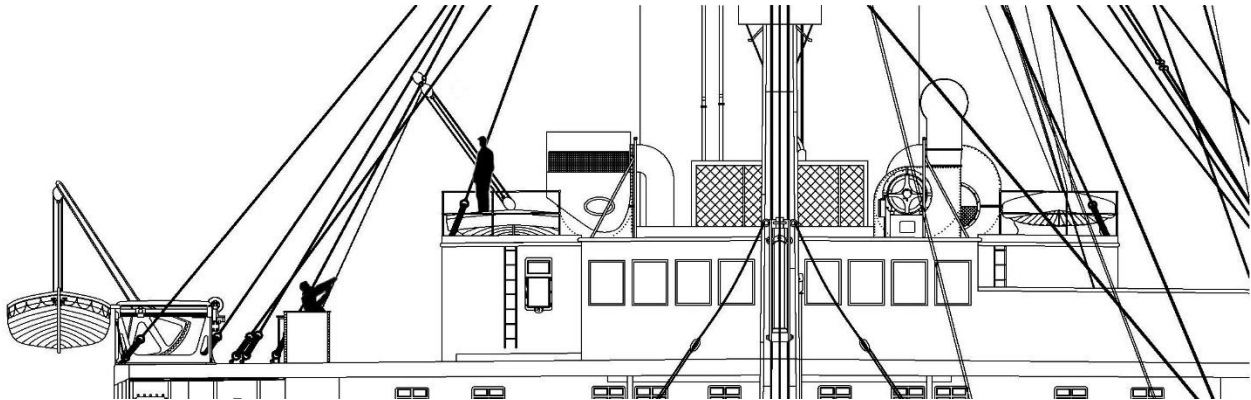
Figure 9 shows crew beginning to hoist the collapsible boat with one crew member in boat to fend it away from the deckhouse with a boat oar.

Crew beginning to hoist collapsible boat

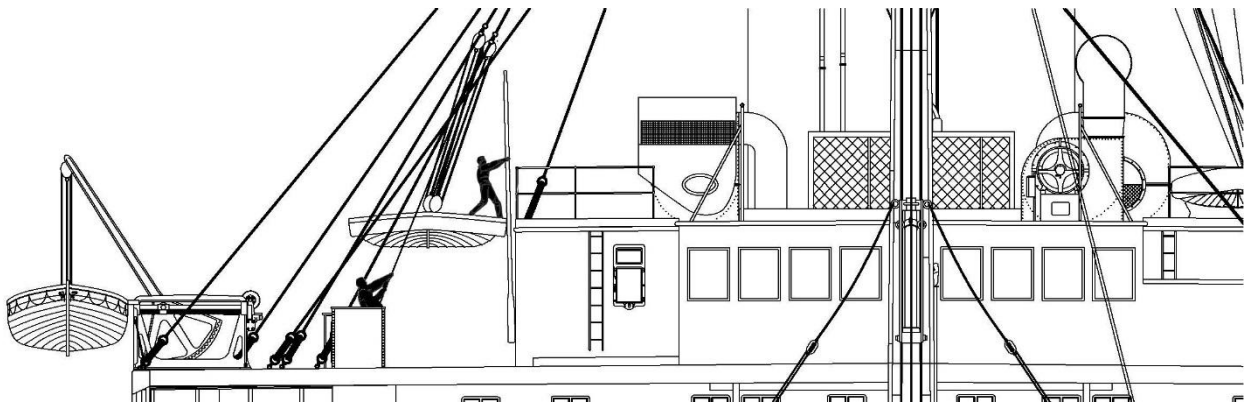
Figure 10 shows boat being cleared of the deck house and a crew member fending it away from the deck house with a boat oar.

Collapsible boat clearing deck house

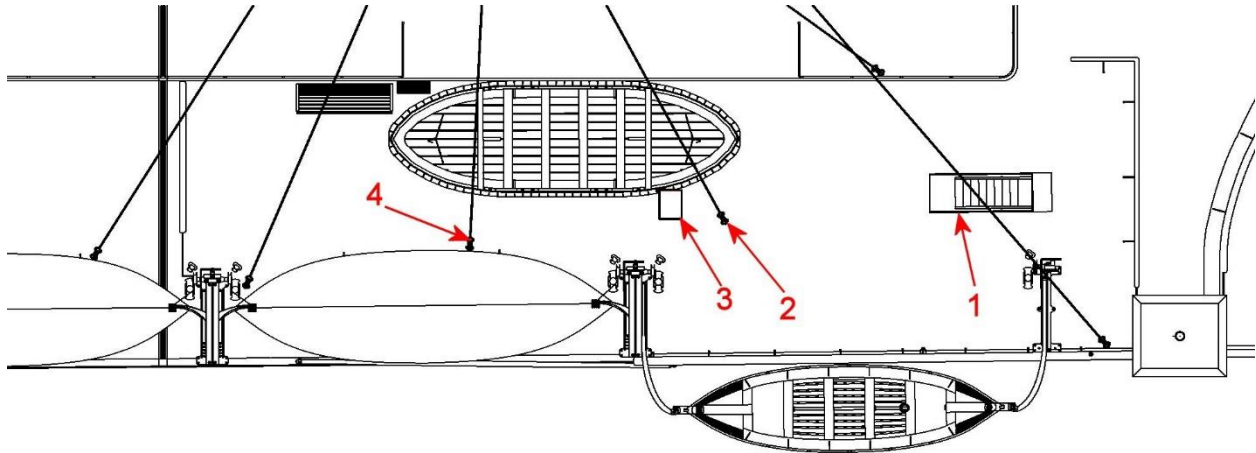
Figure 11 shows the collapsible boat lowered to the deck. In this drawing four obstacles to moving the boat to either the first or second starboard davits are shown. Obstacle #1 is the crew stairway surround. Obstacle #2 is the #3 starboard shroud of the first funnel. Obstacle #3 is the Kelvin sounding machine. Obstacle #4 is the #4 starboard shroud of the first funnel. To move the boat to the first davit would require dealing with obstacles #1, #2 and #3. To move the boat to the second davit would only require dealing with obstacle #4 so this would be the most logical destination for the collapsible boat. There is evidence because of the vertical forward davit arm of lifeboat station #1 on the Titanic wreck that they tried to move collapsible

boat A to this davit position. It may have been possible that the sounding machine was not bolted to the deck but rather had pins which were placed in sockets like the boat chocks. In that case, it would be just as easy to cut the lanyards of shroud #3 and move the boat to the lifeboat station #1. However, we do not know the precise method of securing the sounding machine.

Obstacles to moving the collapsible to a davit pair

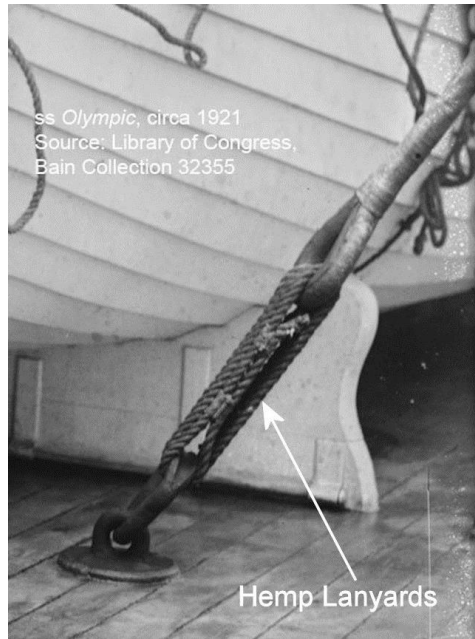
To eliminate obstacle #4, the hemp lanyards between the thimble eyes must be cut with a knife. In the event that the roof top collapsible boats would be needed, the sinking of the ship would be a certainty. Removing one shroud attachment would introduce no undue stability to funnel #1. Figure 12 shows the hemp lanyards at the deck level which would be cut.

Hemp lanyards to be cut to clear shroud from path of collapsible boat

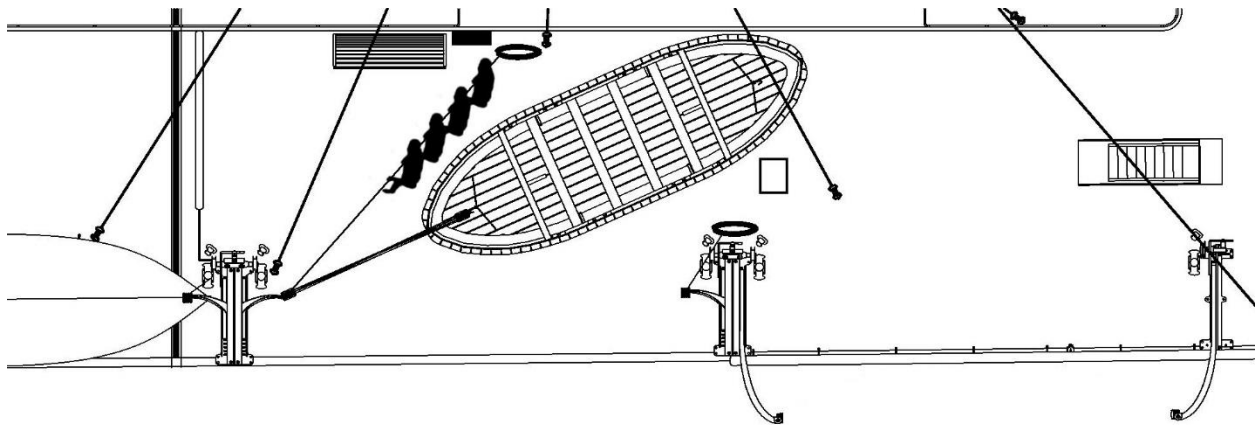
Once the obstacle of the shroud was eliminated the aft davit falls could be attached to the collapsible boat and four crew members could haul it under the davit where the forward falls could be attached. The chocks for the 30 ft. boat would also be removed from the deck. Once under the davits with falls attached, the boat could be made ready for launch and loaded with passengers. After loading, the boat could be launched. Figure 13 shows the boat being hauled into position under the second davits.

Collapsible boat hauled into position for launch under davits
