# An Examination of the Color “Dark Mast” Found on *Titanic*

By Bob Read, D.M.D.

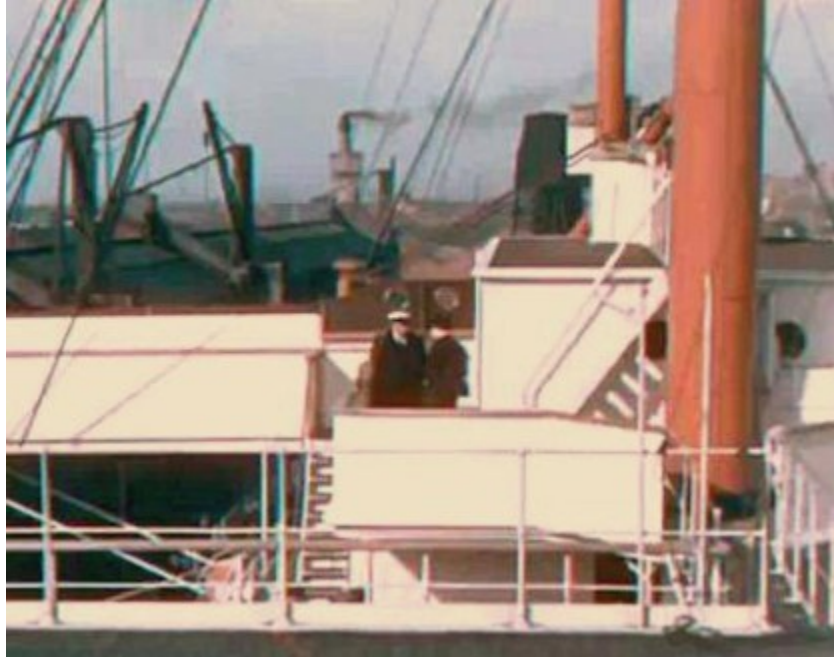
The color dark mast was known before the actual name was identified. From builder’s models and photos, the color was identified as a rust color. Figure 2 is an image from a motion picture taken aboard R.M.S. *Adriatic* in 1926. While the color from the motion picture is not perfect,

this rust color which we now know as dark mast is clearly seen as applied to the ship's masts. In the interest of full disclosure, this film was made with a two-color (red and blue) process. The green component is not present. However, while this photo may not represent the color dark mast perfectly, the color is not so far off that in reality it is some type of dark brown paint.

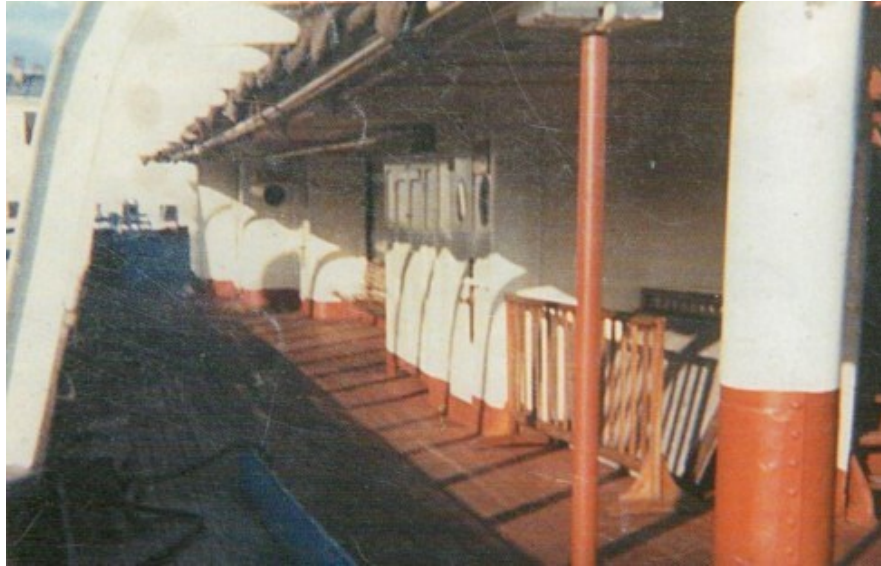
Another White Star Line vessel, the tender SS *Nomadic* had areas painted this same color. In 1934 *Nomadic* was sold to Societe Cerbourgeoise de Sauvetage et de Remorquage and renamed *Ingenieur Minard*. Her funnel livery was changed but other areas of *Nomadic's* original livery have remained the same. Figure 3 is a photo taken aboard which shows this same rust color.

The first areas of White star Line ships identified from models as being painted this color were what are known as “dadoes”. In figure 3 we can see that the lower parts of the deckhouses and columns were painted dark mast. These lower areas are known as “dadoes”. The primary purpose for painting these lower areas a darker color than the upper white was that they didn’t show dirt as much as if the part near the deck were painted white.

To further illustrate what happens to the appearance of the color dark mast when photographed by blue sensitive black and white film, Figure 3 will be used. This photo was edited to simulate what it would look like if photographed by blue-sensitive black and white film. The result is show in Figure 5. You can see how dark the dark mast areas are. This isn't a matter of altering brightness. You can see the white areas are relatively unaffected.

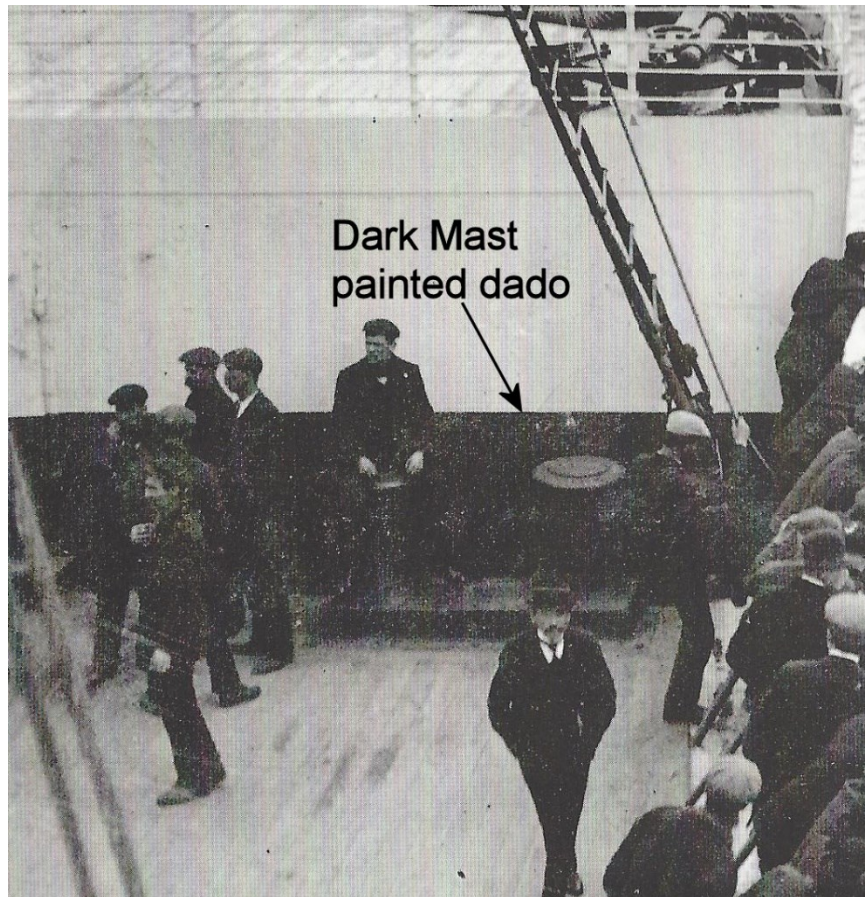
Knowing what the color of the dadoes in *Titanic’s* well decks was, it was possible to see the effects of early blue-sensitive black and white film on how this color appeared. Most black and white film at the time of *Titanic* was blue-sensitive. The effect of this type of film was that it made warm colors such as reds, yellows, and oranges appear very dark. It also made blues appear almost white. Figure 4 is a photo showing the forward well deck area of *Titanic*. The well deck dadoes which were painted dark mast are clearly visible. It is also apparent that these areas appear very dark with the blue-sensitive black and white film.

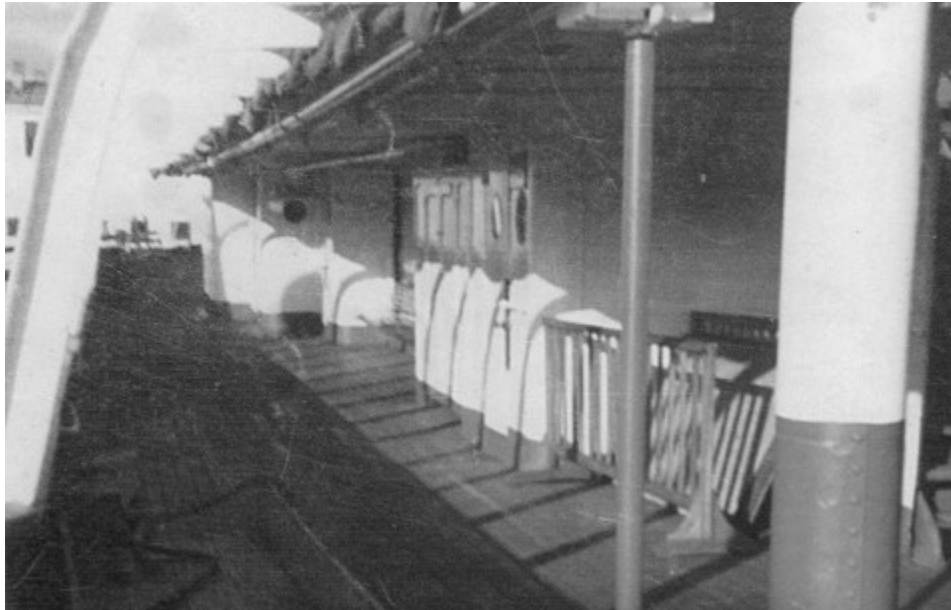
Figure 6 shows the same photo if it were simply converted to a black and white image which would result from the use of modern black and white film.

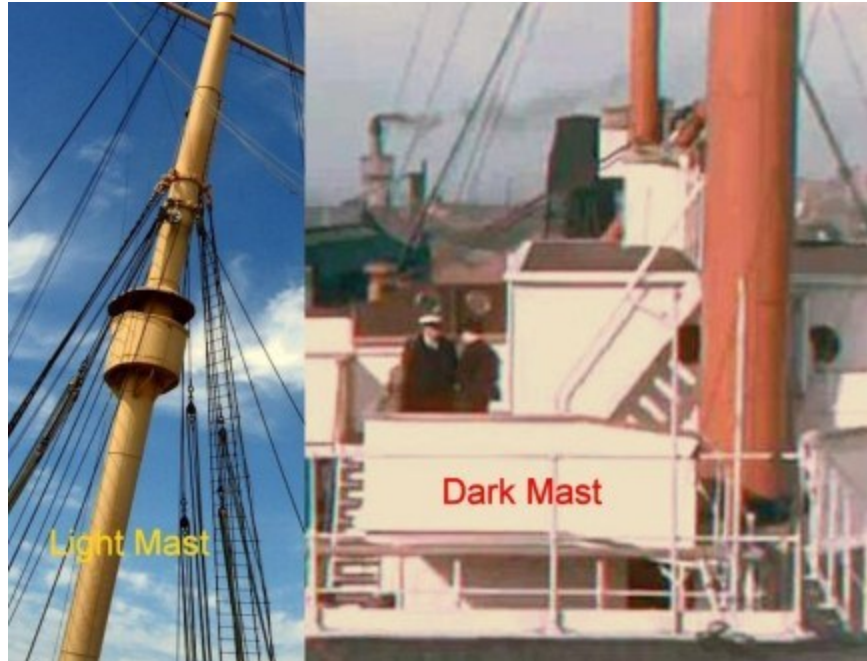
A point which was raised during some online forum discussions was that if this is supposedly dark-mast then why doesn't it look very dark? The answer is that it isn't called dark mast because it is inherently dark. It is called dark mast in contrast to another color which was used below decks on *Titanic*, namely "light mast". Figure 7 shows a comparison between the color "light mast" used on *Queen Mary* and dark mast on *Adriatic*.

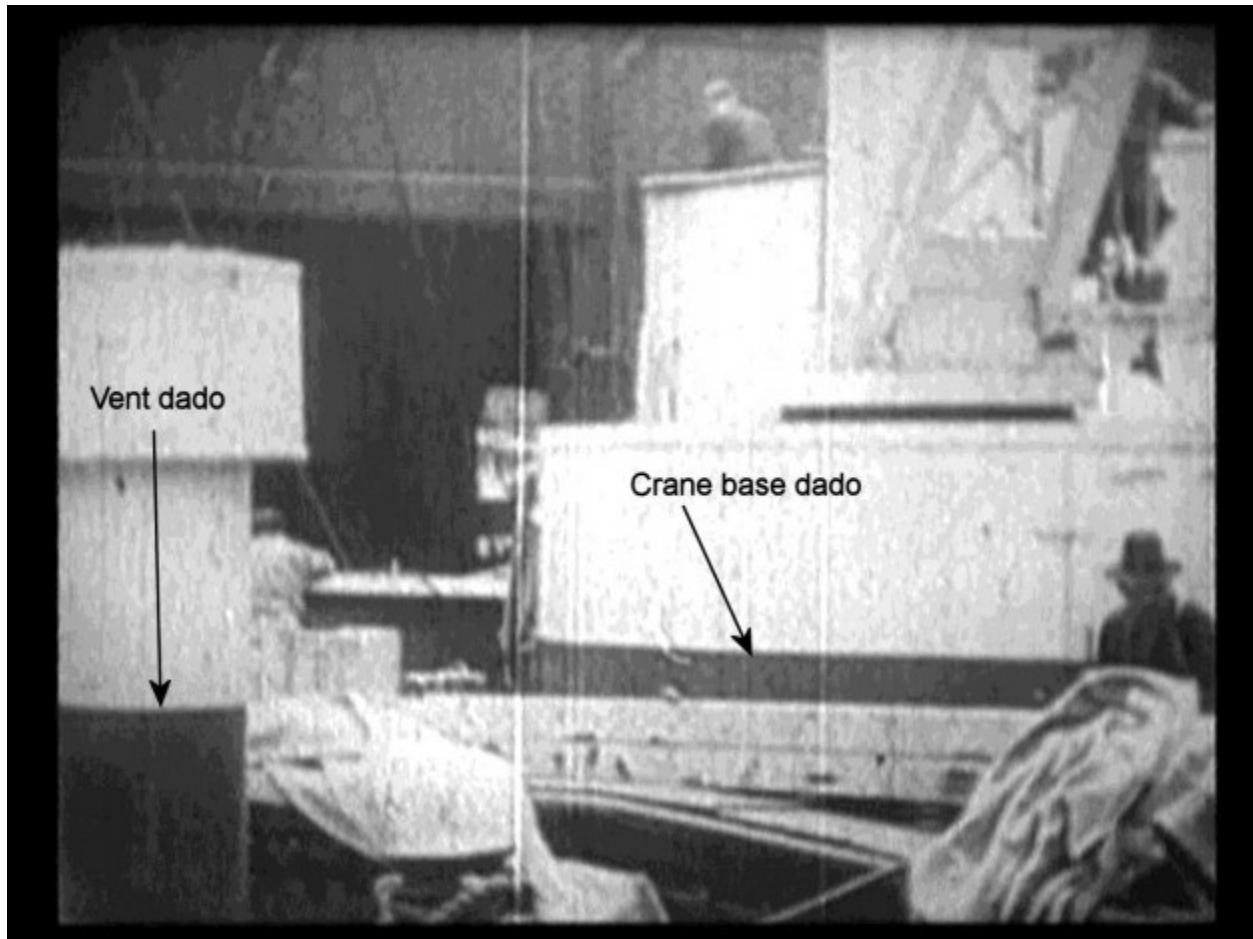
The first category of undocumented areas of dark mast application is one where there is no documentation but there is little, if any, doubt about the presence of dark mast. The application areas which would fall into this category are the electric crane base and ventilator dadoes in the forward and aft well decks. Figure 11 shows the forward well deck of *Olympic*

showing the dados of a ventilator and one of the electric crane bases. There is nothing in black and white photos which would rule out dark mast application to these areas.

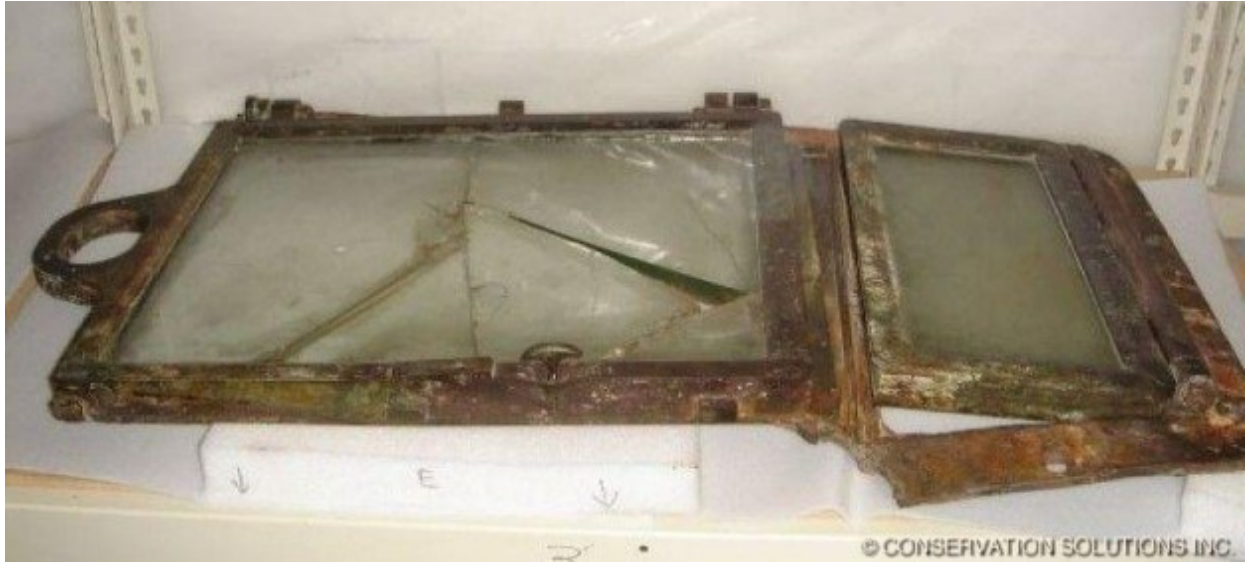
Figure 12

The second area where there appears to be evidence of dark mast paint application but where there is no specific documentation is to the cast brass officers' quarters windows. In 2000, an officers' quarters window was recovered by RMS Titanic Inc. The window before conservation procedures were undertaken is shown in Figure 12.

In looking at the window before conservation procedures, one would think that he is looking at a brown paint on the window. However, any coloration on the surface at this point can't be taken as evidence of any particular color of paint. Figure 13 shows one of the officers' quarters windows in place on the *Titanic* wreck.

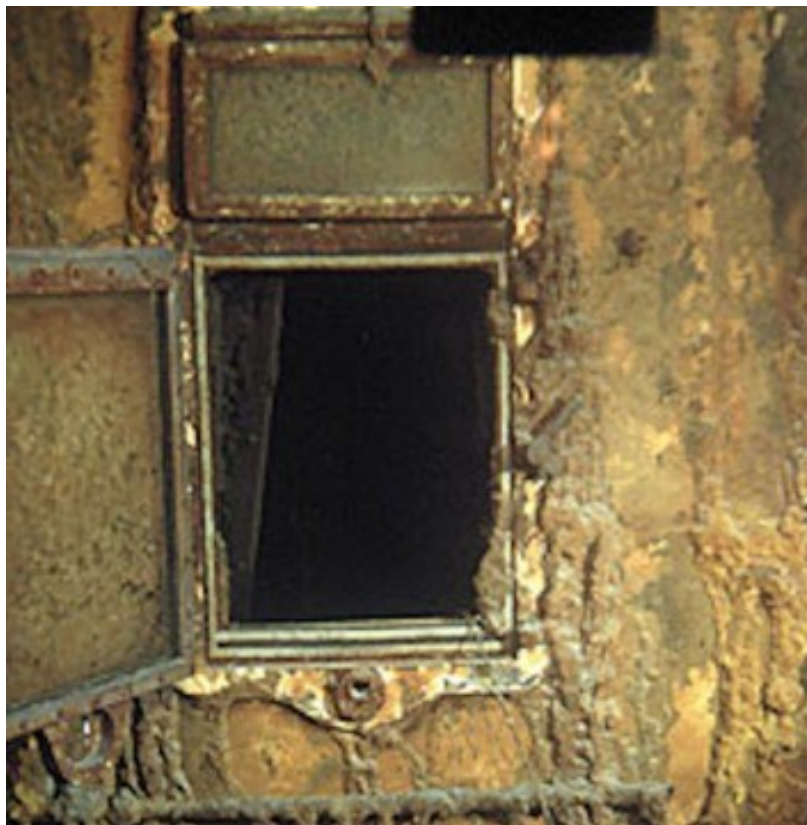
Figure 13

As one can see in this photo, it is impossible colors in this state. Because of the accretions, the once bright white bulkhead walls are a brownish gray color which is far from their original state. Over a period of a year, the conservation procedures were undertaken by Conservation Solutions Inc. When finished this was seen in Figures 14 and 15.

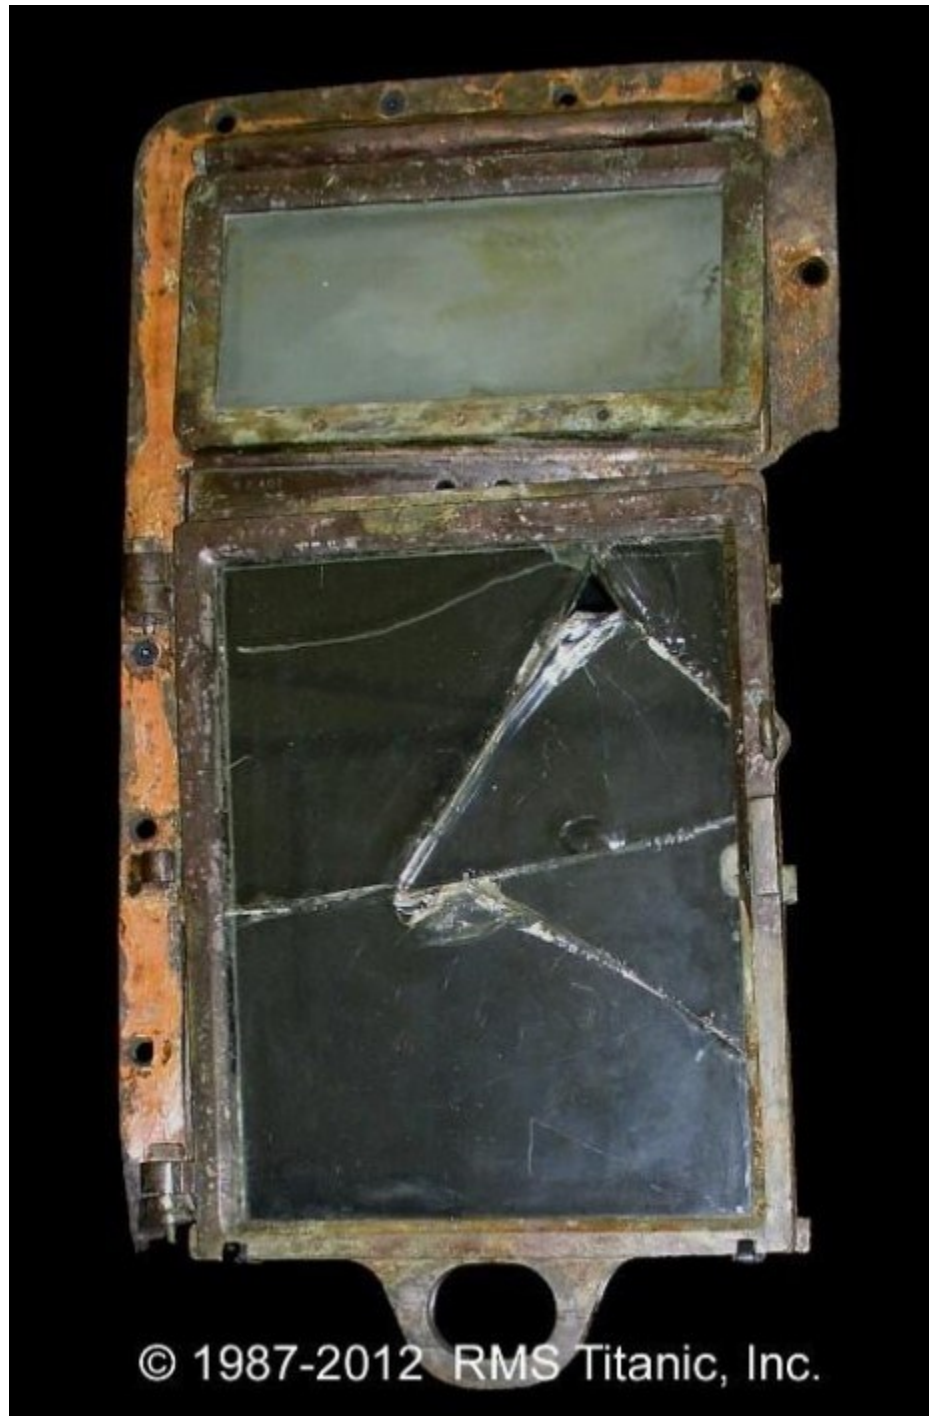
Figure 14

As can be seen in Figure 14, the only paint which is left on the window frame is primarily on the left and top sides of the frame. The rest of the frame is oxidized brass with no residual paint. Some have looked at the frame which has undergone conservation and think that the brown is paint however it is merely bare oxidized brass.

The real controversy which has arisen about this frame has to do with the paint remnants. Some have accepted the evaluation of noted Titanic authorities who contend that the paint remnants are merely primer and the deep brown color coat has been completely lost.

I disagree. I believe that what is seen on the window frame is the dark mast paint we have previously described. The primer which was exclusively specified in the *Britannic* Specification Book for many varied applications is red oxide or as it is also known, red lead. I contend that the color seen on the windows is not a red oxide primer. Figure 16 shows the color of red oxide primer in an actual application rather than a paint chip.

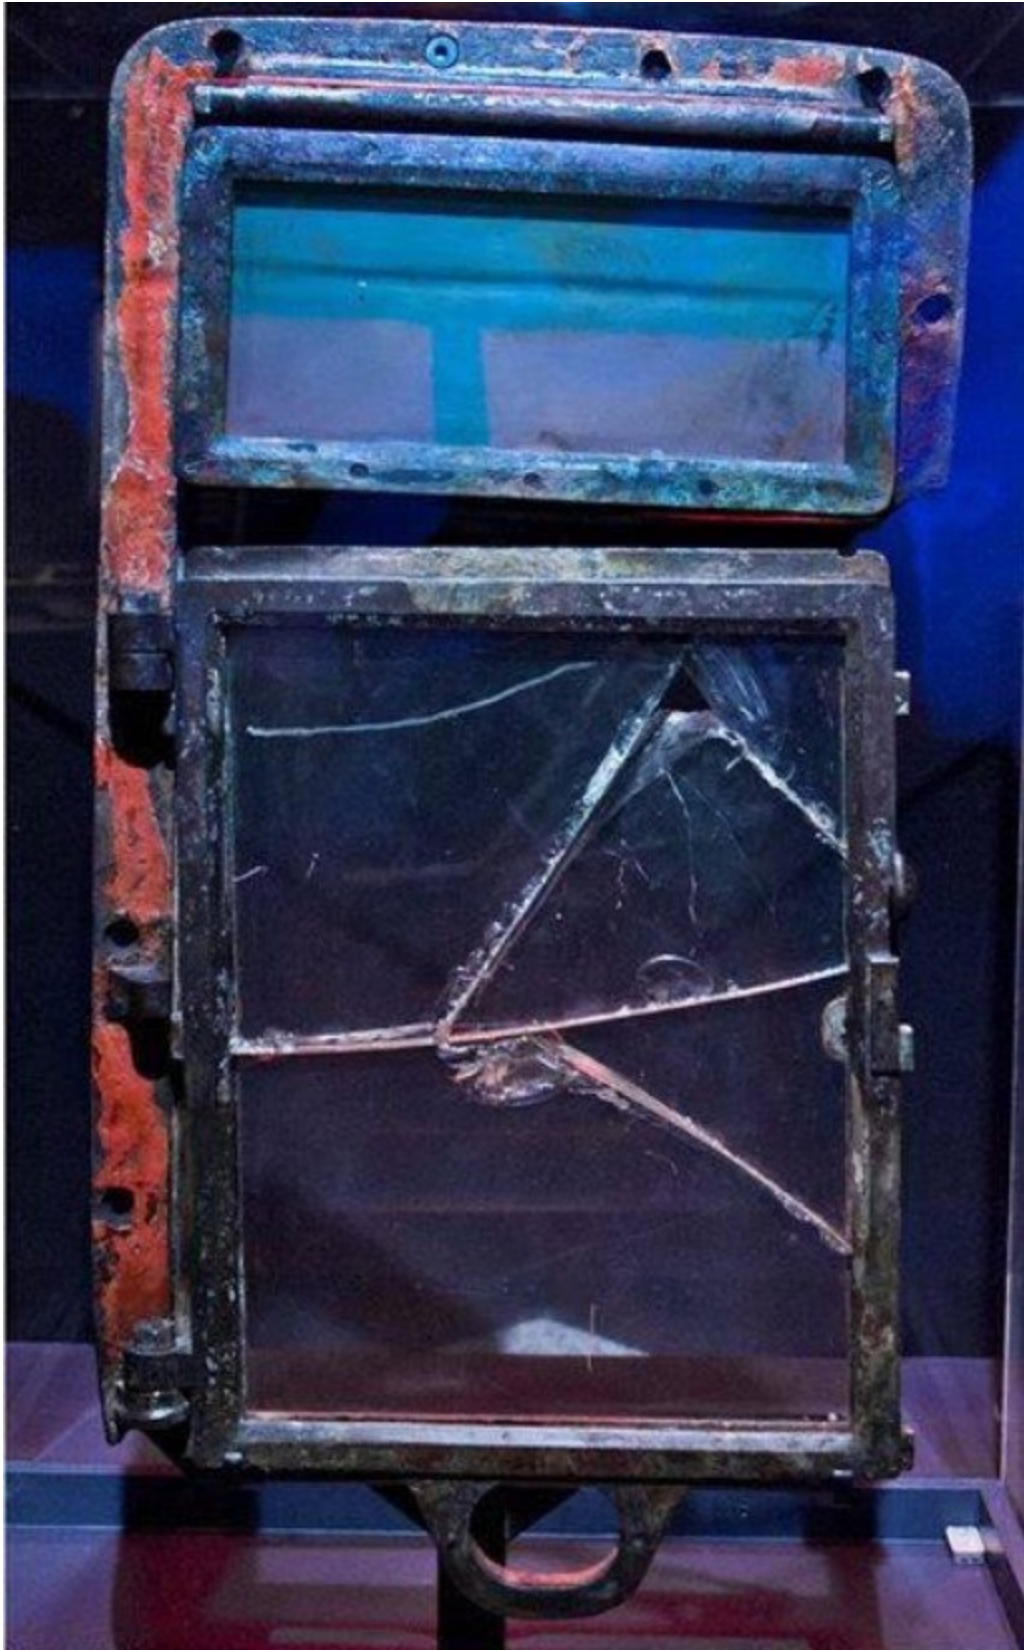
Another point is that if this were red oxide primer on the window, why would we not see dark brown paint adhering to it? The purpose of a primer is to increase paint adhesion to the surface to be painted and to provide a flat surface to which the color coats of paint can adhere. It is difficult to believe that every trace of the supposed dark brown paint was selectively removed from the frame with not a bit of it adhering to a primer coat. I would refer anyone who believes this is merely primer to the conservator, Conservation Solutions, Inc. They described the conservation process this way: "After recovery in 2000, the window was desalinated over a period of a year and placed on display. Despite the violent damage that tore away one side of the bronze frame, the 1-inch-thick glass was broken but in place, **original painted finishes were intact** [emphasis added], and both casement and transom hinges functioned." This was the only painted finish on the frame. There is no mention of any other paint being "lost". The Conservation Solutions, Inc. article can be found here: [Titanic Officers' Quarters Window Conservation and Mounting](#). Some may look at Figure 14 and believe that they are looking at dark brown paint on the window frame rather than bare oxidized brass. Figure 17 is taken in different lighting conditions with more of a blue light and you can see the oxidation on the bare metal and nothing which would indicate brown paint.

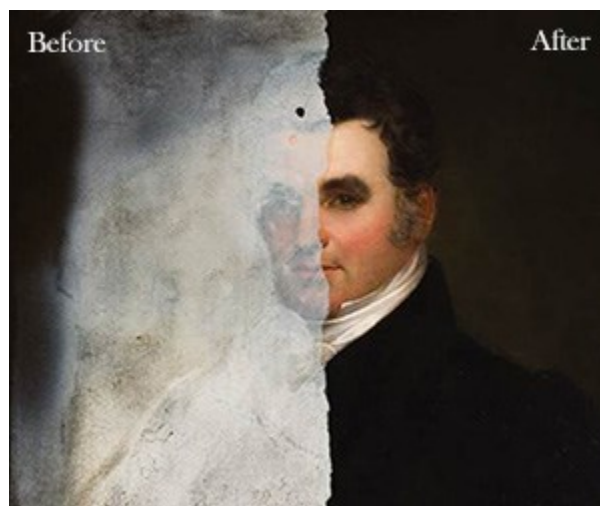
Another objection to the paint of the officers' quarters windows being dark mast is that critics say that any paint on the window frame has been irreversibly altered after 88 years underwater so that we can't tell what the original color was. No evidence has ever been offered to support this objection. Water damaged paint has been and is restored on a regular basis. Figure 18 shows a before and after photo of a painting which was water damaged. The restoration was done by Lis Art Conservation and Restoration Services. A description of their water damage restoration services is given [here](#).

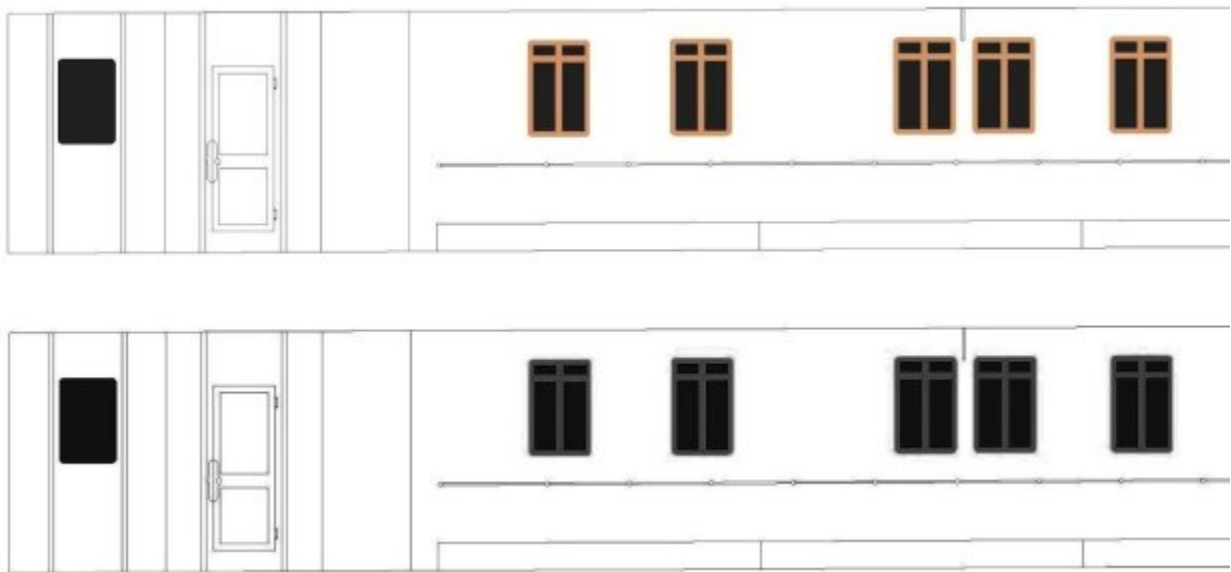
the rather limited color palette used in exterior areas of the ship. Below decks there was some use of a color called “chocolate” in work areas. There is not one reference to its use above decks. The first area may be speculative, but by association the painted brass window frames on forward A and B decks may well have been painted dark mast. If a dark brown color was in use for window frames on the boat deck it would seem logical that it would also be used on the brass framed windows on forward A and B decks. But since we have evidence of dark mast being used on the window frames on the boat deck officers’ quarters windows, it is likewise reasonable to speculate that this color was also used on the A and B deck forward brass framed windows. Figure 19 shows a colored drawing of some of *Titanic’s* A deck forward windows if they were painted dark mast. Below this is the same drawing converted to how it would appear if the colors were recorded by blue sensitive black and white film.

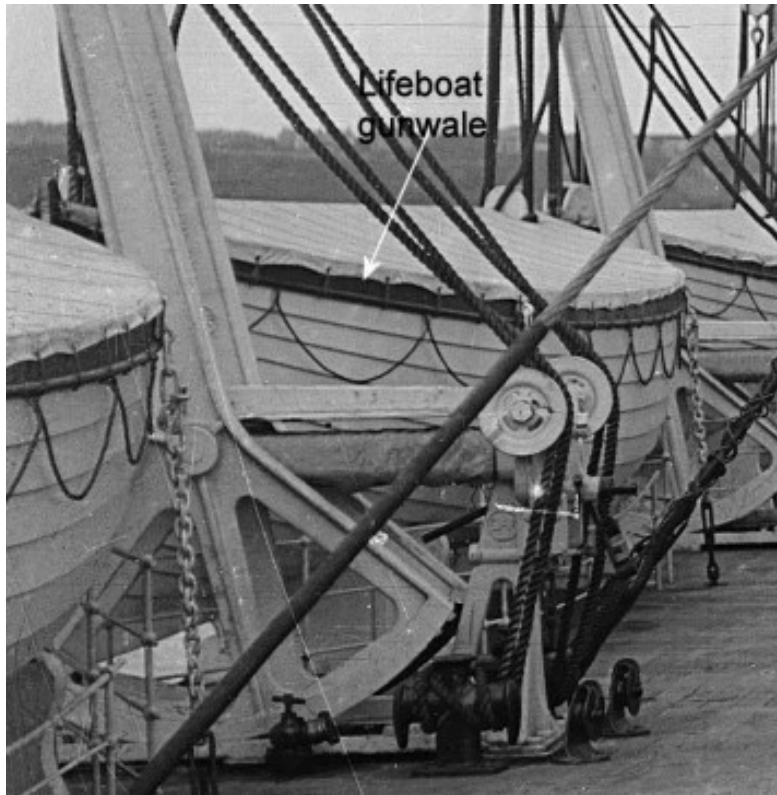
A second area which has the same dark painted appearance in blue sensitive black and white photos is the gunwales of *Titanic’s* lifeboats. There is no documentation or direct evidence here. Figure 20 shows the lifeboat gunwales as recorded by blue sensitive black and white film.

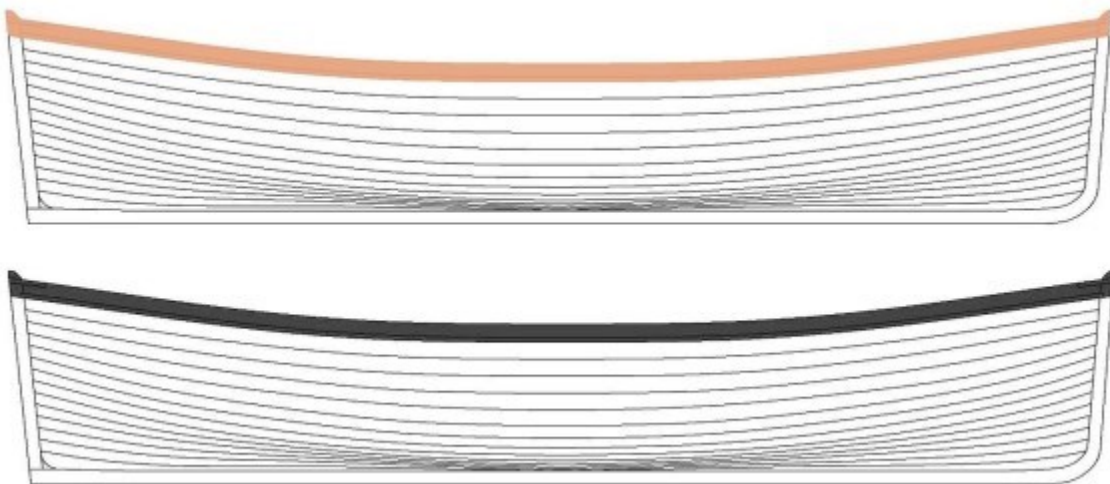
Figure 21 shows drawings of *Titanic's* lifeboats. This is a comparison of a color drawing which has the gunwales painted dark mast and a conversion of the image to what would be seen in a blue sensitive black and white photo. This shows how dark this color can look in blue sensitive black and white film images.

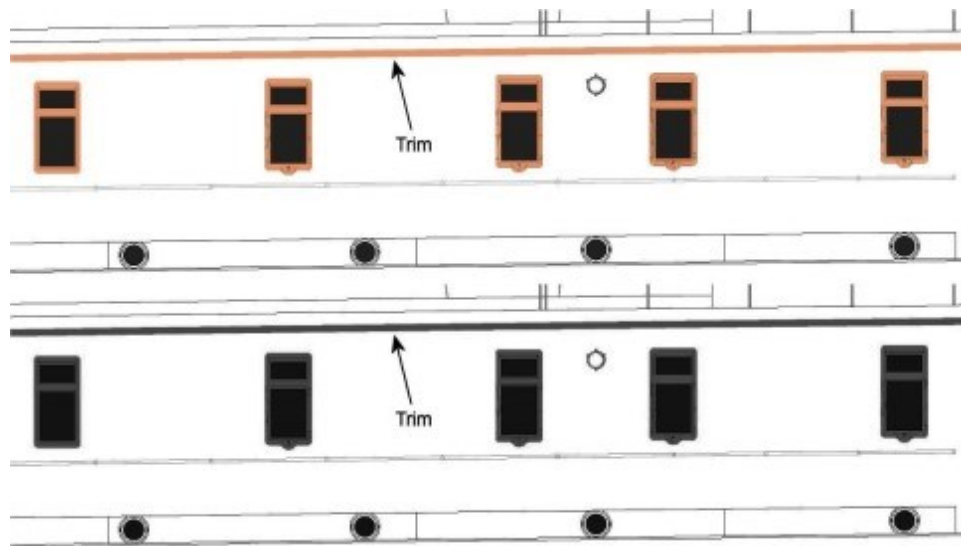
The third area which has the same dark painted appearance in blue sensitive black and white photos is the painted trim in various areas. This trim is primarily seen around the roof of the deckhouses under the first and second funnels. Figure 22 has a color drawing of the officers' quarters deckhouse showing the location of the painted trim and below it is the same drawing converted to the appearance it would have if it were recorded on blue sensitive black and white film. Again, paint application here is speculative but it appears at least reasonable given what we know of the application of dark mast to other areas.
