Operation of *Titanic's* Engelhardt Collapsible Lifeboats

By Bob Read, D.M.D.

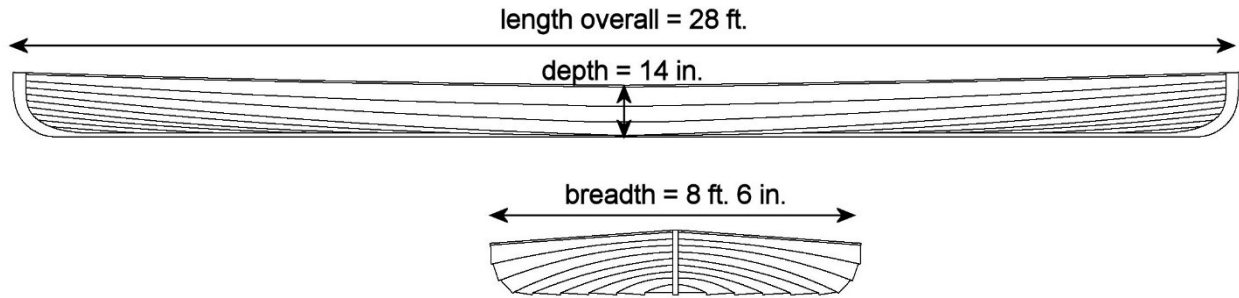
Figure 1

Principal dimensions of *Titanic's* Engelhardt boat wooden hull

The principal dimensions of the wooden hull were: Length overall = 28 ft., Depth = 14 in., Breadth = 8 ft. 6 in.

Figures 1 and 2 show the dimensions of *Titanic's* Engelhardt boat without the bulwarks.

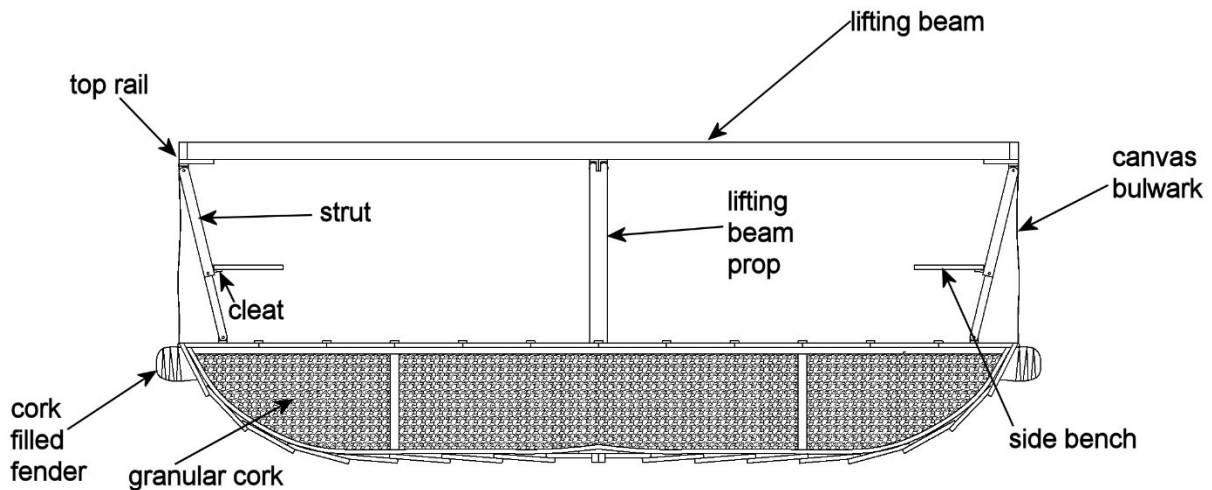
Figure 2

Top rail, struts, and lifting beam in raised position

The structures above the deck of the hull consisted of a top rail which was connected to the deck by folding struts. Figures 2 and 3 show the top rail, struts, and lifting beam in both collapsed and raised positions.

To raise the top rail and canvas bulwarks which were attached to the outer surface of the top rail and the deck, the two lifting beams were raised which unfolded the struts. The struts were two channel section lengths of steel. The lower part of the strut fit inside the upper part when they were collapsed and folded. The upper part of the strut was fastened to the top rail with a hinge. The bottom part of the strut was attached to the deck with another hinge. There was a third hinge between the upper and lower sections of the strut.

Figures 2 and 3 are shown in Figure 7 as a section between B-B. Figures 4 and 5 are shown in Figure 6 as a section between A-A.

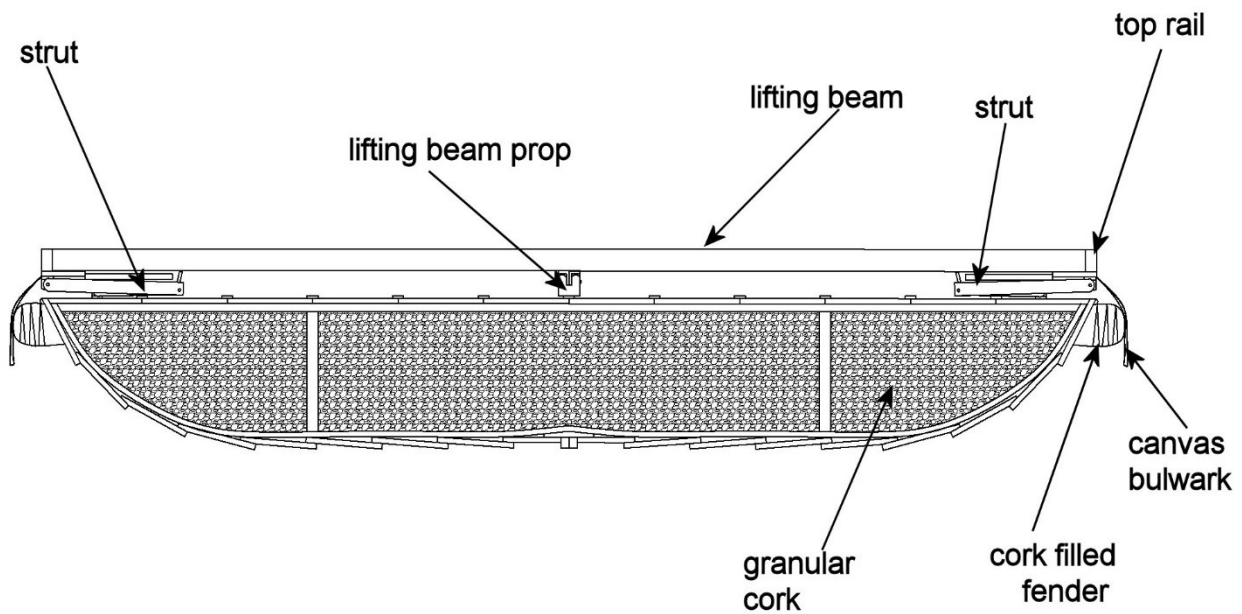
Figure 3

Top rail, struts, and lifting beam in collapsed position

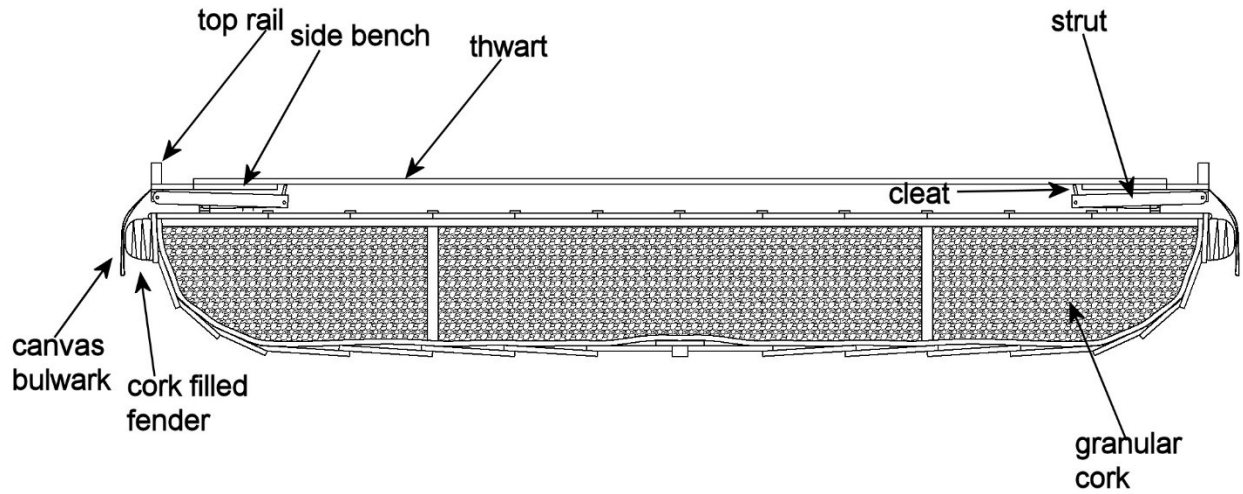
Figure 4

Side benches, thwarts, and bulwarks in collapsed position

The side benches and the thwarts were a one-piece unit. This seat unit was “free-floating” in that it had no attachment to any other structures. When the top rail, lifting beams, and canvas bulwarks are being raised, there are cleats on the inboard surface of the struts which engage and lift the seat unit to the proper height. The weight of the seat unit prevents the struts from collapsing. Also, the lifting beams have hinged props which rotate downward and support the lifting beams at the proper height.

Figures 4 and 5 show the seat unit in its collapsed position then supported by cleats on the struts in its raised position.

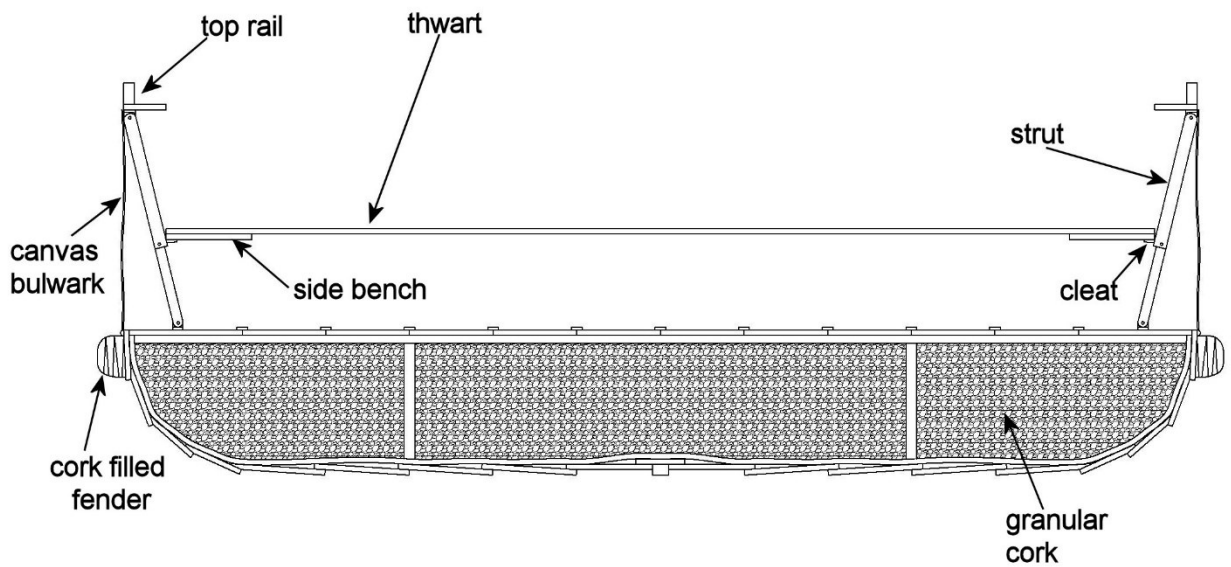
Figure 5

Side benches, thwarts, and bulwarks in raised position

To lower the bulwarks, the seat unit must be lifted slightly to take the weight off the struts. Then the lifting beam props are disengaged and the lifting beam is pushed downward which causes the struts to begin to fold. The seat unit is released and the weight causes the bulwarks, struts, and seat unit to fold down to their lowest collapsed position.

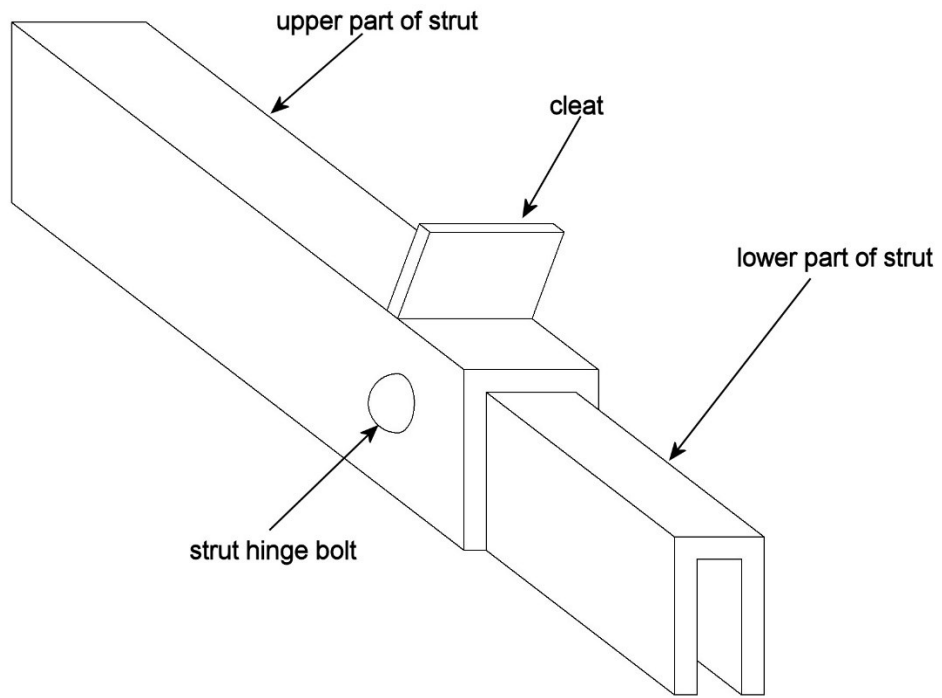
Figure 6

Construction of strut

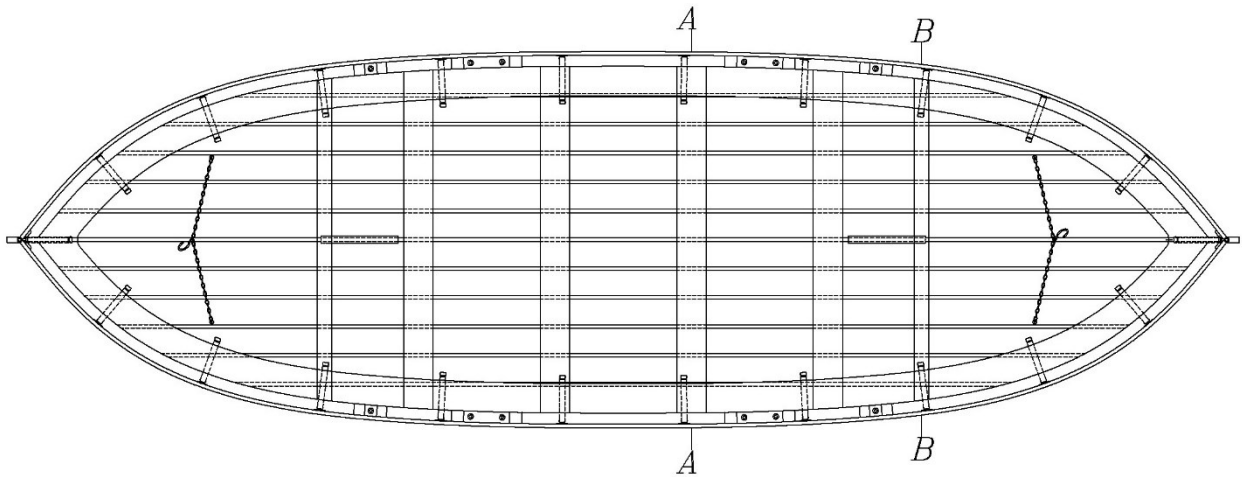
Figure 7

Engelhardt boat in collapsed position showing reference sections A-A and B-B

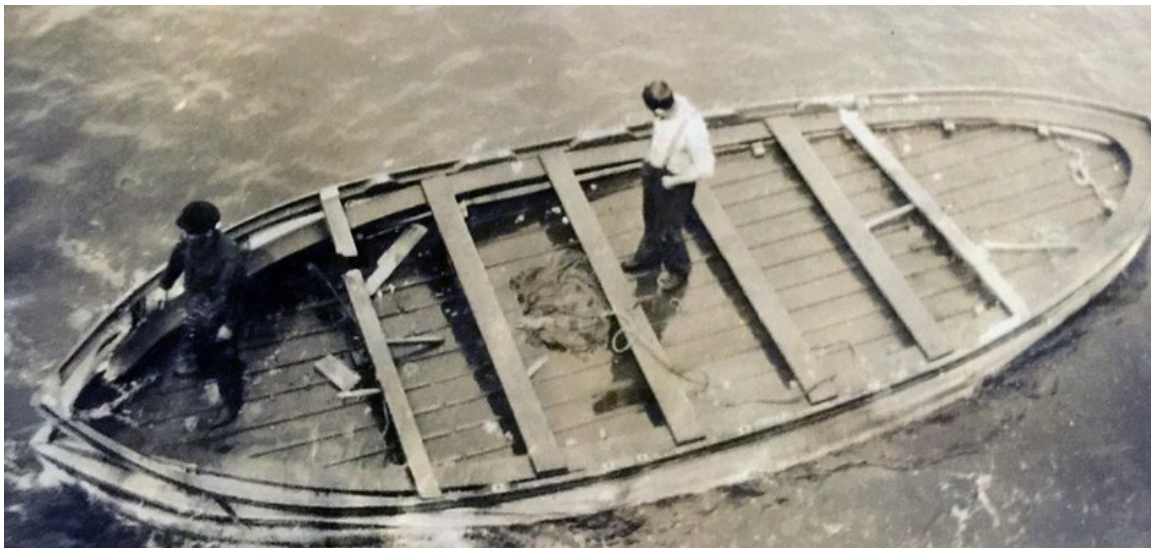
One of *Titanic's* Engelhardt boats found by RMS *Oceanic*

Figure 8 is a photo of one of Titanic's Engelhardt boats which RMS *Oceanic* found.

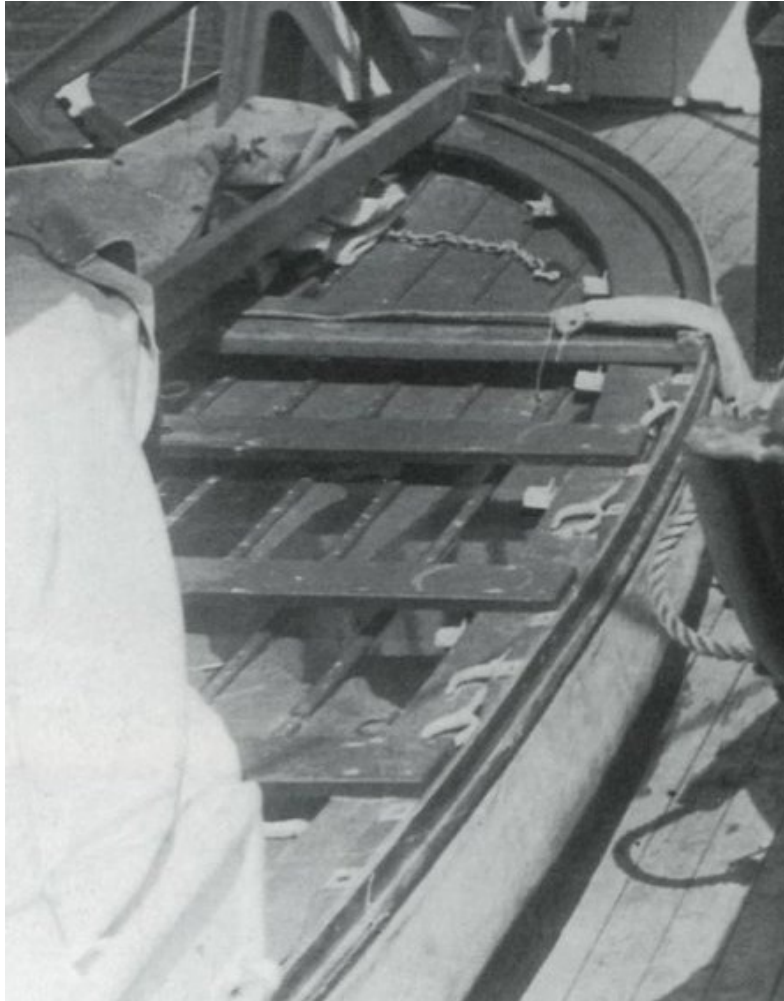
Figure 9

Engelhardt boat aboard RMS *Olympic*

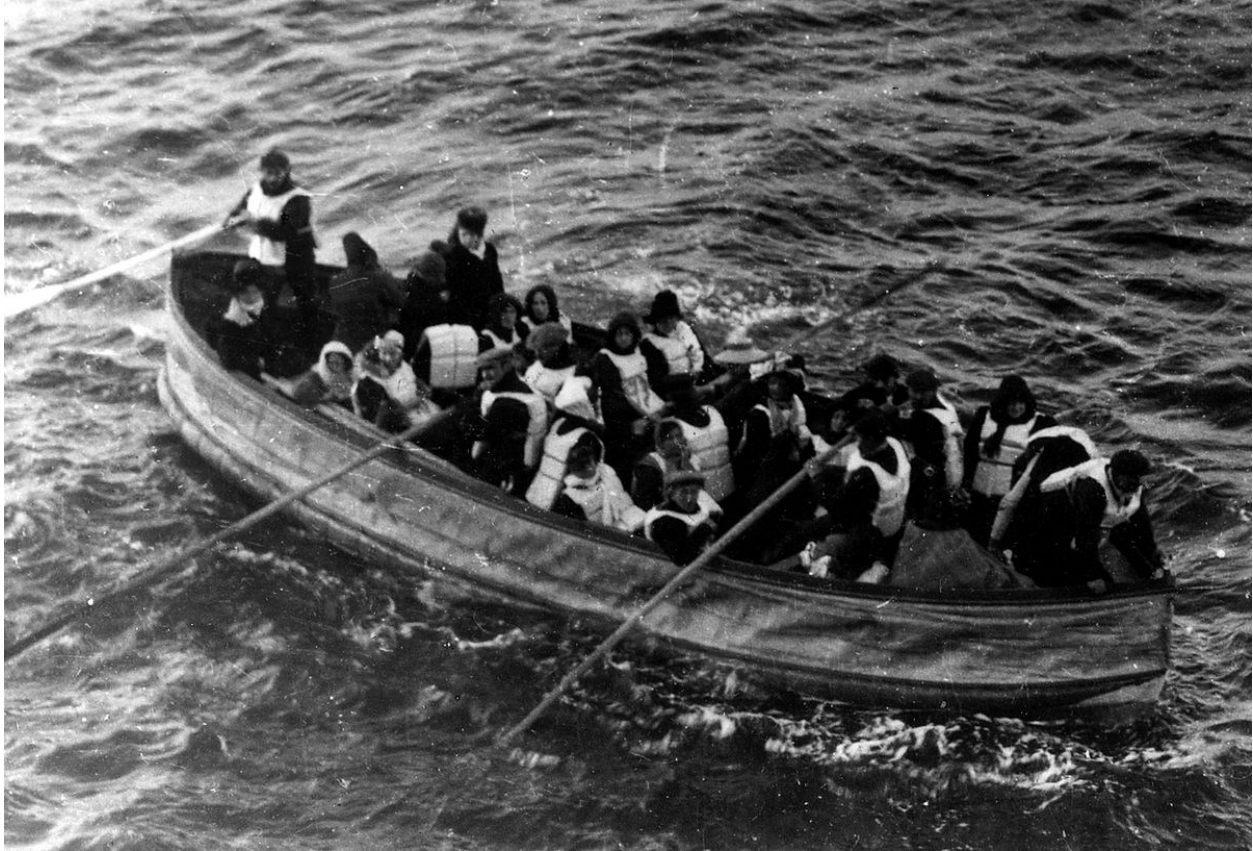
Figure 10

Titanic Engelhardt boat heading for RMS *Carpathia*
