# Wooden Plank Sheathing of *Titanic's* Forecastle Deck

By Bob Read, D.M.D.

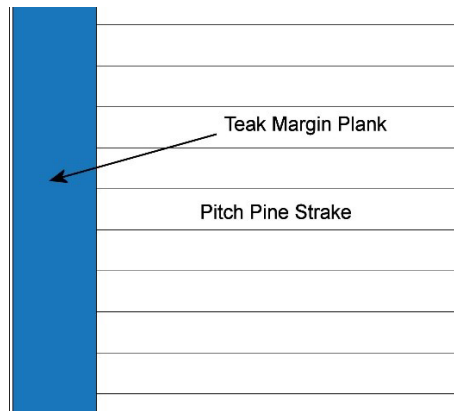
Figure 1 shows some of the terms discussed above which are labeled. In the drawing the pitch pine planking is not colored. The teak planking is colored blue.

### Plank sheathing terminology

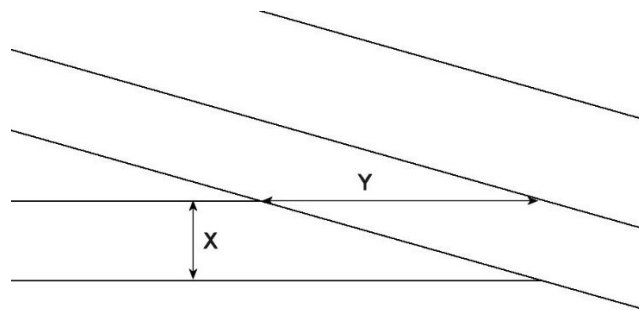
Figure 2 shows planks meeting a margin plank at an angle. The angle is such that if the planks were cut to the angle of the margin plank there would be a long featheredge on the plank end. If the length of this bevel  $Y$  is measured, it can be seen that it is greater than the width  $X$  of the plank. This means the plank must be nibbed.

Bevel where pitch pine planking meets margin plank

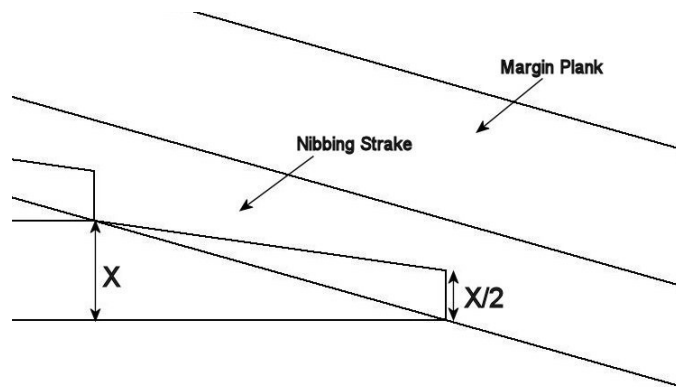
Figure 3 shows how the plank is nibbed. Where the bottom edge meets the margin plank, a distance one half of the width of the plank is measured perpendicular to the plank. From the end of this line, another line is drawn to the point on the plank where the top edge meets the margin plank at full width. The plank is now cut to these nibbing lines. The plank is then set against the margin plank and the margin plank is cut to match so the nibbed plank fits into it. In this figure you can see that the length of the bevel of the plank is greater than the width of the plank  $X$ , so nibbing is needed. On the outboard edges of *Titanic's* forecastle deck there was a margin plank and inboard of it was a "nibbing strake" also of teak, into which planks were nibbed.

### Procedure for nibbing planks

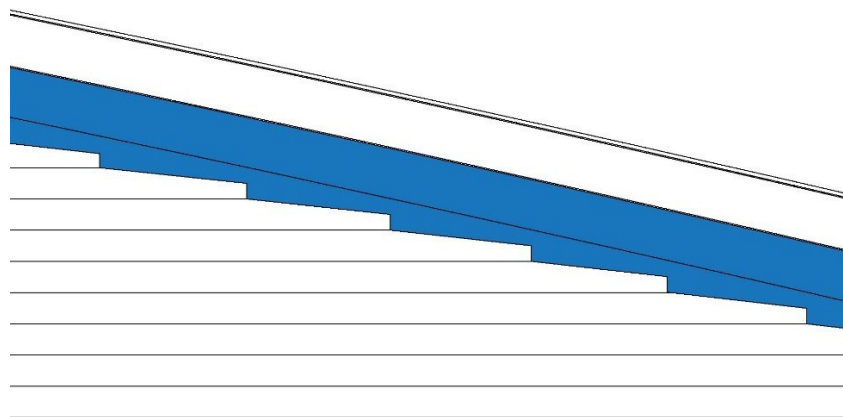
Figure 4 shows the finished nibbing into the nibbing strake inboard of the margin plank.

### Planks nibbed

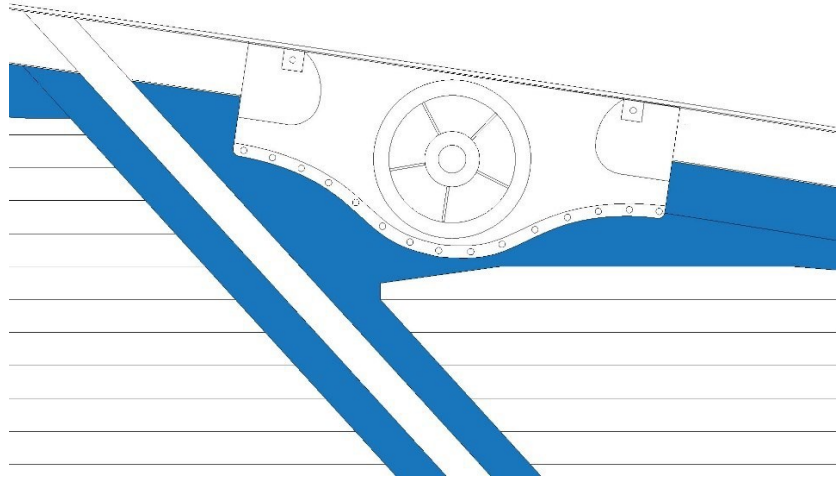
Figure 6 shows the planking around the single roller fairlead just forward of the breakwater. The roller fairleads sat directly atop the teak margin planking and were riveted through the steel deck below. The outboard edge sat over the steel channel section waterway.

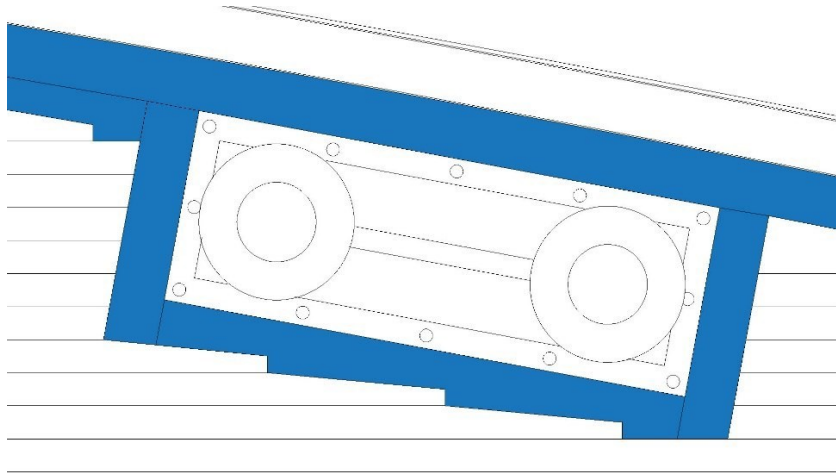
Figure 7 shows the area around the aftmost bollard. The bollards were riveted directly to the steel deck. Therefore, a teak margin plank had to be fitted around it. This drawing shows the margin planks around the bollard and the nibbing of the pitch pine planks into it.

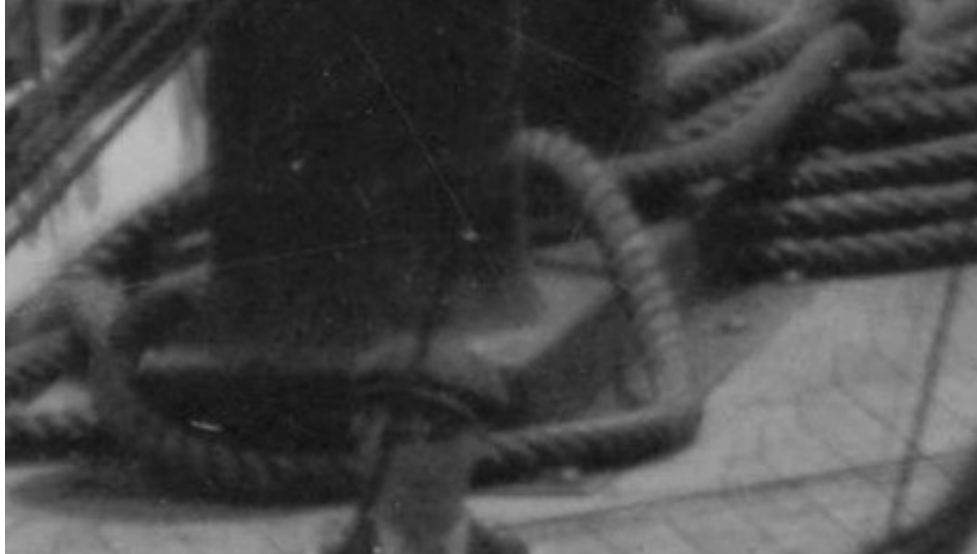
Figure 8 shows the nibbing of the pitch pine planks into the margin plank around a forecastle bollard on *Olympic*.

### Deck sheathing around forecastle bollard

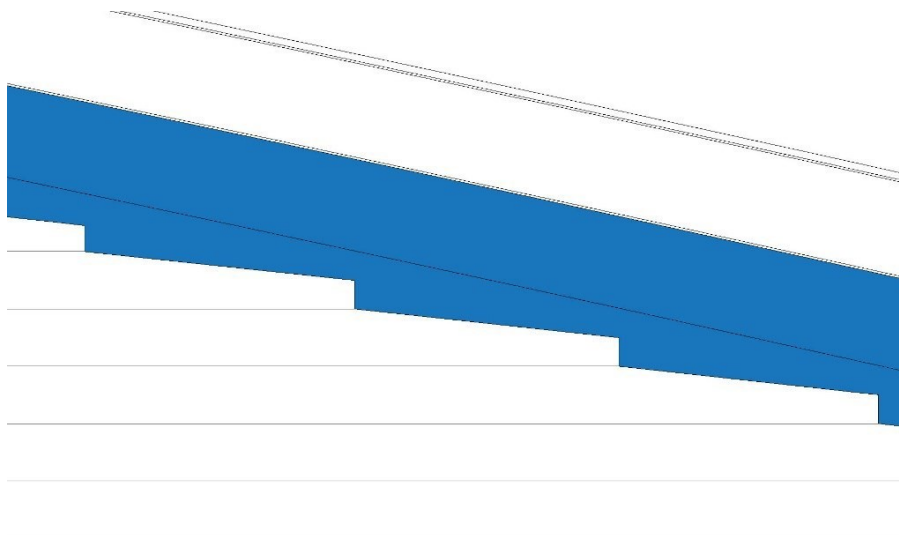
Figure 9 shows the nibbing of the pitch pine planks into the teak margin plank which is inboard of the channel section waterway.

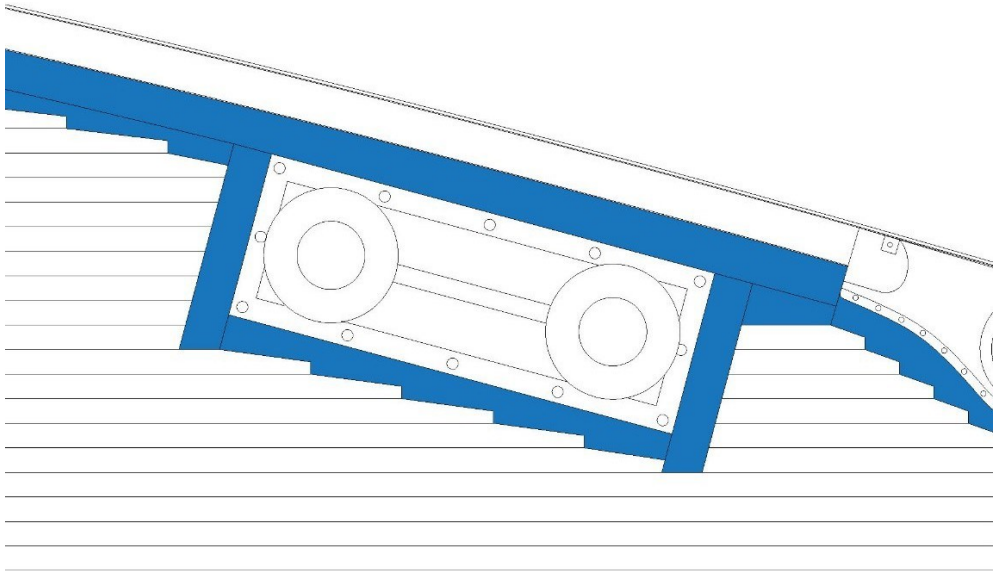
Figure 10 shows the middle bollard just aft of the double roller fairlead and teak margin planking and the pitch pine planking nibbed into it.

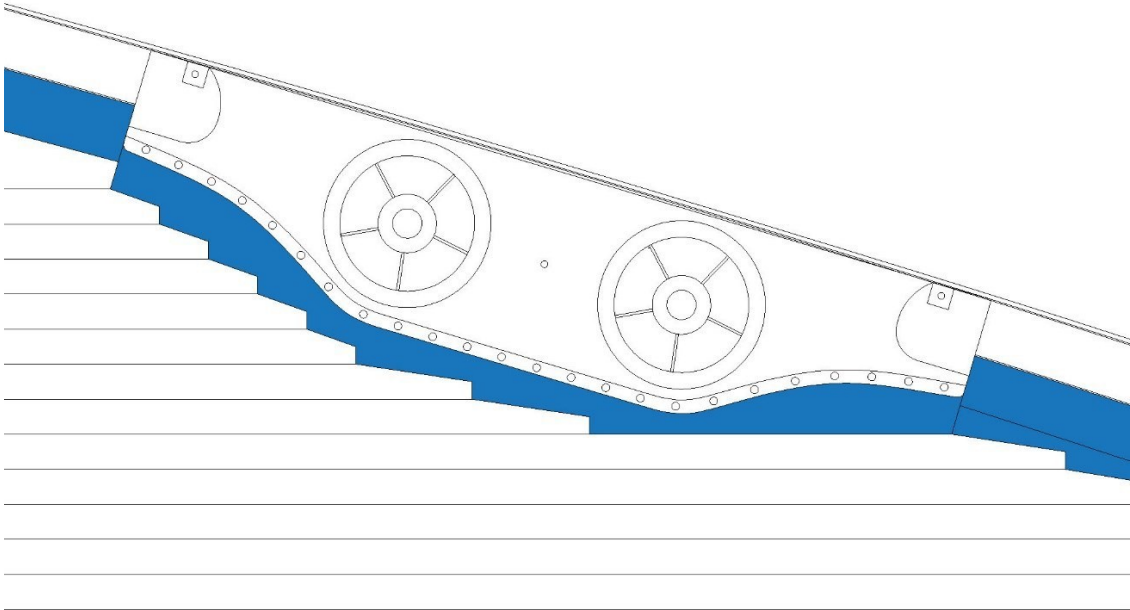
Figure 11 shows the teak margin planking and pitch pine planking around the double fairlead.

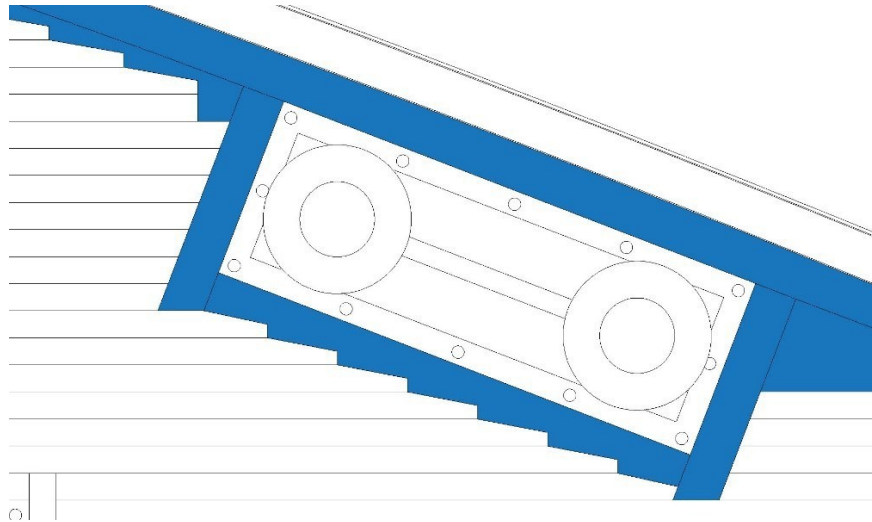
Figure 12 shows the teak margin planking and the pitch pine planking around the forward bollard.

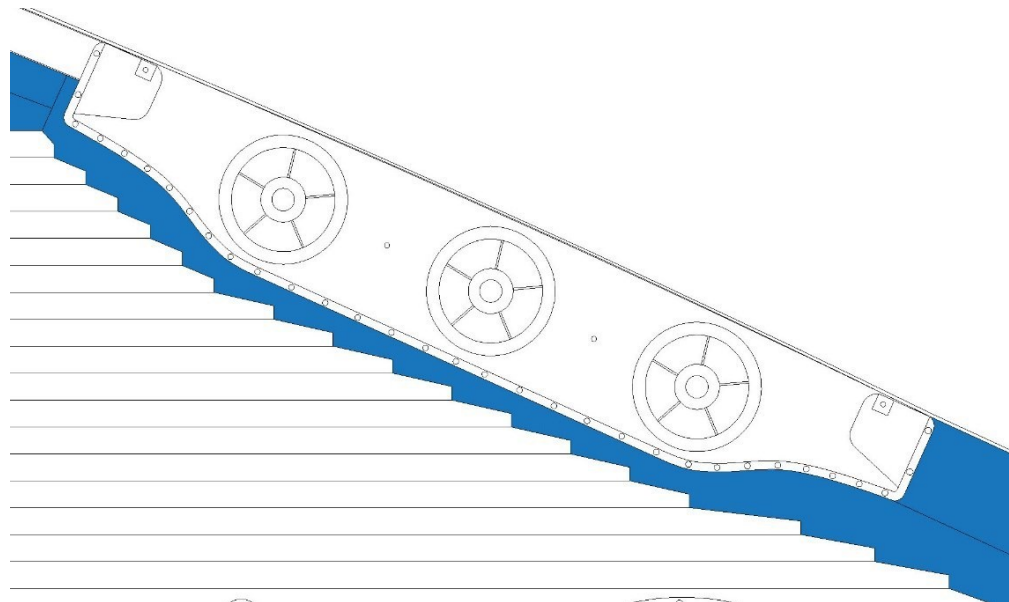
Figure 13 shows the treble roller fairlead. The waterway terminates just aft of the fairlead. The fairlead sits completely atop the margin planking.

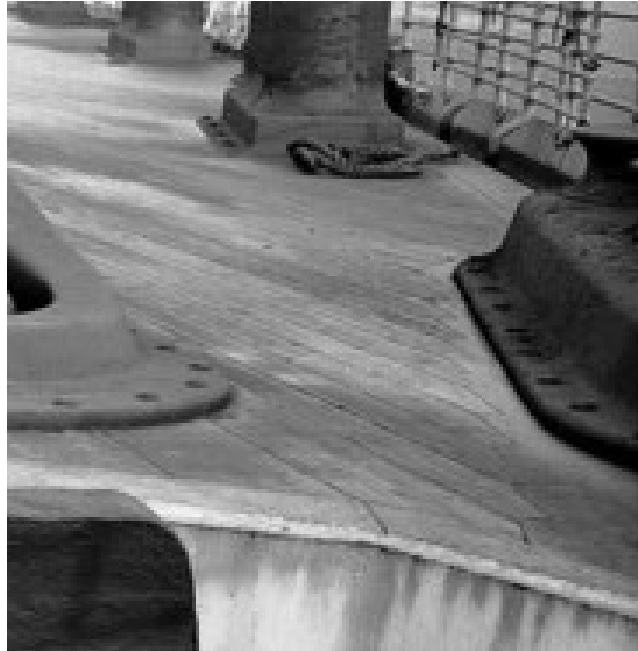
Figure14

Figure 14 shows an Olympic photo of the nibbing of pitch pine planks around the treble fairlead.

### Planking around treble fairlead

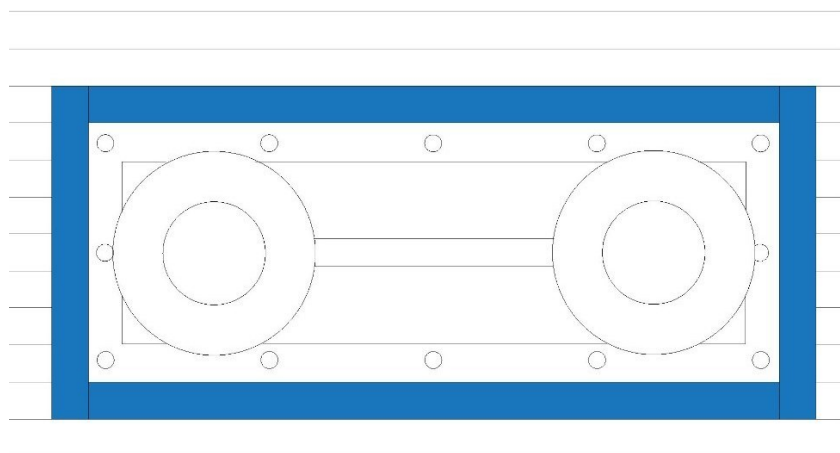
Figure 15 shows the inboard bollard which sits fore and aft parallel to the midline. No nibbing is necessary into the teak margin planks around this bollard.

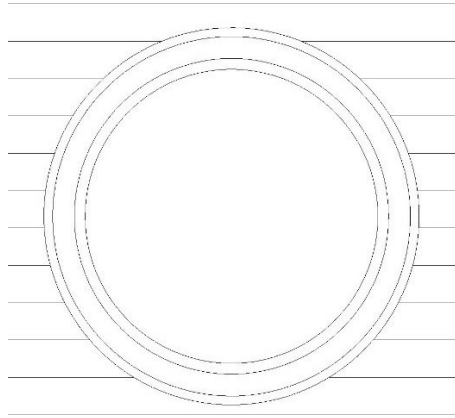
Figure 16 shows a rear capstan. The capstans had lower flanges that fit on top of the surrounding pitch pine planking. They did not require teak margin planking around them.

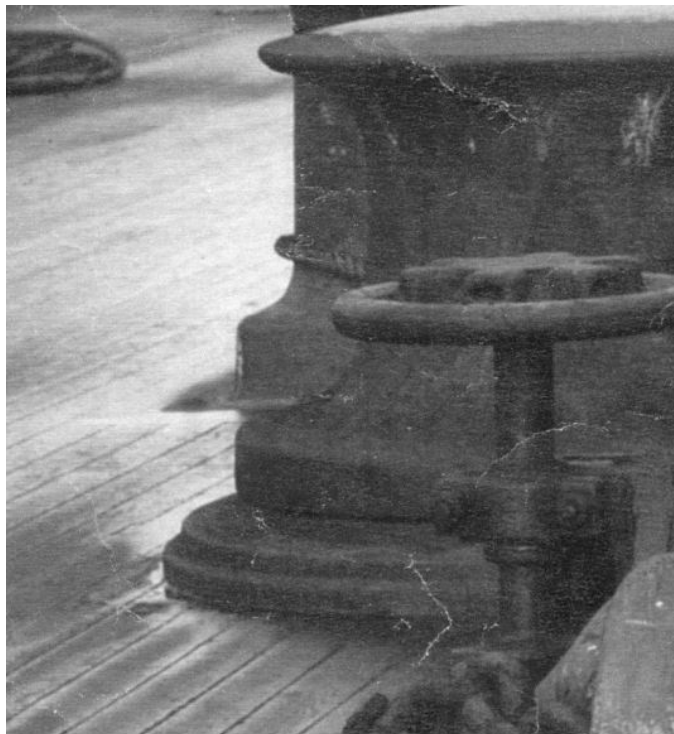
Figure 17 shows the lack of margin planking around a capstan of *Olympic's* forecastle.

Pitch pine planking around capstan

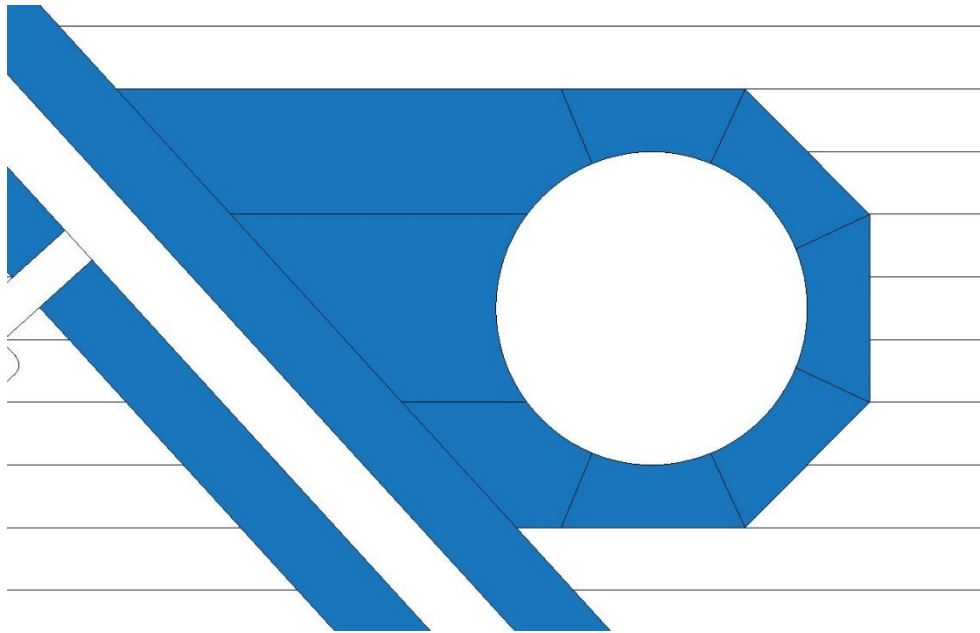
Figure 18 shows the margin planking around the base of the cowl vent on the port side just forward of the breakwater.

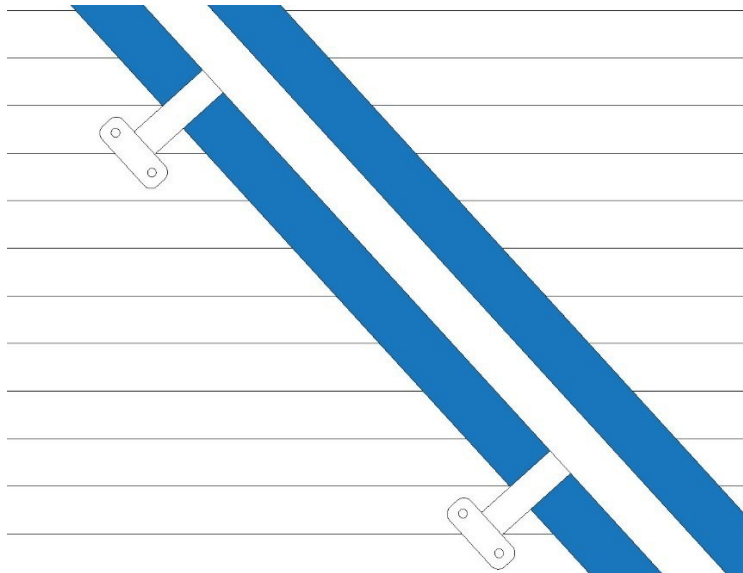
Figure 19 shows the teak margin planking fore and aft of the breakwater. The breakwater stays on the aft side of the breakwater are bolted through the pitch pine planks.

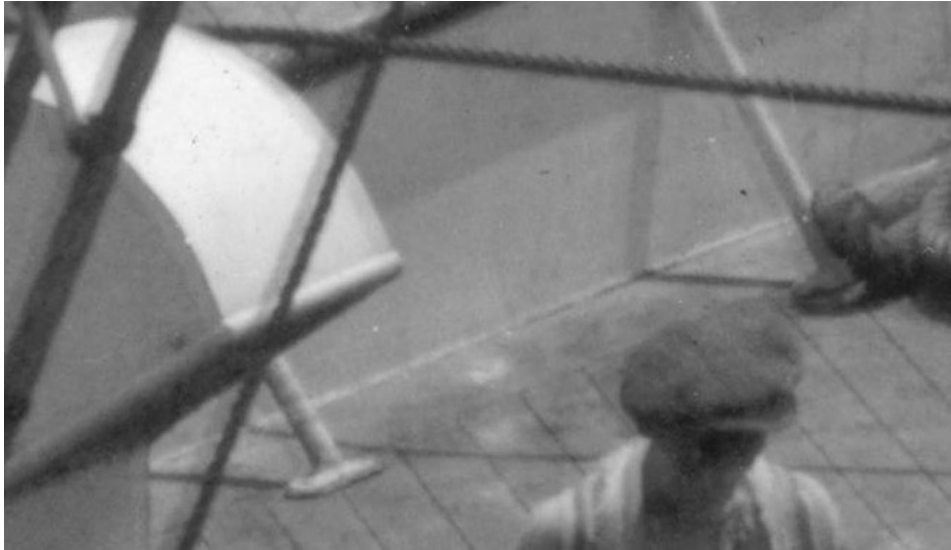
Figure 20 shows the margin planking on the aft side of *Olympic's* breakwater.

### Planking on the aft side of *Olympic's* breakwater

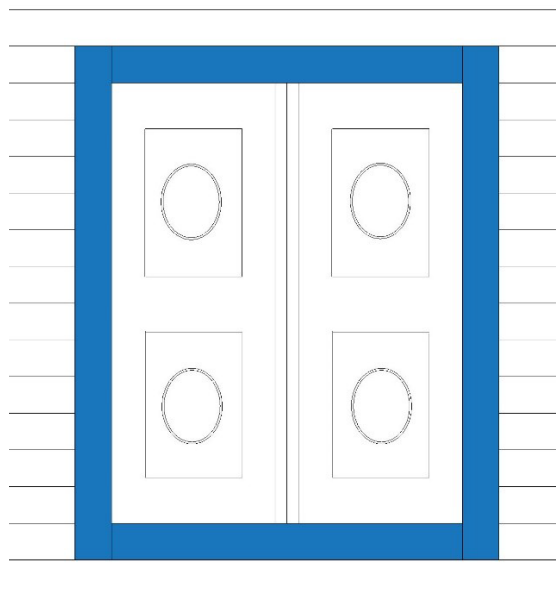
Figure 21 shows the margin planking around the skylight on the port aft of the forecastle. The skylight sits square with the run of the pitch pine planking so no nibbing is required.

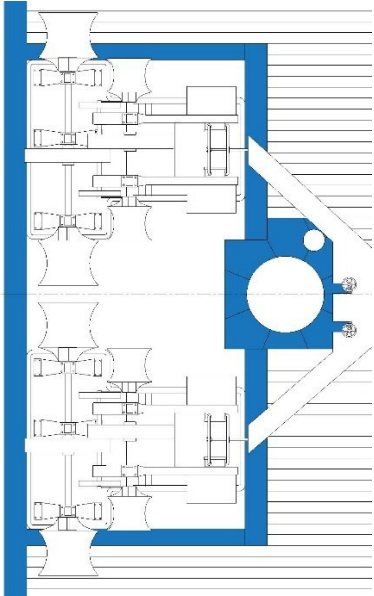
Figure 22 shows the margin planking around the steam winches at the aft of the forecastle deck. The winches sit atop a cement base which is first poured inside the margin planks which form the perimeter of the cement base.

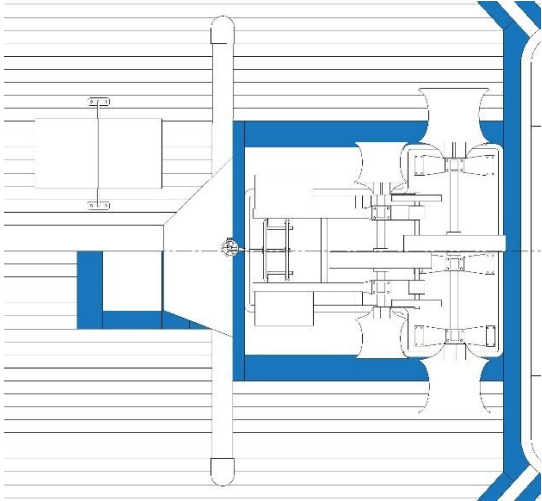
Figure 23 shows the margin planking around the forward steam winch and the ventilator duct on the starboard side of the steam pipe cover.

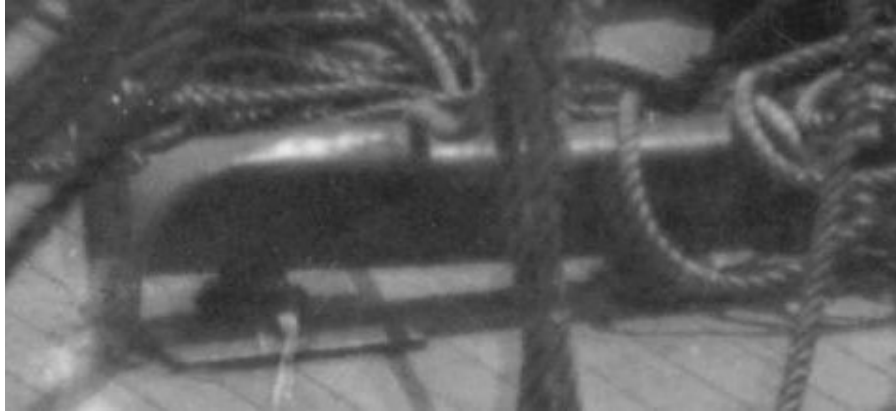
Figure 24 shows the absence of any margin planking under the lateral steam pipe cover branch on the port side of the midline of *Olympic*.

Pitch pine planking under steam pipe cover

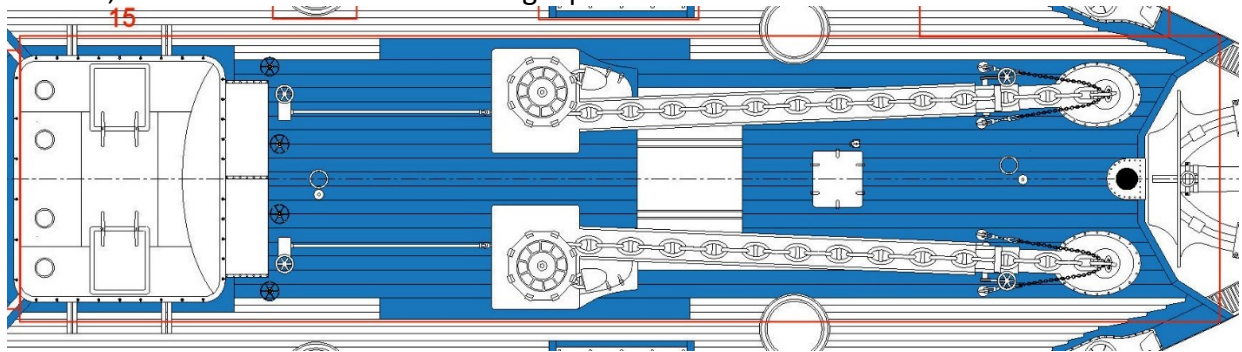
Area #15 shown in Figure 25 encompasses the area from the #1 cargo hatch forward to the forward anchor well. This area is unique in that there is teak planking in this entire area. The planks here are 10 inches wide by 4 inches thick. There are two planks outboard of the windlasses which are 15 inches wide by 4 inches thick. These are the only exceptions. Where the thicker central teak planking meets the thinner 3-inch-thick pitch pine planking, the thicker teak planking is planed so there is a smooth transition as can be seen aboard RMS *Oceanic* in Figure 26. There is photo evidence on *Olympic* which confirms this smooth transition. Forward, the anchor well has a teak margin plank on its aft side.

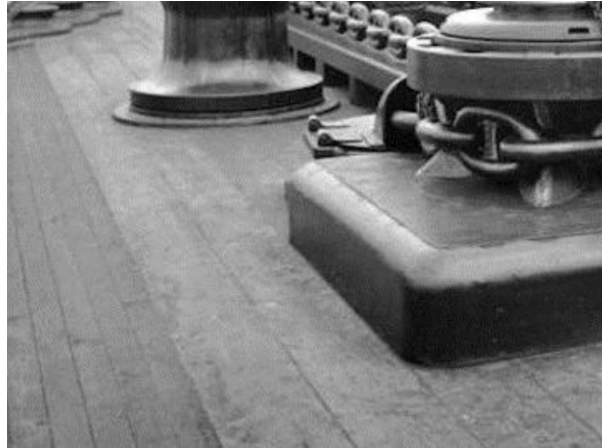
Figure 26

Smooth transition between teak and pitch pine planking on *Oceanic*

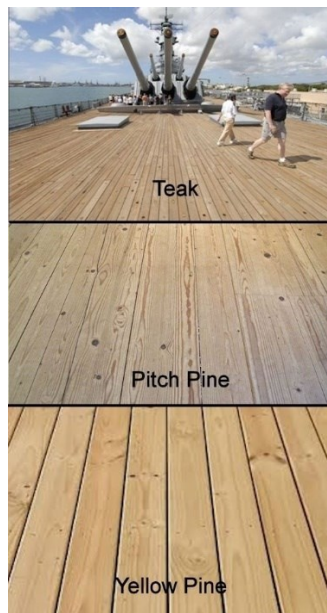
In the previous version of this article I portrayed the pitch pine and teak as two very different colors so there wouldn't be any confusion which was which. Unfortunately, I started seeing models with the teak portrayed as a reddish wood almost like redwood with a pronounced contrast between it and the pitch pine. Figure 27 shows three examples of not overly weathered teak, pitch pine and yellow pine.

Comparison of colors of wood species used on Titanic

As soon as even mild weathering occurred on these different types of wood, the color differences would become even less noticeable.
