# The Knees to the Outboard Bulwarks and the Aft Bulkhead of *Titanic's* Forward Well Deck

By Bob Read, D.M.D.

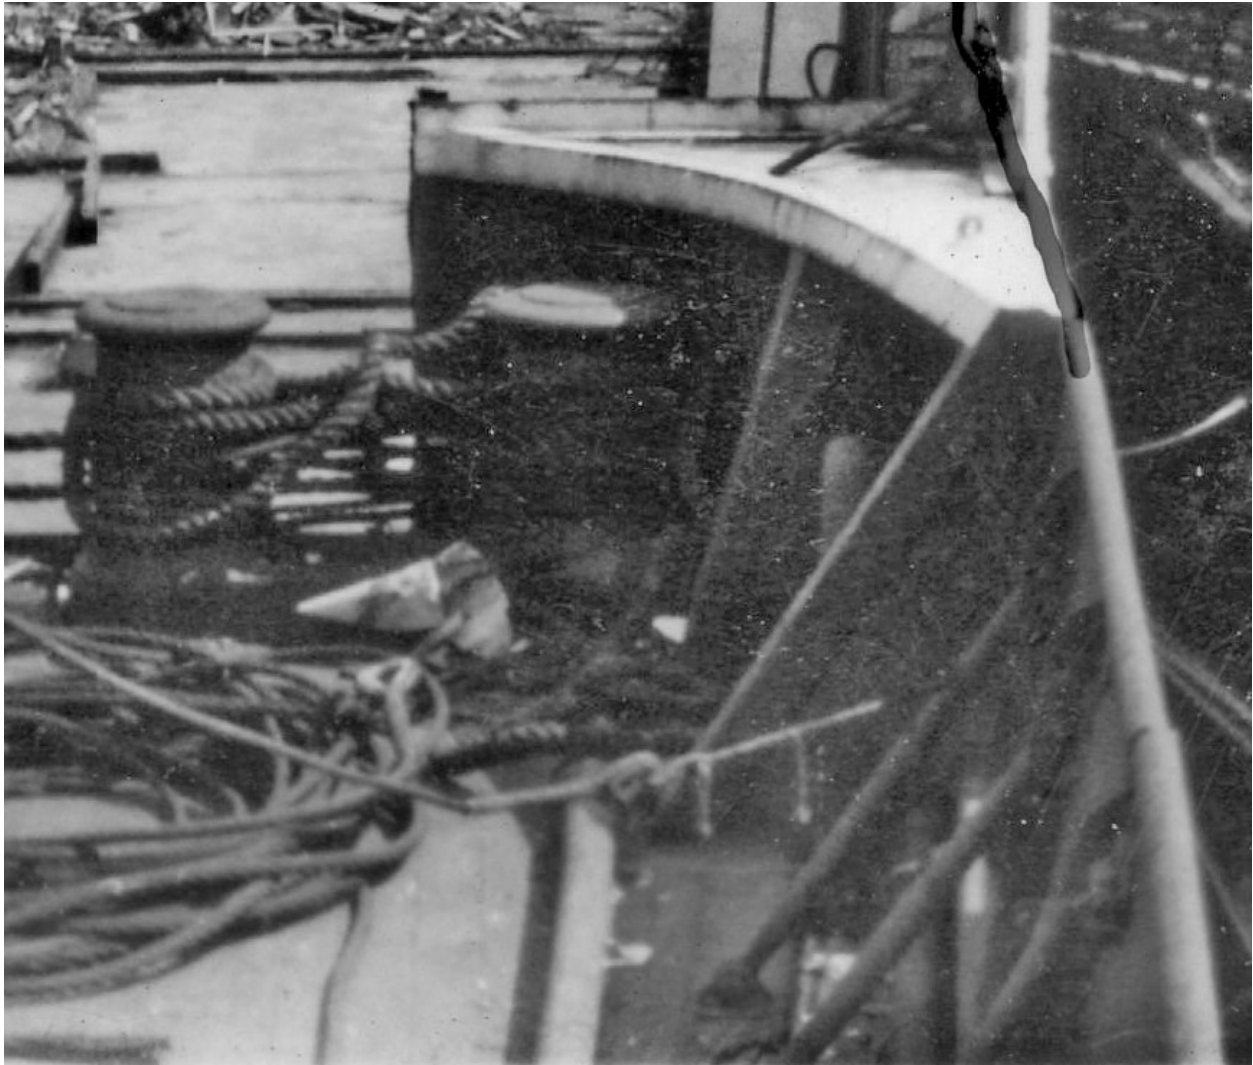
Figure 2

#### Port aft corner of forward well deck of *Olympic* at breakers in 1935

This cropped photo shows previously unknown details of the area of the aft outboard corners of the forward well deck. In the photo we can see that this is more than a simple plate. There are support structures below the horizontal plate structure. This photo reveals more information than any other previous photo. Consequently, we will be referring to it throughout the article.

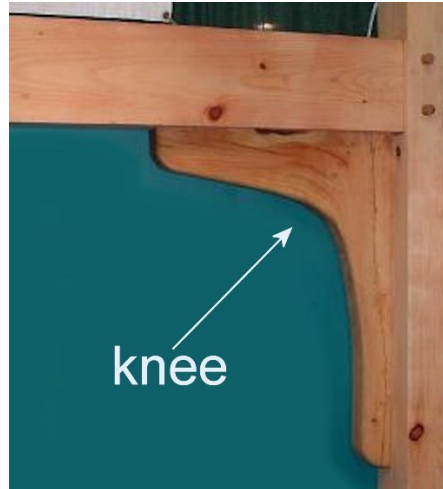
Rather than being an anchor plate for backstays it appears that the plates in question served another purpose. I believe that they were structural reinforcing “knees”. Knees reinforce, strengthen, and stiffen the junction between two structures which are at roughly ninety degrees to each other. Figure 3 shows a wooden knee between vertical and horizontal timbers.
