Iron Ladders to *Titanic's* Poop Deck: A New Discovery

By Bob Read, D.M.D.

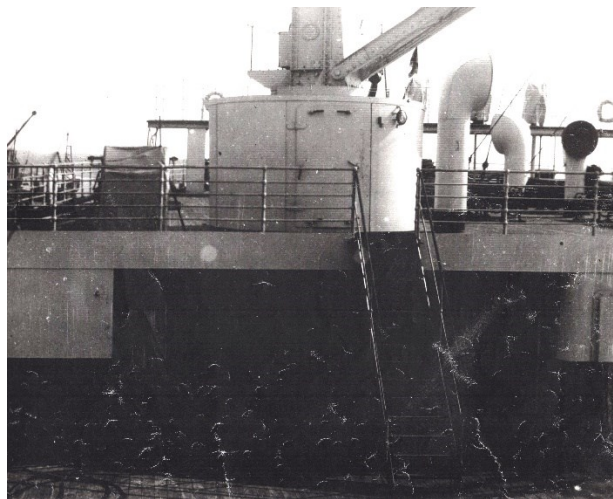
An iron ladder from *Olympic's* aft well deck to her poop deck was discovered from the photo in Figure 1.

Photo in which iron ladder discovery was first made

It is easy to see that the photo in Figure 1 is not of sufficient quality to identify the iron ladder under the stairs. Therefore, digital enhancement was performed in a photo editor to reveal details in the darkness under the removable stairs. Figure 2 shows a cropped, digitally enhanced version of this photo which clearly shows the presence of an iron ladder next to the stanchion which was recently found and was discussed in a separate article.

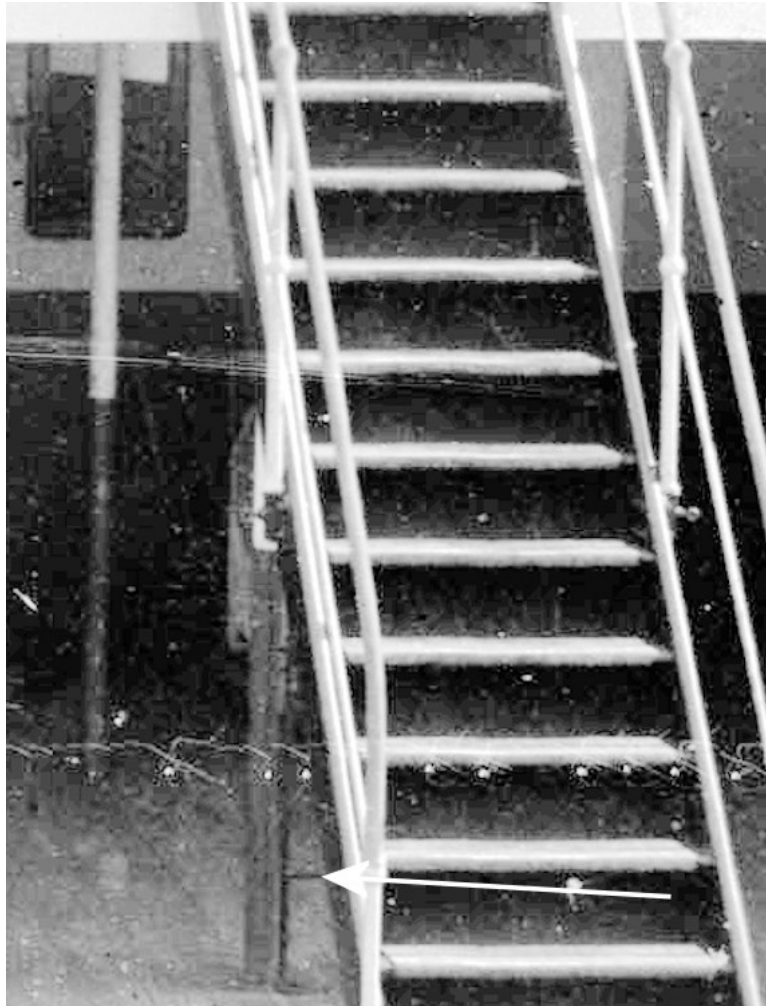
Figure 2

Iron ladder under removable stairs in enhanced photo

In Figures 2 & 3 we can see that the iron ladder is fixed to the deck at the bottom and to the forward plating forming the aft bulkhead of the aft well deck area at the top of the ladder. It can't be determined whether there is any attachment to the stanchion outboard of the ladders. A similar set-up is found at the aft part of A deck where there are two iron ladders next to stanchions up to the aft end of the boat deck. Figure 4 shows this similar set-up at the port aft part of A deck where an iron ladder can be seen next to a stanchion up to the boat deck.

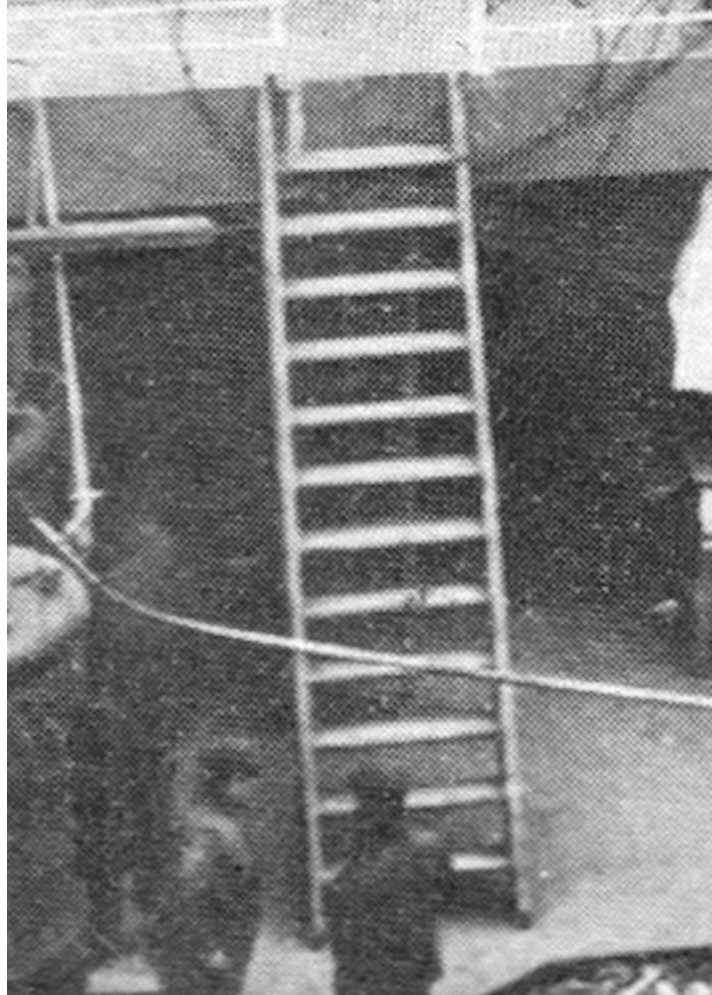
After finding the iron ladder in this photo I consulted with fellow Titanic researcher, Ralph Currell, to verify the discovery. Ralph searched his photo archives and found an additional photo taken during *Olympic's* fitting-out. In the photo in Figure 3 taken during fitting-out, a temporary wooden ladder is being used for access to the poop deck. You can see aft of the ladder between the rungs, evidence of an iron ladder which has already been installed.

Iron ladder aft of temporary wooden ladder

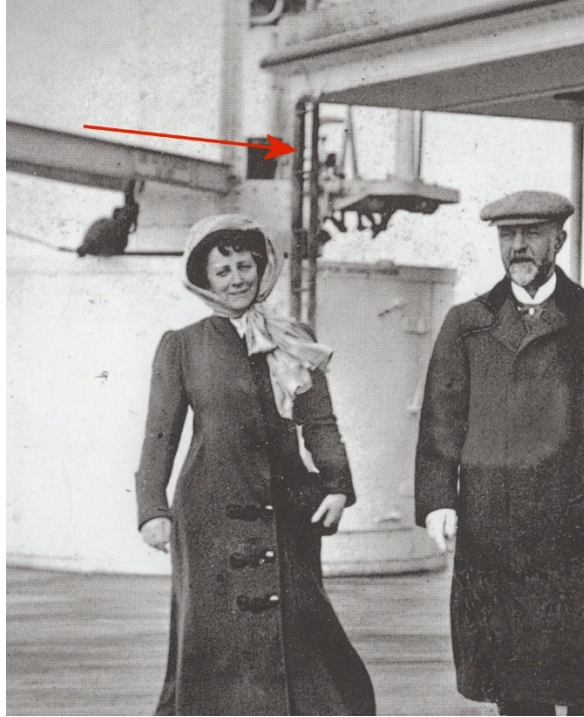
Figure 4

Iron ladder next to stanchion on Titanic's aft A deck

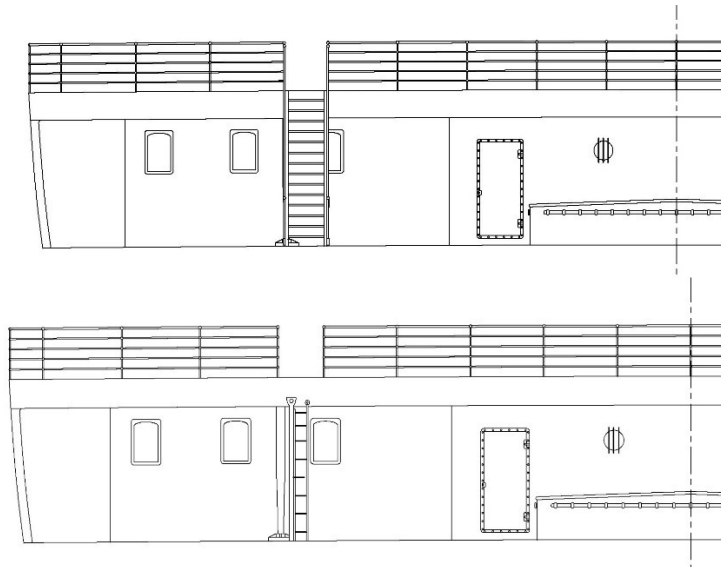
Figure 5 illustrates the aft well deck with removable stairs installed and with them removed showing the iron ladder up to the poop deck.

Removable stairs in place and removed showing iron ladder

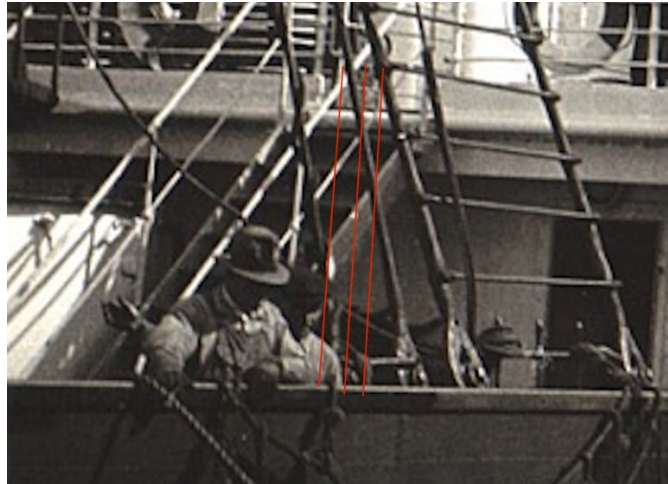
At this point it would be logical to ask if there were similar iron ladders under the removable stairs in the forward aspect of the aft well deck up to B deck. Figure 6 shows a photo of the starboard removable stairs in the aft well deck up to B deck. In this photo a red line has been drawn showing the center of the stairs. Two lines flanking the center red line have been drawn which show the width of an iron ladder. It can be seen in this photo that we would be able to see a ladder from this angle.

Red lines showing where forward iron ladder would be expected

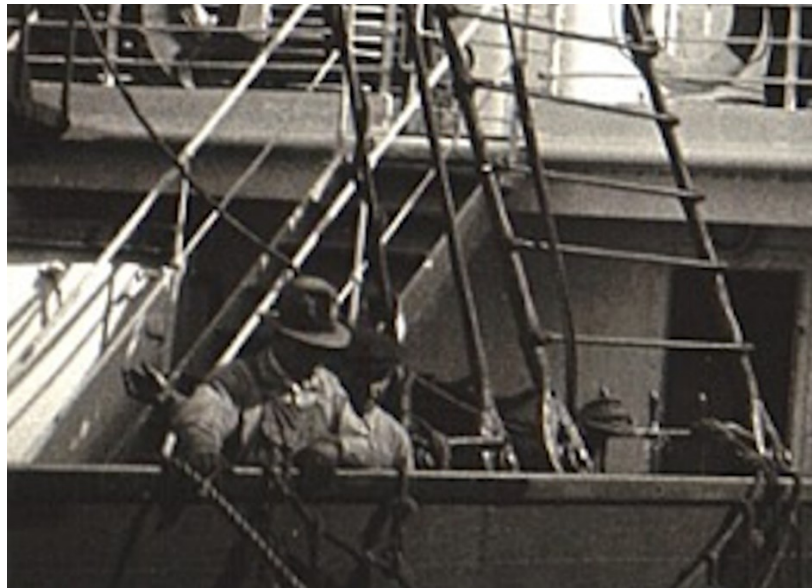
Figure 7

Original photo showing no evidence of an iron ladder to B deck

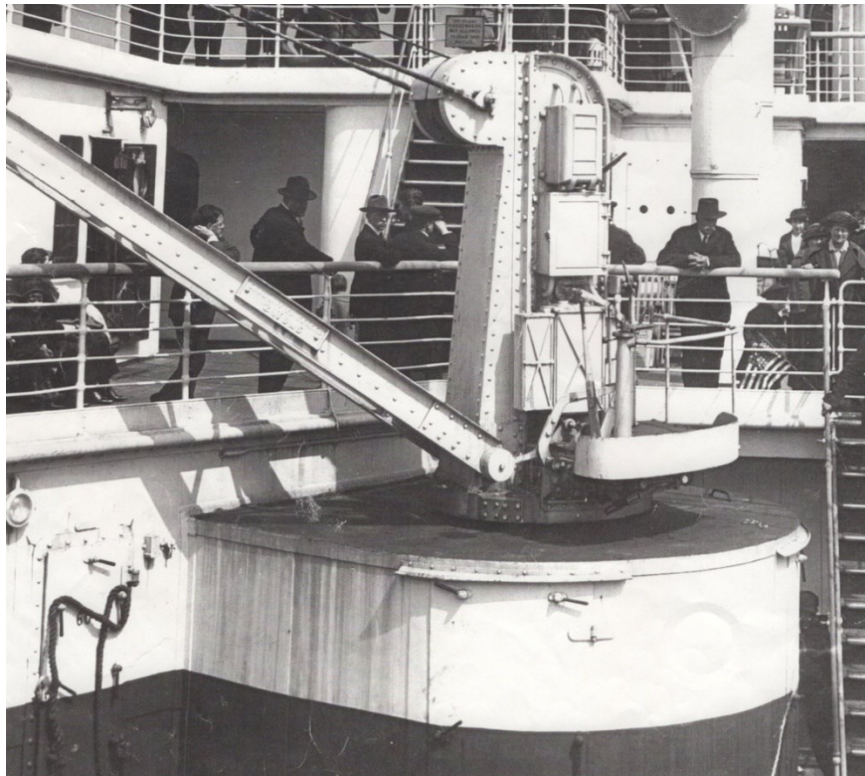
There are several answers to this question but the simplest is that the iron ladders under the forward removable stairs in *Titanic's* aft well deck to B deck were not needed because they would have been redundant. In this particular location, access from the aft well deck to B deck is easily achieved by other means. In Figure 8 one can see a simple route by climbing the iron ladder on the forward side of the cargo crane to the top of the base. From there it is a simple matter to proceed to the inboard side of the top of the crane base and step up to the outboard side of the railing and climb over it to B deck.

Route from inboard of top of crane base up to B deck

An iron ladder could have been installed under the removable stairs here but it would have required the installation of a stanchion up to B deck similar to the aft iron ladder installations.
