# Murray's Boat Disengaging Gear

By Bob Read, D.M.D.

## Introduction

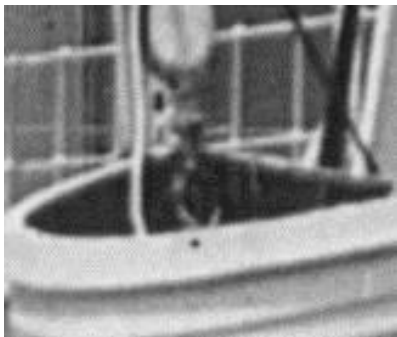
Figure 6

The next aspect of the photos to be examined is the apparent difference between the gear seen in the 30 ft. main lifeboats as seen Figure 2 and those seen in the 25 ft. emergency lifeboats as seen in Figures 6, 7, and 8. If you compare these gear, what one notices is that the fork which

holds the axle for the hook on the 25 ft. boats has its tines spaced fairly widely apart. For some time it was difficult to reconcile the appearance of these with those seen in Figure 2. Figure 8 began to offer some clues. As we can see in this photo, there is a chain shackle fixed from the fall block through the tines of the gear's fork. What I believe this shows is why the tines of the 25 ft. boat gear needed to be wider. The 25 ft. emergency boats were always suspended in the falls. They did not rest on chocks. With this constant strain on the gear, there needed to be a safety measure to prevent damage to the boat if the gear would accidentally disengage. The way this was accomplished was by a chain shackle where the chain attached to the block and rove through the hook and its axle so that if the hook accidentally disengaged, the weight of the boat would be borne by the chain. The fact that there were two different variations of the Murray's gear was confirmed by a search for documents relating to the gear in the British National Archives. Figure 9 is the Log book which referenced the two designs of the Murray's gear. Design A referred to the gear for the 30 ft. main lifeboats and Design B referred to the

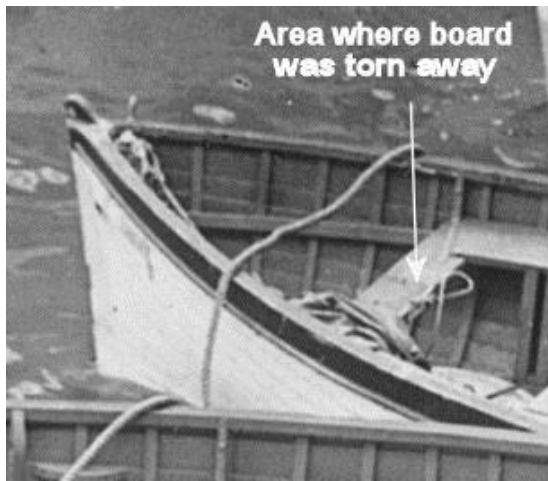
Recently an observation was made which helped explain some of the discrepancies seen in the 25 ft. boat disengaging gear. Figure 25 is an enlargement of the aft area of one of the 25 ft. boats. I have placed an arrow pointing to an area on the aft thwart which is a different color. What this indicates is where a fore and aft board attached to the aft thwart. Figure 26 shows the outline of where this board would have been before the board was torn away. The disengaging gear on the 25 ft. boats was angled to accommodate the spacing between Titanic's davits. Probably when this boat was being hoisted aboard R.M.S. Carpathia, the boat was being hoisted in such a manner that the force on the disengaging gear was vertical rather than at its

designed angle. This tended to lift the fore and aft board away from its fastening. After this board was gone, the disengaging gear now is not held in its designed position but falls toward the aft end of the boat as we see in the photo. This discrepancy hindered accurate interpretation of the set-up of the disengaging gear on the 25 ft. boats for some time.
