Titanic's B Deck Mystery Object

By Bob Read

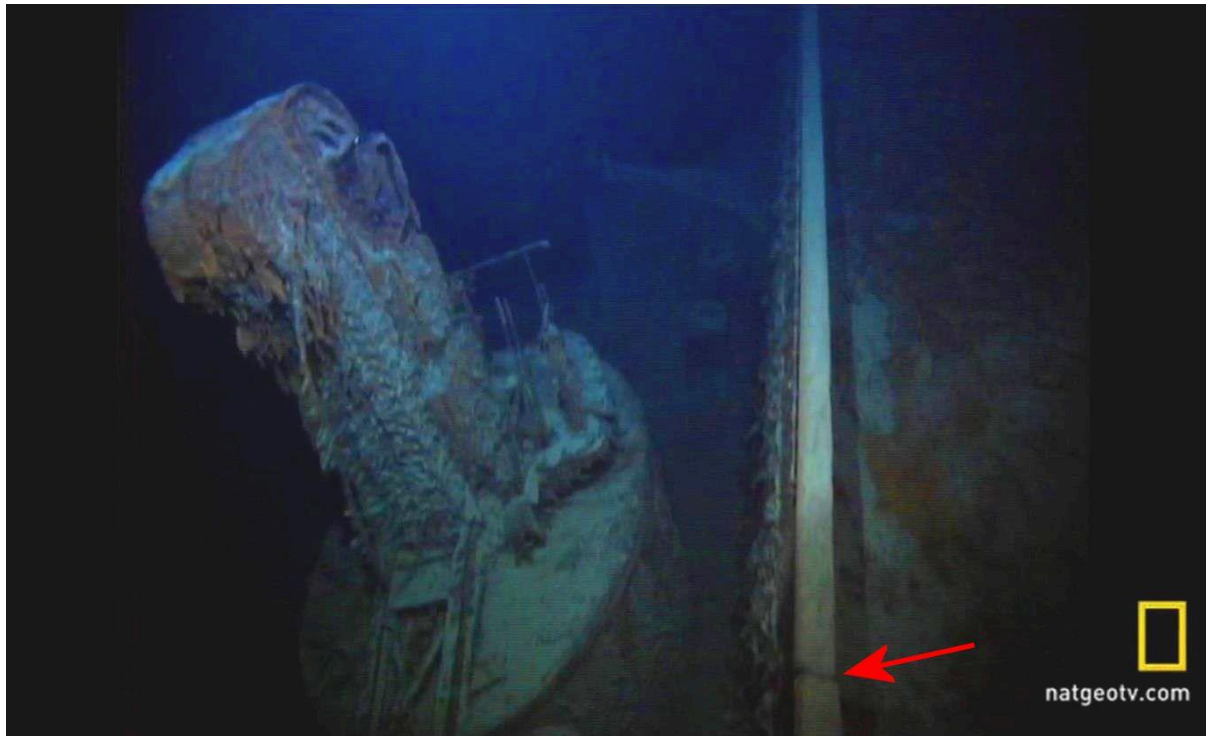
Figure 11 show a higher definition image of the caprail seam to starboard of the mystery object. What we see is a simple butt joint. A simple butt joint would be necessary for a removable section of caprail. The fact that this is a simple butt joint argues against this being just a standard caprail seam. In the book *Ship Joinery; The Woodwork Fittings of a Modern Steel Vessel*, by S.G. Duckworth, published in 1923, the method for forming a joint in a railing is illustrated. Rather than a simple butt joint it is a “scarf joint” which is used to add strength to the joint. Figure 12 shows the illustration from the book of a scarf joint. This adds weight to the notion that this may in fact be a removable railing section.

Unlike theories which focus primarily on the object itself, this theory attempts to reconcile the asymmetry of the stairs from B deck to the forward well deck. It also addresses the missing bulwark stays. If there is a vulnerable part of this theory it would be the evidence for the caprail seams. The seam outboard of the object is fairly distinct. The inboard seam is less so. This could be because of silt buildup in the seam. If it would turn out that there is, in fact, no inboard seam, then this theory would fall because there has to be a removable caprail segment for this theory to work. Hopefully the high definition images from the later expedition will show the caprail more clearly. It is clear that there is at least one caprail seam. For those who might criticize this theory, they need to be able to answer why a caprail seam would not be scarfed.
