Open Wash Ports of *Titanic's* Forward Well Deck

By Bob Read, D.M.D.

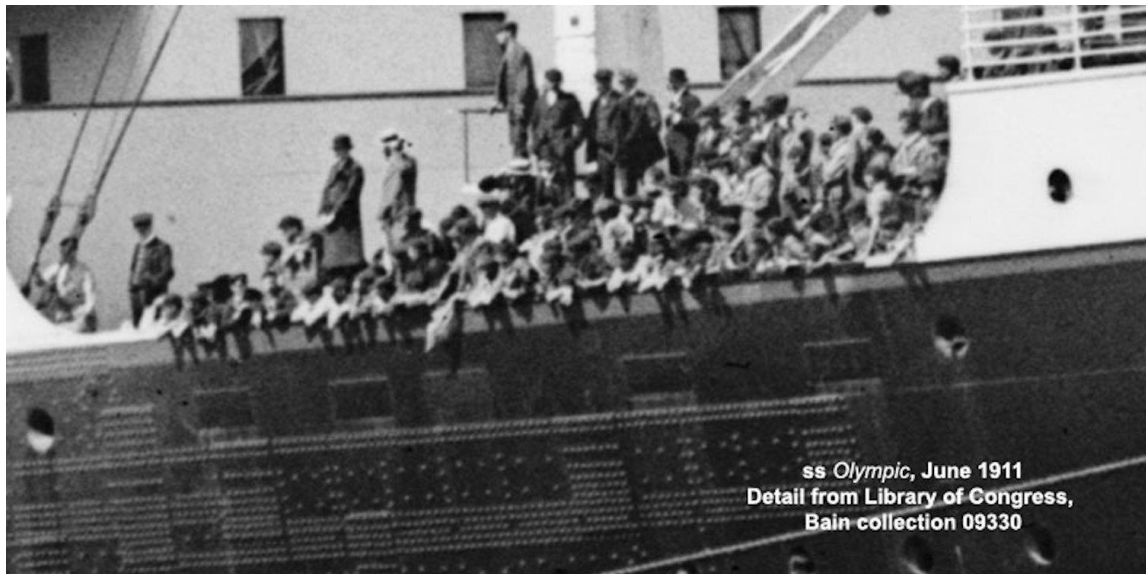
Figure 2 is a maiden voyage photo of *Olympic* showing the wash ports of the forward well deck with the wash port doors present and closed.

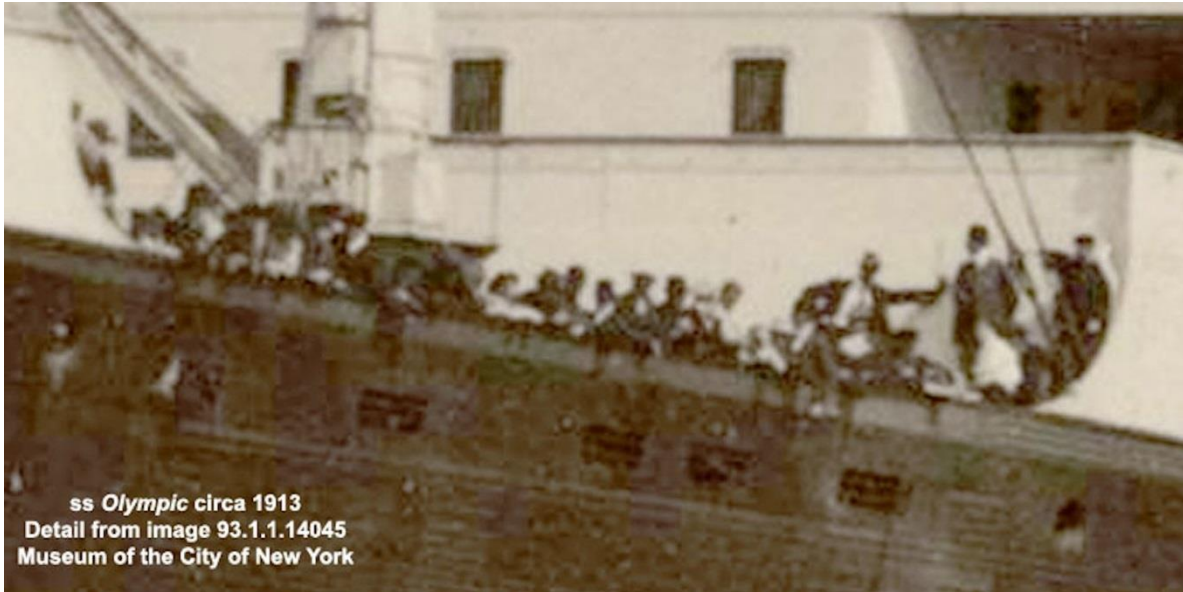
Later *Olympic* had the same modification made to her forward well deck wash ports. In Figure 4, *Olympic's* later open wash ports can be seen.

We know that the wash port doors have been removed because the doors were on the outboard side of the bulwarks and could not swing inboard.

It can be seen in Figure 4 that the open wash ports have two horizontal safety bars. Even the wash ports in the bulwarks of the aft well deck have both safety bars and wash port doors.
