Wooden Plank Sheathing of *Titanic's* Poop Deck

By Bob Read, D.M.D.

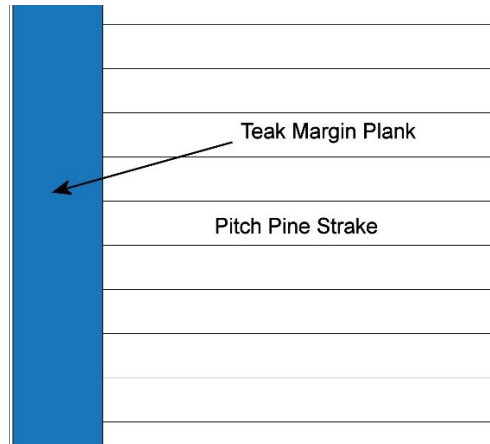
The term for the rows of planking is a “strake”. A strake could be made up of a single plank or of several planks. Where several planks met within a strake is known as a “butt”. In examining photos of *Titanic's* poop deck, it appears that full length planks were used. The only place where butts are found is where the pitch pine met the teak planking. Planking of teak around the perimeter of the deck and around certain deck structures was known as “margin planking”. Figure 1 shows some of the terms discussed above which are labeled. In the drawing, only the teak planks are colored.

Plank sheathing types

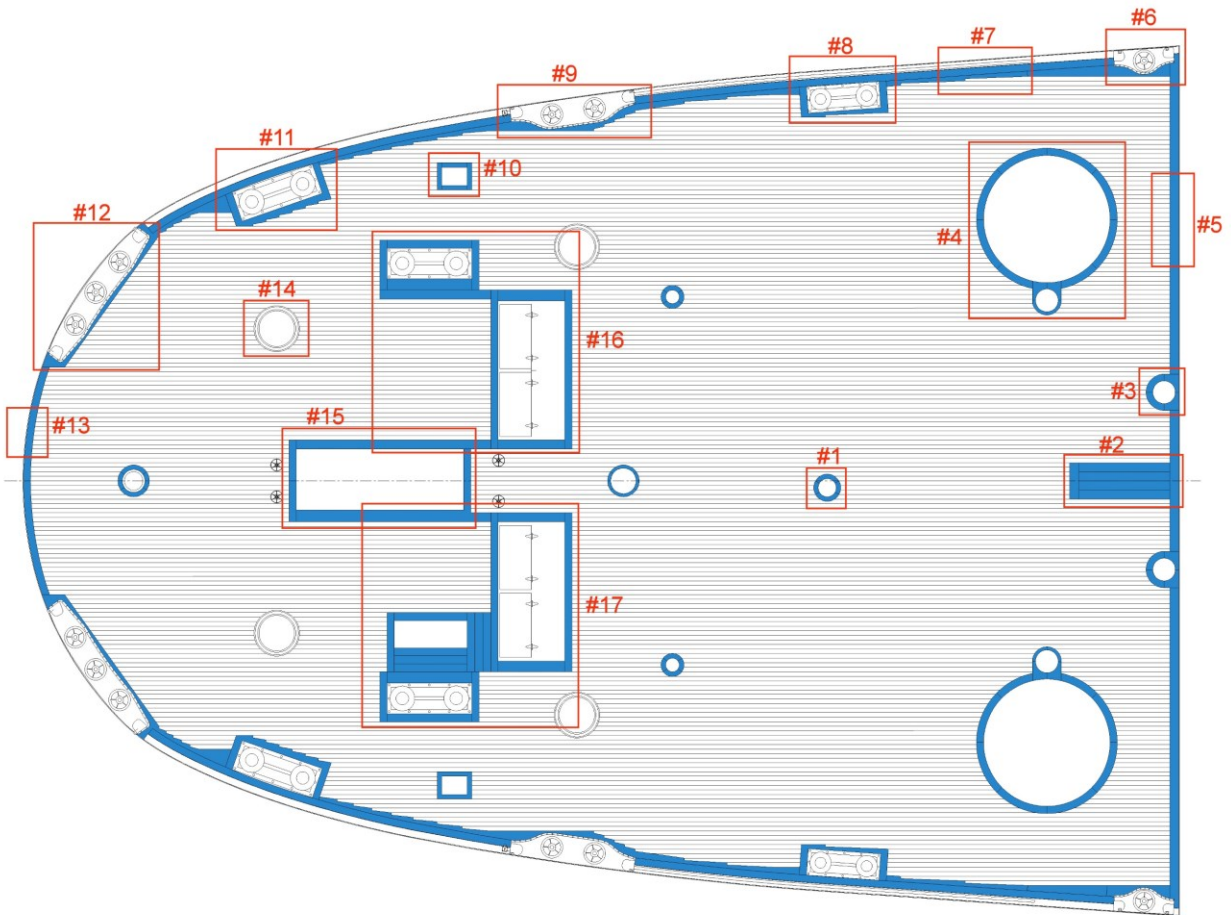
Figure 5 shows an overall view of *Titanic's* poop deck sheathing. A number of individual numbered areas within the red rectangles will be individually discussed.

Areas of plank sheathing detail

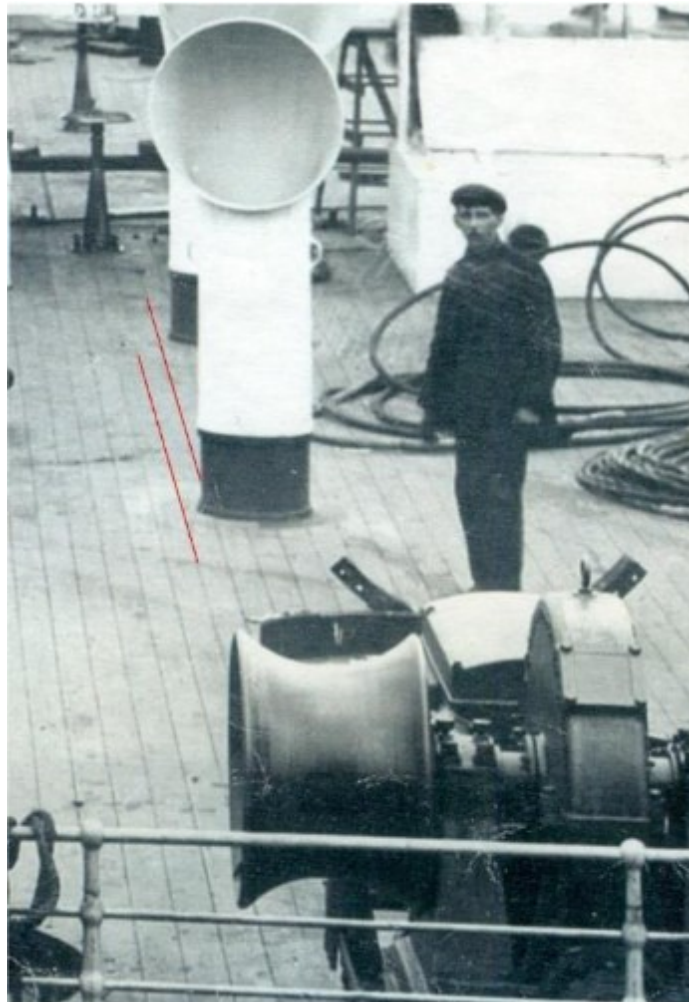
Offset of cowl vent to starboard of midline

Figure 6 shows the planking around one of the cowl vents on *Titanic's* poop deck. Around the base of the vent are four radial margin planks surrounding the base of the vent. The reason this particular cowl vent was chosen was to point out a unique aspect of this cowl vent that unlike the larger cowl vent aft of it, this cowl vent was not positioned on the fore and aft midline. It is positioned slightly to starboard. In Figure 7 this is illustrated. Planking seams allow us to determine the positions of these vents. The starboard edge of the base of the aft cowl vent is further inboard than the forward cowl vent even though the aft cowl vent has a larger diameter. This means that the forward cowl vent is not positioned on the centerline like the aft cowl vent.

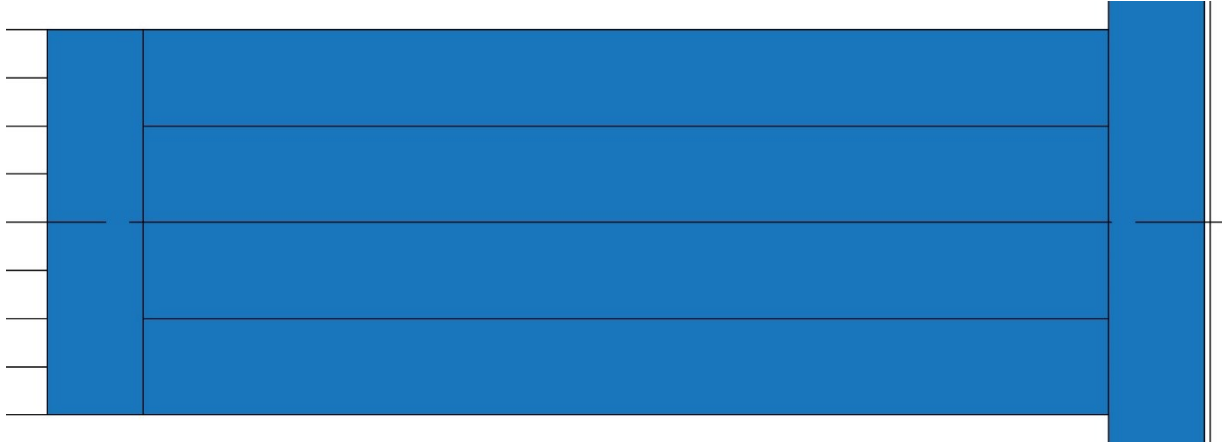
Figure 8 illustrates the planking around the electric cargo winch on the forward poop deck. The weight of the winch is borne by broad teak planks underneath it.

Teak planks under electric winch in area #2
