Titanic's Boat Deck Waterproofed Wood Roofs

By Bob Read, D.M.D.

Introduction

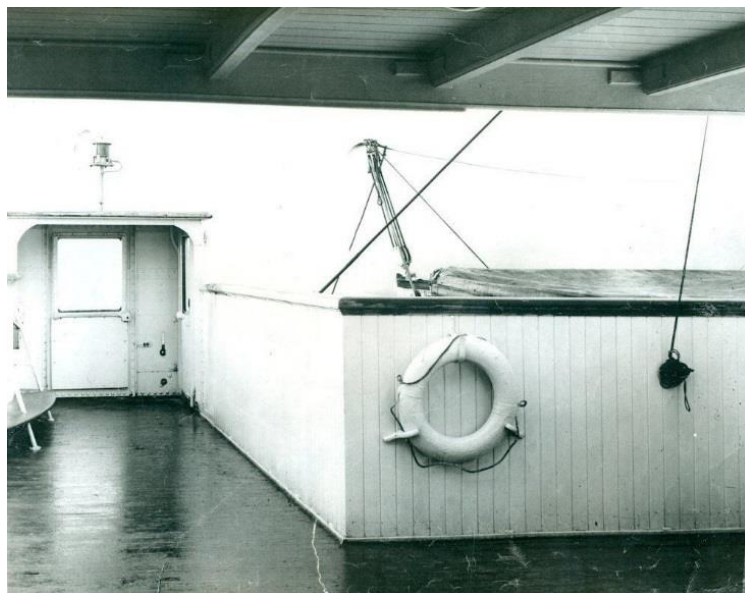
Navigating bridge roof Interior

In this photo you can see the individual wood planks of the underside of the roof. The process for waterproofing the navigating bridge roof was:

1. Tongue-in-groove pine boards were used for the roof. The boards were screwed to the underlying roof beams with brass screws.
2. The roof boards were painted with a bitumastic paint to seal the boards and joints and to provide an adhesive for the canvas layer.
3. On top of the wet bitumastic paint a layer of canvas duck was applied and the canvas was smoothed out and a wood instrument was used to press the canvas into the grooves at the plank joints.
4. The canvas was painted with several coats of a medium gray enamel.
5. Teak covering boards were applied to the perimeter of the roof boards.
6. Teak “nosing” was applied to cover the teak board ends and the pine board ends. This “nosing” looks like a moulding being half round in profile.

The waterproofed navigating bridge roof was a somewhat special case due to the fact that the entire navigating bridge was of wood construction. This was because the compasses found in the wheelhouse and on the navigating bridge had to be isolated from any steel or iron. We also know something about the wood construction of the navigating bridge roof from photos. Figure 1 shows the interior of *Olympic's* navigating bridge where the roof can be seen.

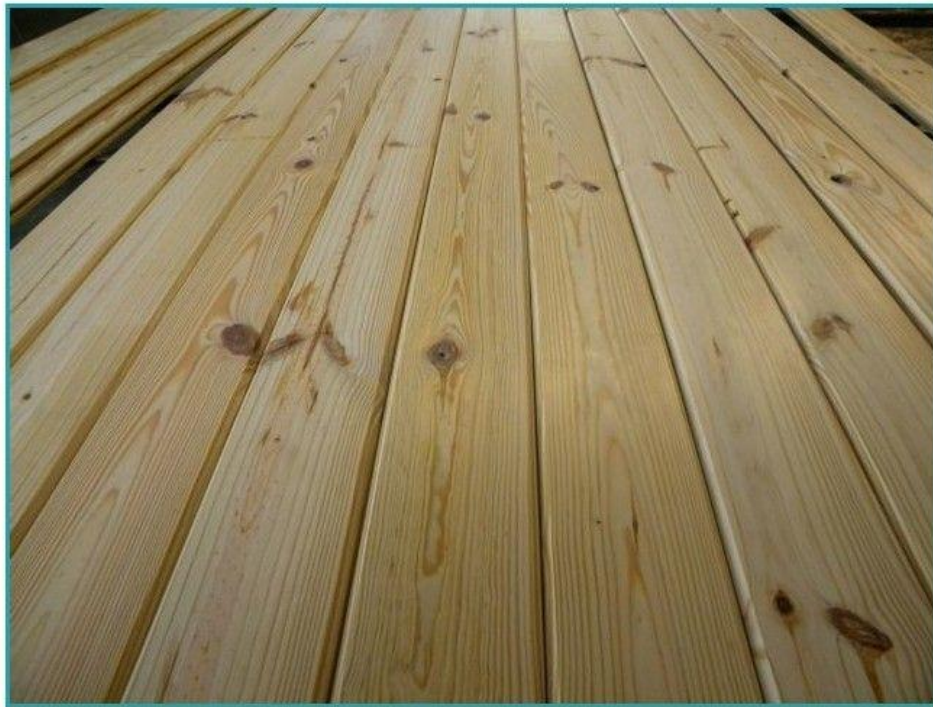
Figure 2 shows the kind of pine boards which were used on the roof of the navigating bridge. You can see the surface grooves between the individual boards.

Pine boards of the type used on the roof of the navigating bridge

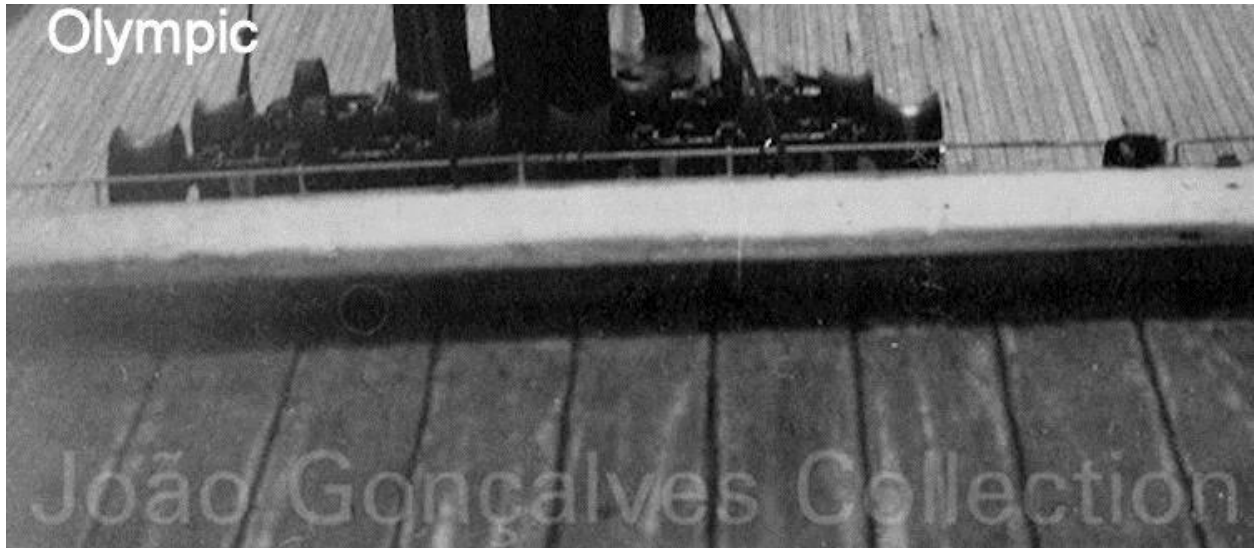
Figure 3

Olympic bridge roof detail

As you can see, the grooves between the boards are still visible. This means that the canvas was pressed into the grooves after the bitumastic paint was applied. It has been suggested that maybe there wasn't any canvas applied and just a dark waterproofing coating was applied. What we must remember is that at this time, sophisticated liquid sealing compounds were not available. The canvas provided a matrix to hold and strengthen the paint to keep it from cracking. The paint in turn strengthened the fibers of the canvas. Together it created an impervious waterproofing technique. Figure 4 shows the extent of the waterproofed navigating bridge roof indicated in yellow.

Until recently it was not known what the surface of the navigating bridge looked like. We could see general colors but the texture of the roof surface was not clear. By kind permission, a photo of *Olympic's* navigating bridge roof was supplied by João Goncalves in Figure 3.

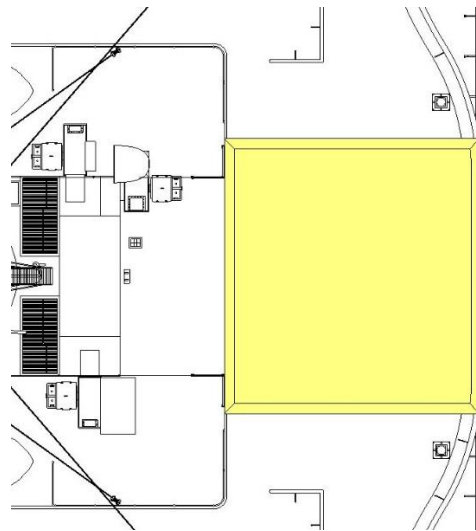
Figure 4

Extent of waterproofed navigating bridge roof

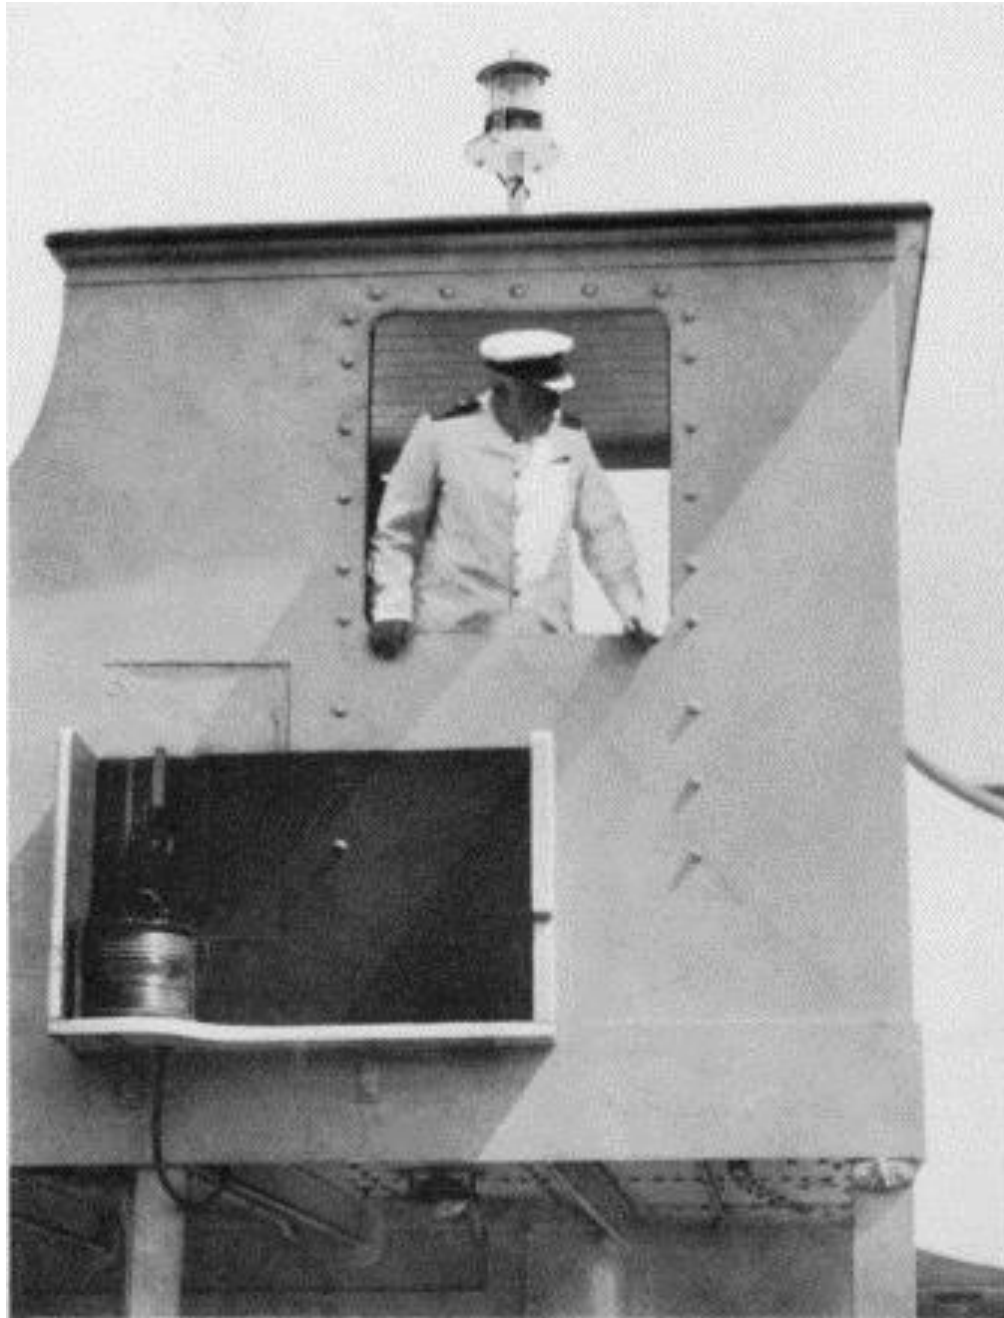
Figure 5

The evidence for a waterproofed wing cab roof can be seen in the starboard *Olympic* wing cab shown in Figure 5. The two aspects that prove this are the individual wood planks which can be seen through the wing cab window and the “nosing” trim which seals the edges of the boards and covering board.

Starboard wing cab roof on *Olympic*

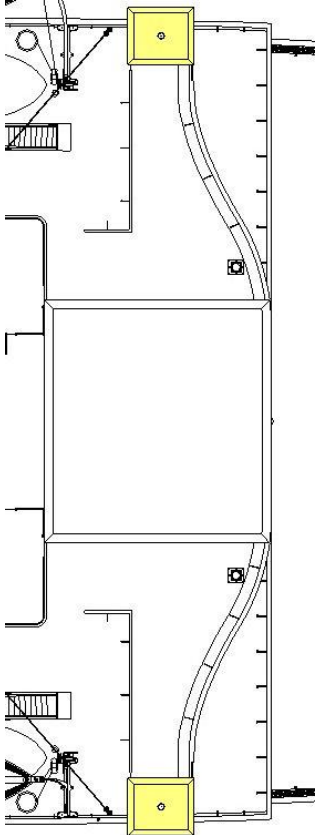
Figure 6 shows the location of the wing cab roofs.

Wing cab roofs

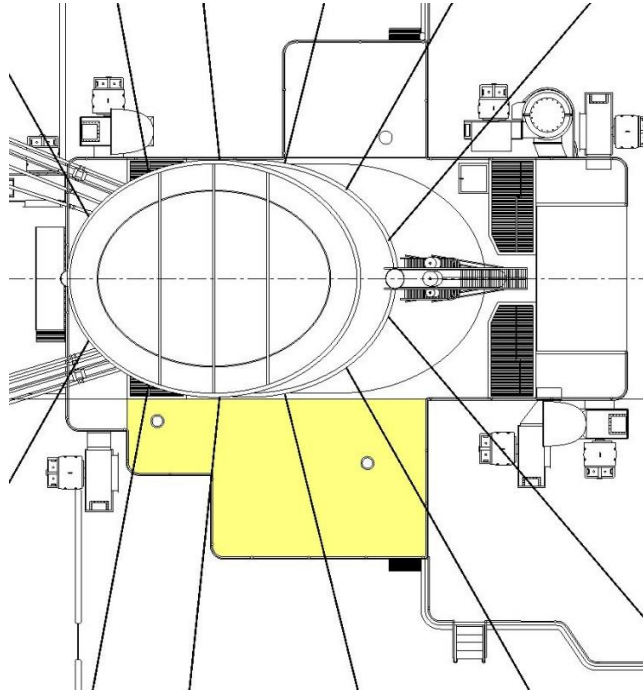
Figure 7

Officers' mess roof

The officer's mess roof represents a departure in the construction and methods of creating a waterproof wooden roof compared to the navigating bridge roof and wing cab roofs. On this roof there was no need for complete wooden construction. Therefore the roof beams were steel. From what we can tell from photos, the underlying wood boards which made up the roof were tongue in groove pine but rather than having grooves at the seams they were flat like commercial wood flooring. Figure 8 show how the tongue in groove planking boards would have looked here.

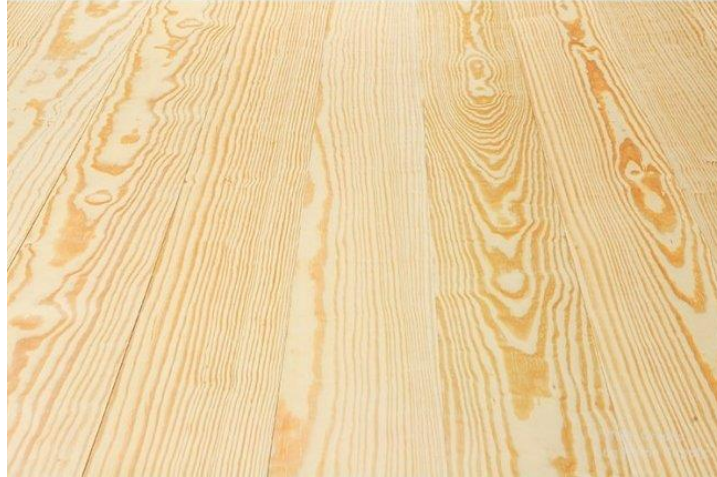
Figure 8

Flat tongue in groove pine boards

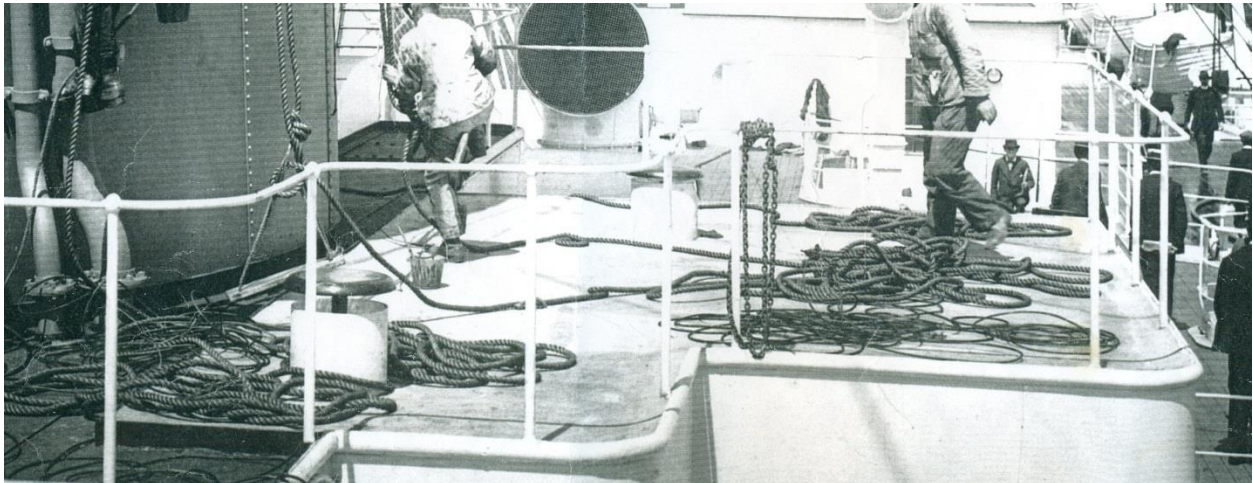
Officers' mess roof of *Olympic*

As can be seen in this photo the roof surface is bounded on the inboard side by steel angles. After the wood planks are bolted to the underlying steel frames, they are painted with a bitumastic paint to seal the boards then canvas is laid on the wet paint as was done on the navigating bridge roof. Since there are no grooves between planks, the canvas can be laid smooth. On this particular roof a covering board can't be used to seal the ends of the planks and canvas because covering boards are only used in applications where the planking overlaps the deckhouse. To seal the canvas and planking, several coats of enamel paint are applied. To seal the perimeter, cement was applied covering the perimeter up to the edge of the deckhouse and up to the inboard steel angles. Roofs of deckhouses which were occupied like

this one had a waterproofed wood roof applied to diminish the heat absorbing effect of a steel roof.

Figure 9 show the completed officer's mess roof on *Olympic*.

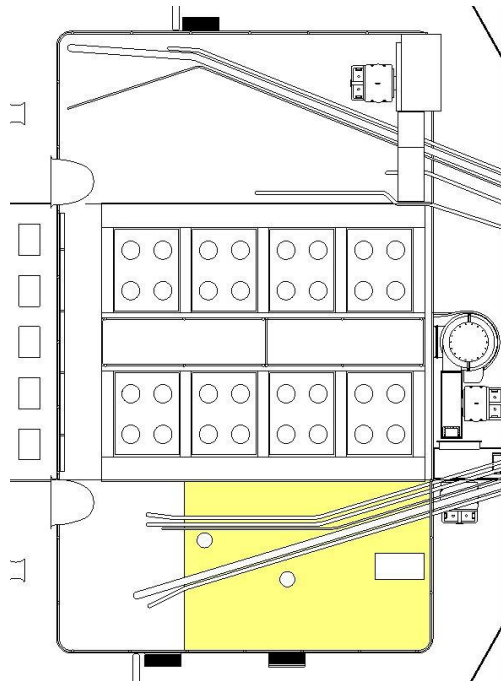
Engineers' smokeroom roof

The installation of a waterproofed wood roof on the engineers' smokeroom is the most speculative of all the roofs which will be mentioned in this article. We don't have any Titanic photos and on Olympic the only photos we have are from the 1920's where the roof was painted in the same shade of dark gray as the metal roofs over the tank rooms. Therefore it is not possible to distinguish color. The reason it is believed that this roof may have been wood with waterproofing is because it has much the same function as the officers' mess and thus would need to have provision made to diminish the effects of a steel plated roof. If it indeed had a waterproofed wood roof then it would have the same construction techniques explained in the section about the officers' mess roof.

Figure 10 show the roof area of the engineers' smokeroom.

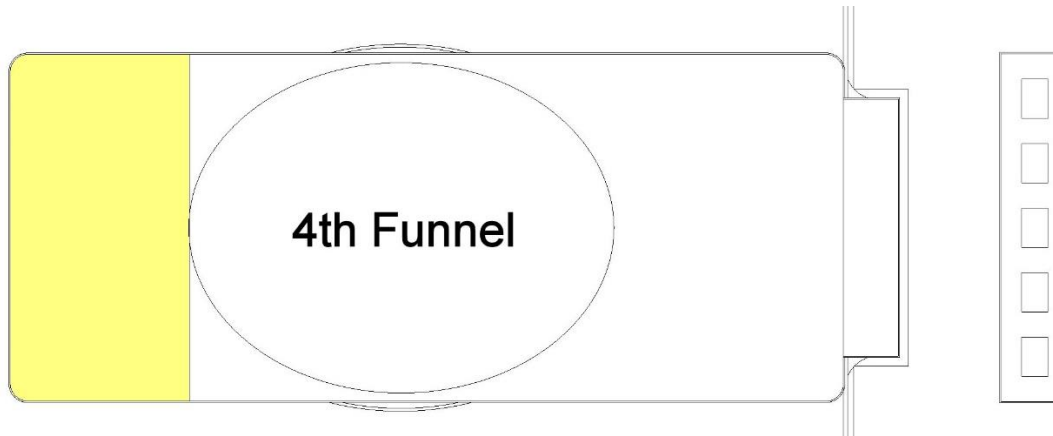
Figure 11 shows the area covered by a waterproofed wood roof over the kennels aft of the fourth funnel. The case for why this is most likely the kennels is explained in this article: [The Case for Dog Kennels on Titanic's Boat Deck](#)

Dog kennel roof

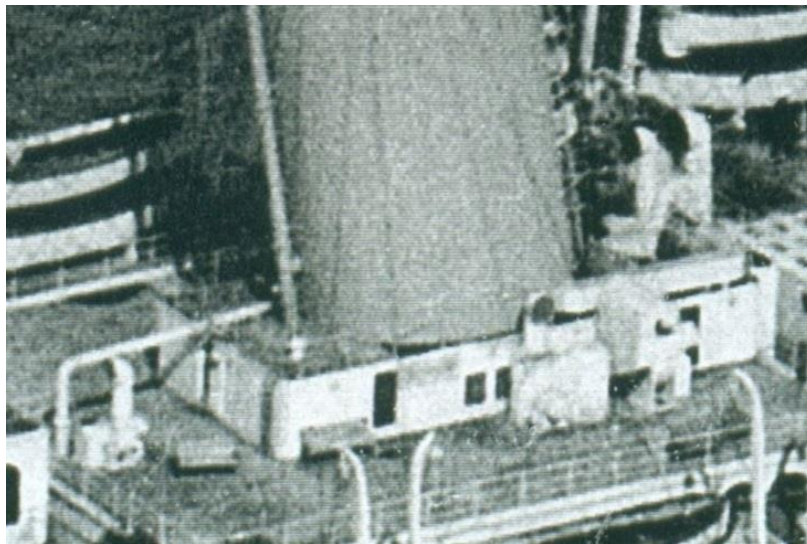
Figure 12 shows an aerial view of this area on *Olympic* after it had been converted to a dog kennel.

Dog kennel roof on *Olympic*

It can be seen that the kennel area aft of the fourth funnel is a lighter shade of gray than the dark gray steel roof forward of it. The method for creating this waterproofed wood roof would have been the same as for the officers' mess roof and the engineers' smokeroom roof.

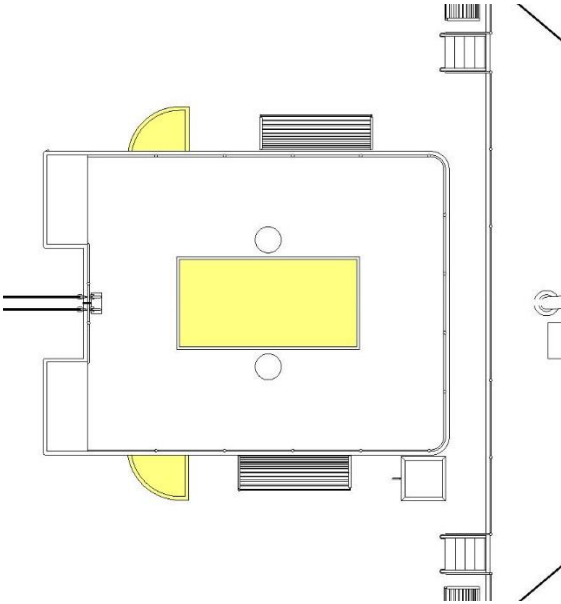
Figure 13 shows the roof of the elevator machinery room over the second class entrance on the aft boat deck.

Elevator machinery room roof

Figure 13 showed the roof of the elevator machinery room. It also shows the semi-circular weather covers over the entrance doors to the Second Class Entrance. While this is not a roof in the strictest sense, it is included here because like the wing cabs, it is of wood construction and provides overhead cover. Figure 16 is a *Titanic* wreck photo showing one of these covers. As can be seen in the photo, the teak covering boards still exist. One aspect that is different about this cover is that it appears that there is still wood material inboard the covering boards. This would indicate that the planking was teak like the covering boards. The method of waterproofing would have been like the navigating bridge roof or the wing cabs.

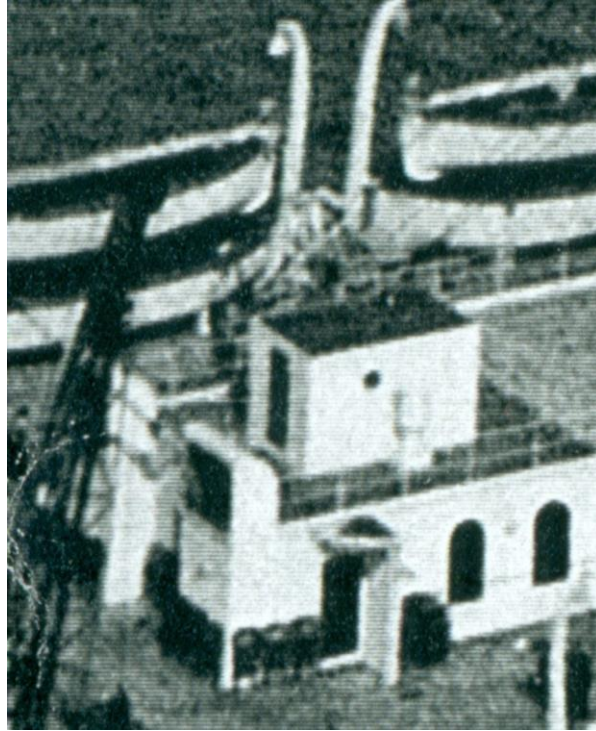
Figure 14 shows an aerial view of the roof of this elevator machinery room and how the color contrasts with the wood sheathed steel roof over the second class entrance.

Elevator machinery room roof

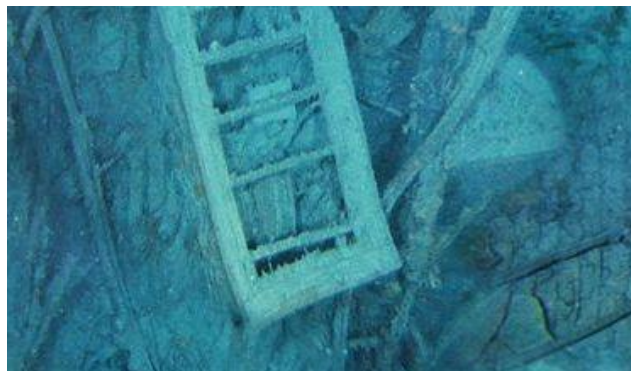
Figure 15

The reason we know that this roof was waterproofed wood construction is because of the Titanic wreck photo shown in Figure 15.

Elevator machinery room roof (*Titanic* wreck)

In the *Titanic* wreck photo we see that the pine roof boards have been consumed leaving only the steel roof beams. This roof treatment was done to help control heat build-up which could affect the functioning of the elevator machinery.

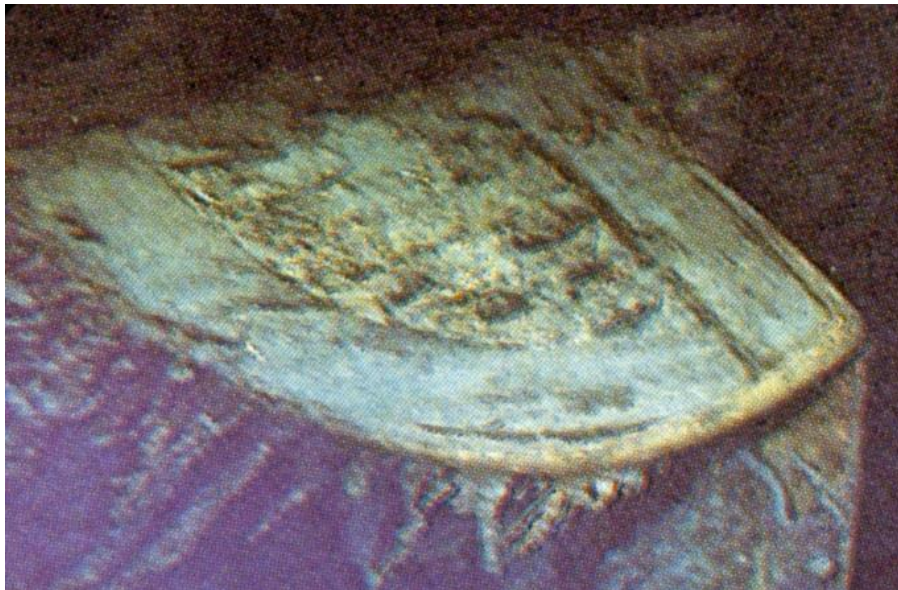
Figure 16

Second class entrance weather cover (*Titanic* wreck)
