The Case for the Objects on the Weather Cover over *Titanic's* Forward Grand Staircase Dome as Scaffolds

By Bob Read, D.M.D.

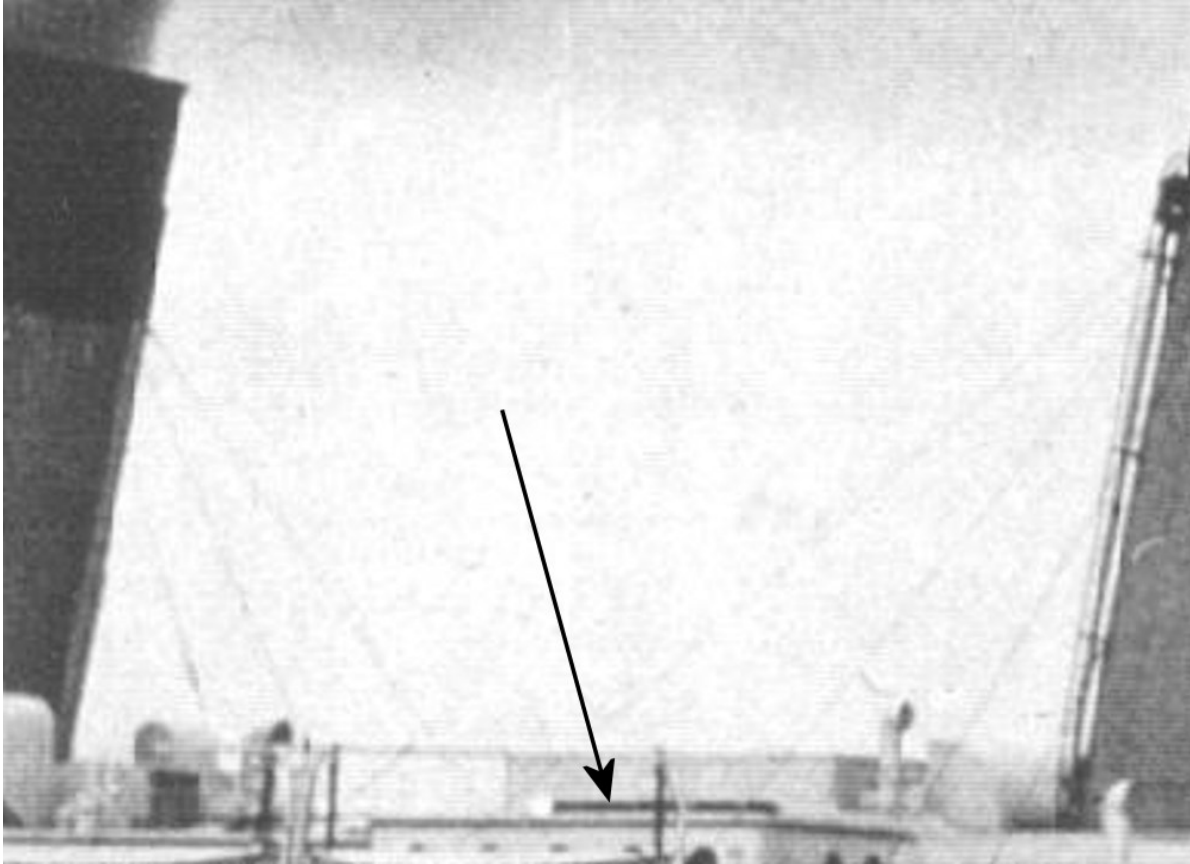
“dark objects” identified on *Titanic’s* weather cover over the forward grand staircase dome

There have been numerous identities proposed for the “dark objects”. They have been variously identified as ventilating devices for the weather cover, boards to keep a canvas cover over the weather cover skylight panes from adhering to the panes if frozen, and boards to be used as awning rafters in the area aft of the first funnel of the roof of the of the officers' quarters deckhouse. This last identity is the one that has endured until the present time. These identities were proposed because there were no close-up photos or plans of these “dark objects”. Figure 1 is about the best photo that we have of *Titanic's* “dark objects”.

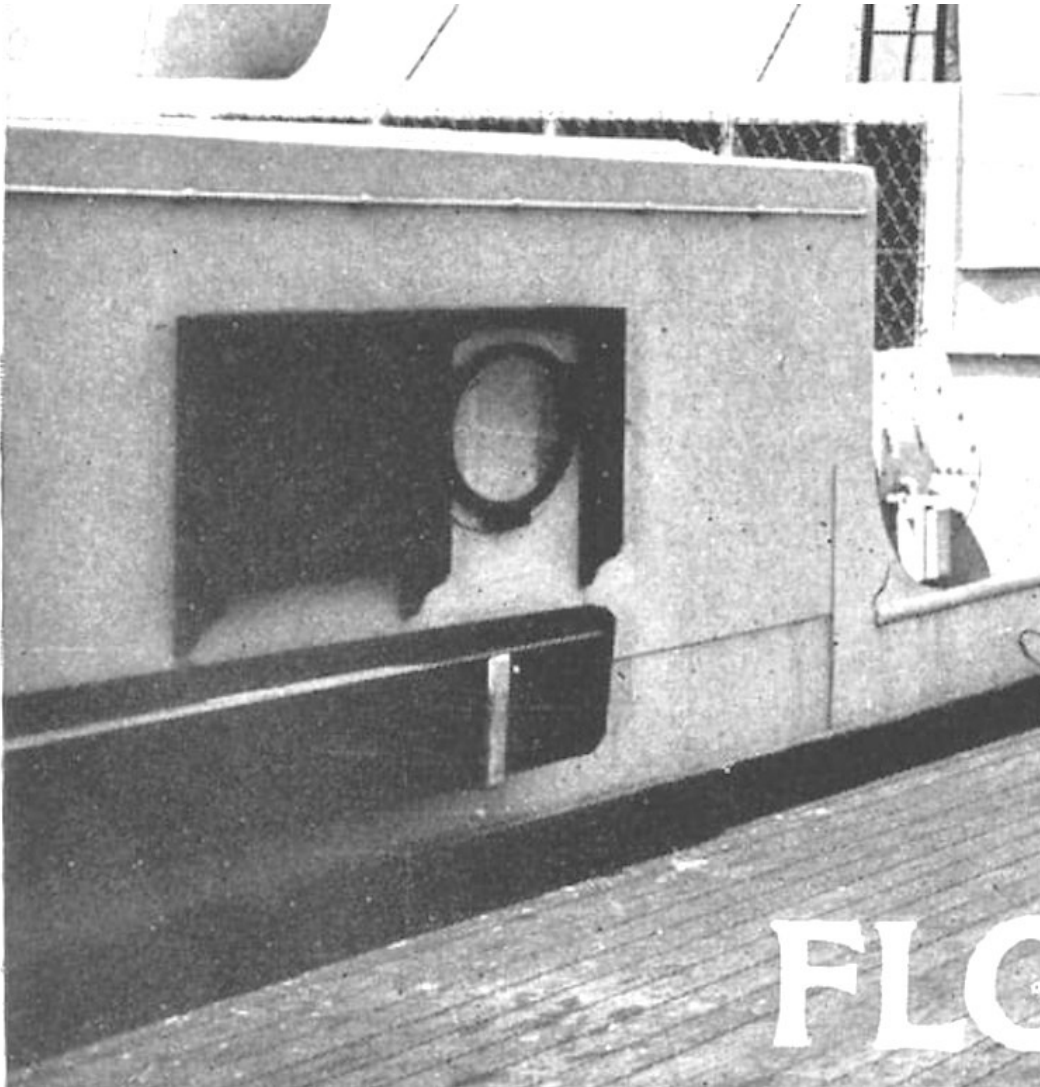
1911 photo of a “dark object” on *Olympic’s weather cover*

Some of the best early evidence came from early *Olympic* photos that gave a clearer view of the “dark objects”. Figure 2 shows a closer view of the “dark object” on the port side of *Olympic’s* weather cover.

Even though Figure 2 was a closer photo, it was still difficult to make a positive identification. This photo had been one of our best photos of the “dark objects”.

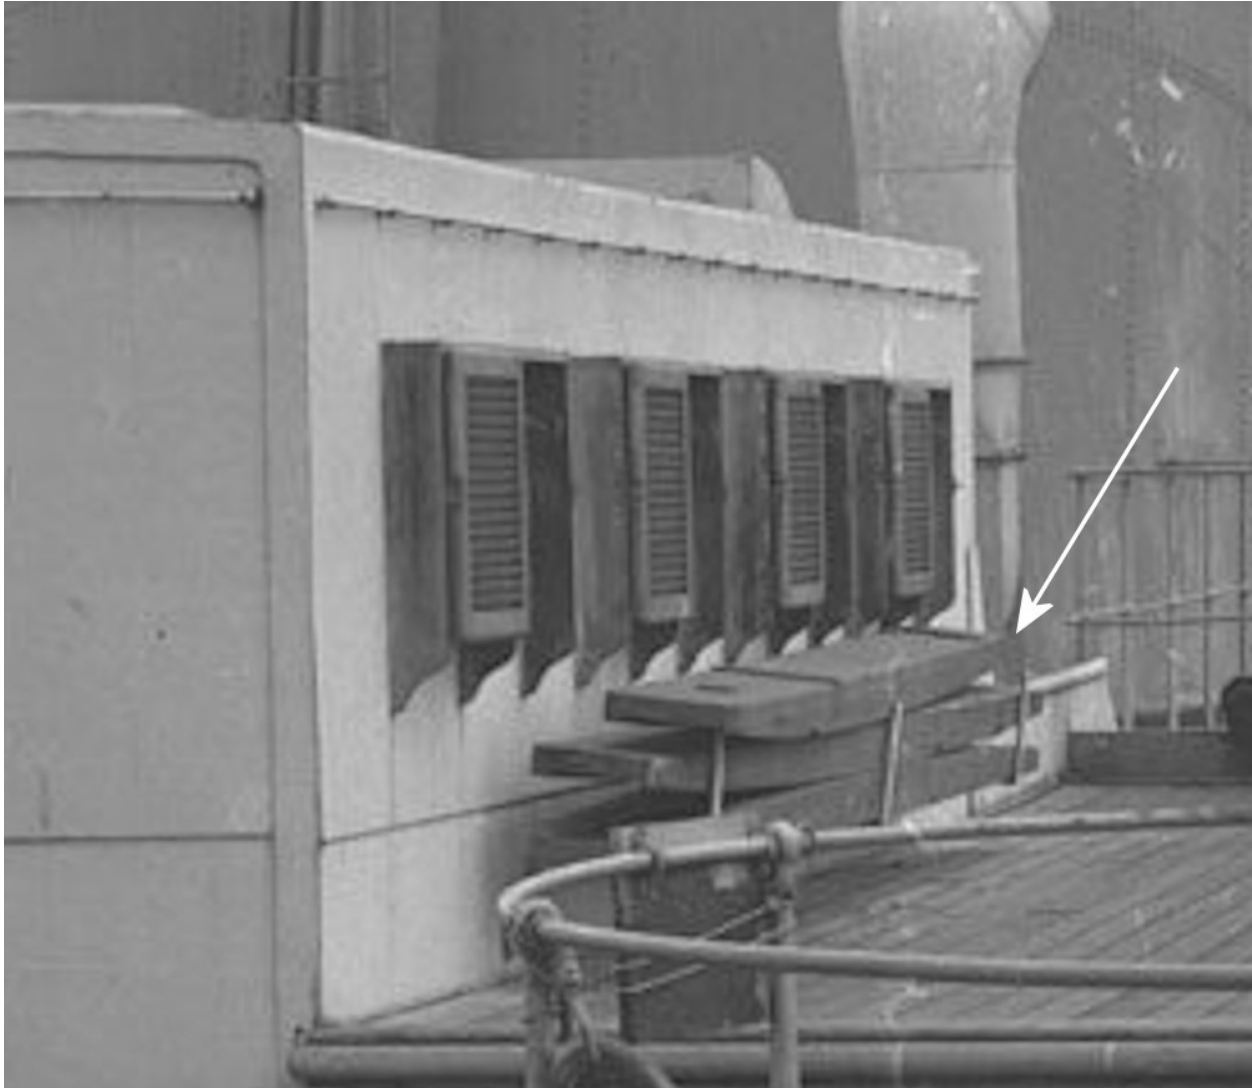
Figure 3

1912 photo of “dark objects” on *Olympic’s* weather cover

At this point we can see a difference between the *Olympic* “dark objects” and what is seen in the 1912 *Olympic photo*. What is the difference? I believe that the three objects in the 1912 photo are the same as the object seen in the 1911 photo. The difference is that rather than three objects seen in the 1912 photo, there is only one in the 1911 photo and it is stowed on its side. The objects have a curved addition on both sides of the bottom. In the 1911 photo, the curved bottom is facing outboard. We can tell that by where the sun is on the object. If it were straight, then the sun line would be straight. But what we see is that as one proceeds forward, the area in the sun is wider. This would correspond with to the wider part of the curved additions to the bottom. What we can see is that in the 1912 photo, storage brackets are wider. We can surmise that the storage bracket in 1912 was meant to hold three objects stowed on their sides like in the 1911 photo.

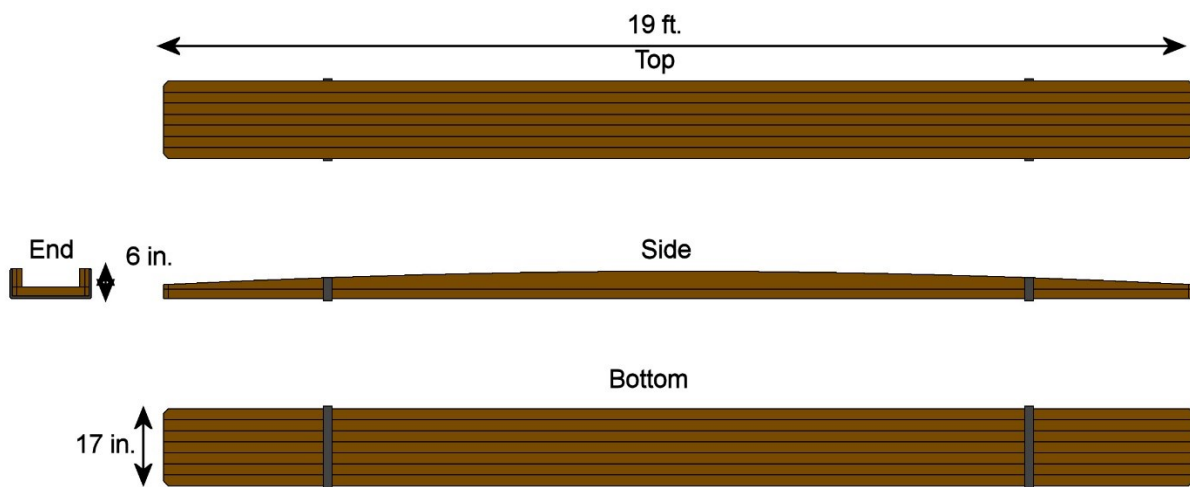
Dimensions and structure of "dark objects"

Numerous photos and plans of both *Titanic* and *Olympic* were studied and measurements were taken to determine the dimensions of the "dark objects". Figure 4 shows the dimensions of the objects.

Using the known dimensions of structures near the "dark objects", proportional equations were used to determine unknown dimensions of the "dark objects".

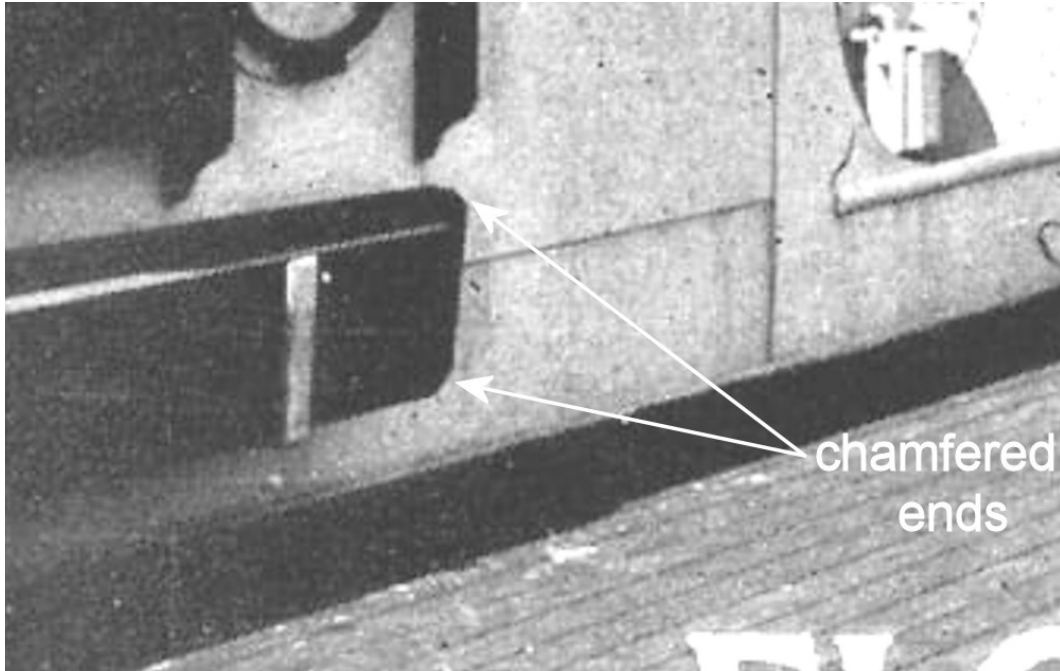
Chamfered ends of "dark object" on *Olympic* in 1911

At this point we can use the dimensions and configurations of the "dark objects" to determine their identity. The feature of the "dark objects" which goes the farthest in establishing their identity is what is seen in Figure 5 which is the 1911 *Olympic* photo.

Notice in Figure 5 the corners of the object are chamfered as indicated in the photo. This is a common feature of scaffold boards. Figure 6 shows a modern scaffold board with the same chamfered corners.

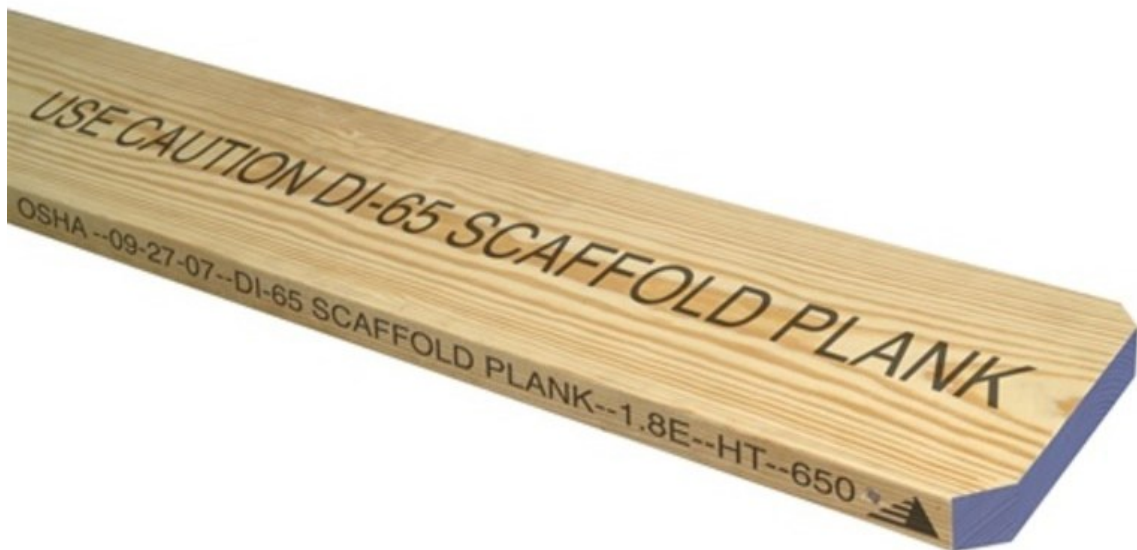
Figure 6

Modern scaffold plank with chamfered corners

These chamfered corners were to prevent splitting if the scaffold was accidentally dropped on one of the corners.

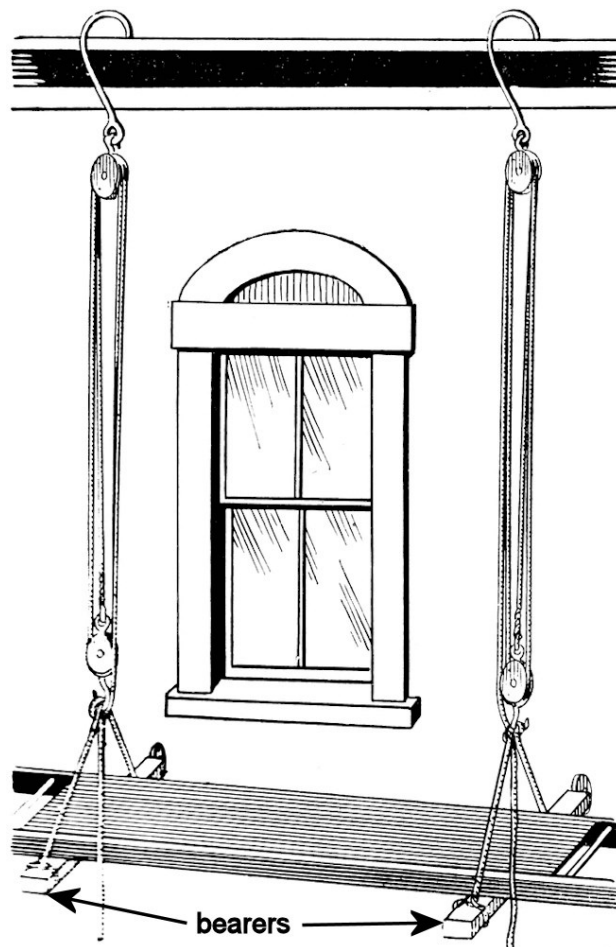
Figure 7

Set-up of swing stage scaffold

The proper name for this type of a scaffold is a swing stage scaffold. It is used for painting or maintenance on the sides of deck houses on the sides of the ship. For our purposes, we will simply call them suspended scaffolds. The scaffold was suspended by manilla rope with blocks attached to the rope stirrups which attached to timbers known as “bearers”. This set-up is shown in Figure 7.

The bearers were of such a length that they held the scaffold away from the side of the work surface so that workers could be seated and there would room for their legs. Though not exactly the same design, Figure 8 shows some examples of multiple board scaffolds.

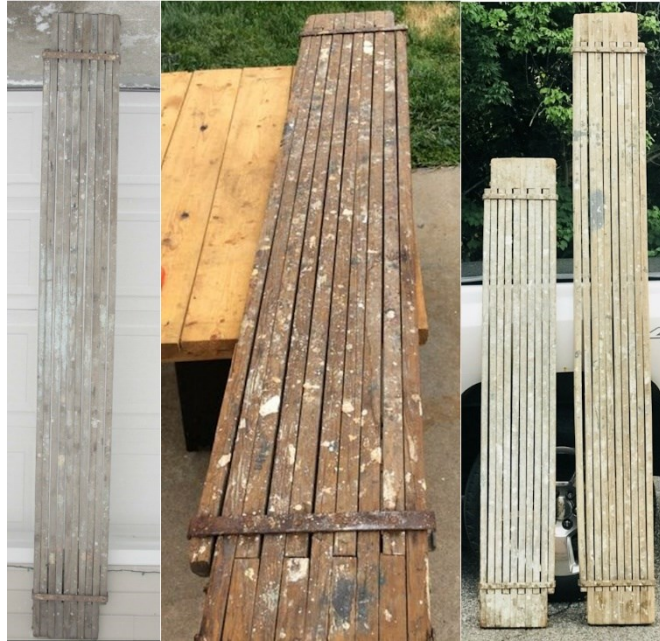
Figure 8

Multiple board scaffolds

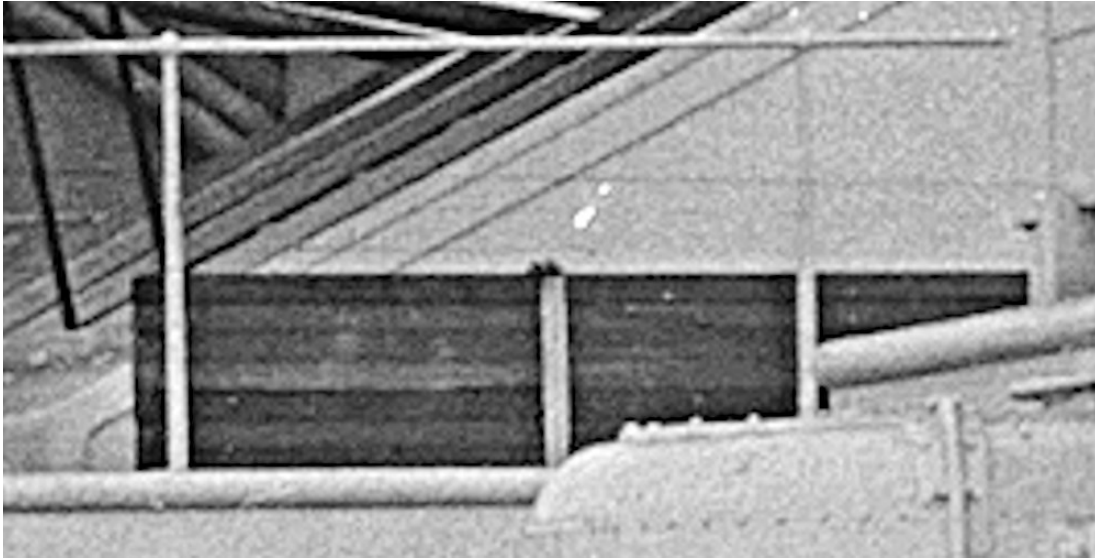
Wooden structure on roof of *Titanic's* tank room roof

We now turn our attention to the roof of *Titanic*'s tank room. In Figure 9 we see what appears, at first glance, to be a stack of simple boards. But is it?

If we again take measurements with respect to landmarks on the roof such as railings and stanchions, we find that the length is 19 ft. like our scaffolds on the forward weather cover. They apparently never stowed these scaffolds so that the bottom edge was resting on a deck or a roof. They were elevated slightly so that they wouldn't be sitting in pooled water and could therefore dry thoroughly. Taking this into account, the width of the "boards" we see would appear to be 17 inches. We can now see that what we are looking at is another scaffold identical to the others. We don't see the iron band because it is obscured by the stowage bracket. The ends are partially obscured by railing stanchions. If we draw a line across the top of the top board, we can see that the line does not touch the board at the end. This can be seen in Figure 10.

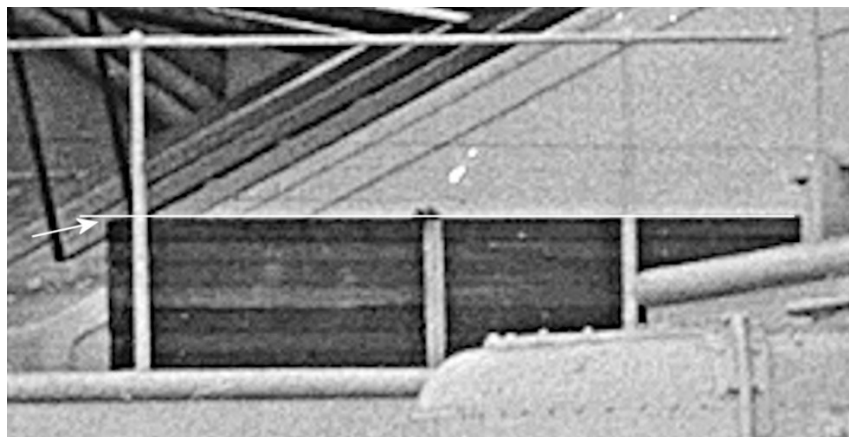
Figure 10

Scaffold chamfered corner

This would indicate a chamfer like the other scaffolds. The chamfer at the bottom can't be seen because it is below the level of the deck house trim. Given all these observations, it becomes clear that we are looking at a scaffold on the roof of the tank room rather than just a stack of individual boards.

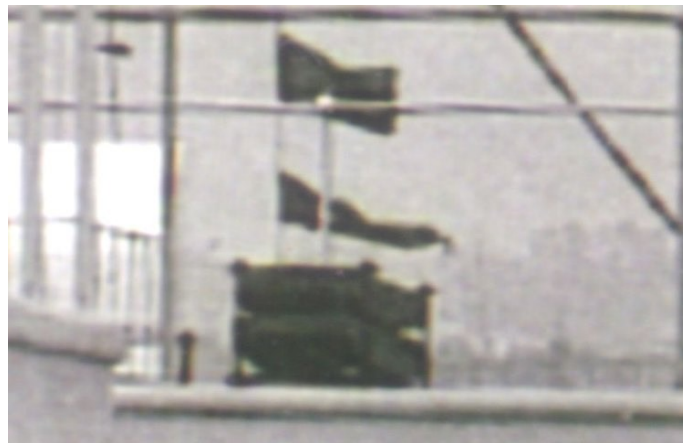
Figure 11

1911 photo of scaffolds on *Olympic's* tank room

What we see is a rack which stowed scaffolds identical to the ones we have been considering. In fact, Figure 12 shows a more complete view of 1911 *Olympic's* tank room roof where we can see that there were actually four of these racks with scaffolds stowed on them.

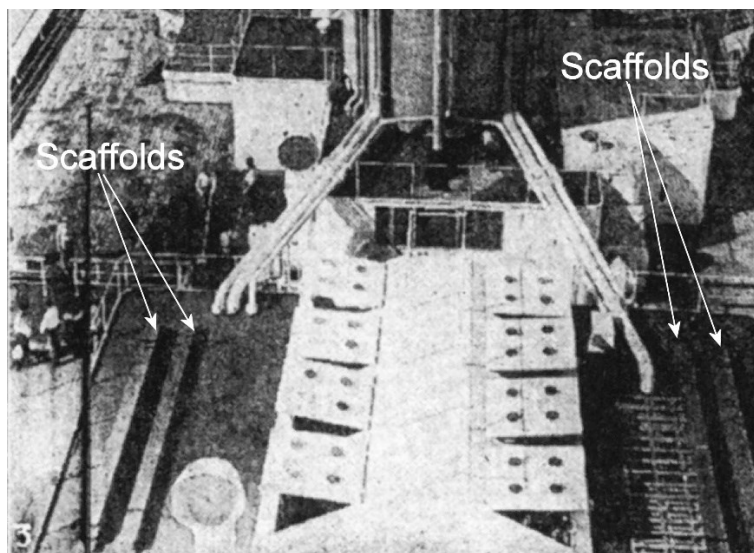
Figure 12

1911 photo of scaffolds on *Olympic's* tank room

This was possible on *Olympic* in 1911 because not nearly as much of the roof space was taken up by water mains. By 1912 *Titanic* and *Olympic* had changes made to the water mains which all but eliminated the possibility of stowage of scaffolds on the tank room roof. *Titanic* was able to stow one on the aft railing of the tank room. From Figure 9 which we viewed previously, there is no indication that more than one scaffold was stowed on *Titanic's* tank room roof.

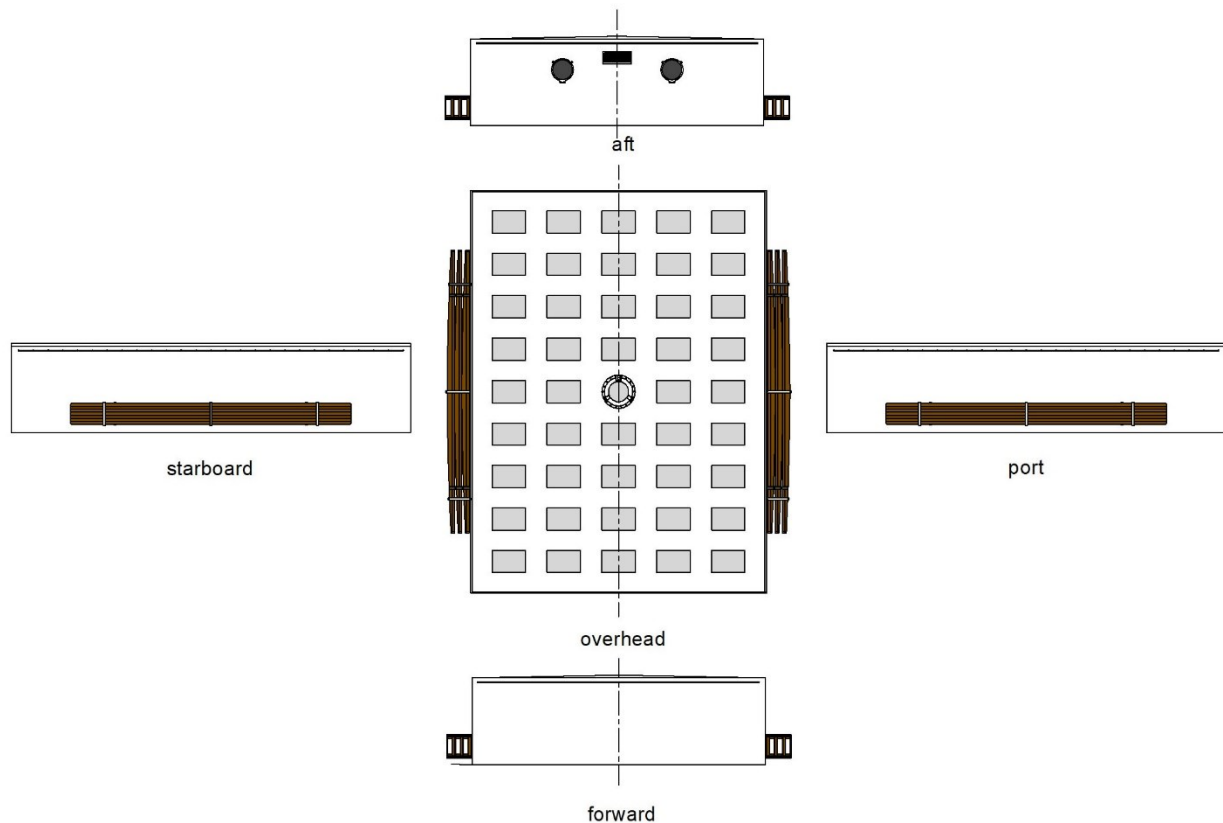
Elevation and plan views of stowed scaffolds on *Titanic's* forward weather cover

Figure 13 shows plan and elevation views of the scaffolds stowed on port and starboard sides of the weather cover over *Titanic's* forward grand staircase dome. Because of the 1912 evidence, three scaffolds are shown stowed on each side.

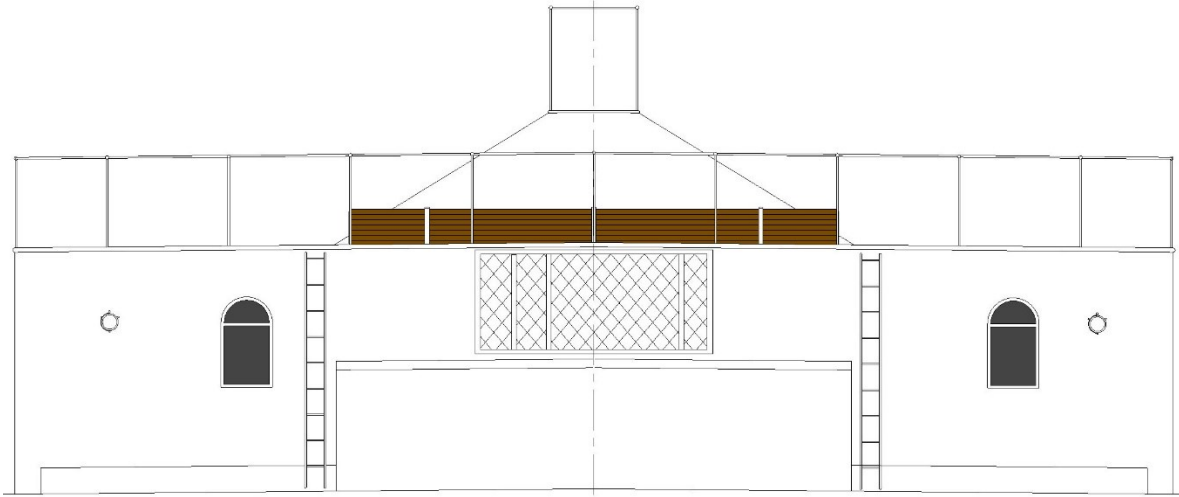
Elevation view showing single scaffold on roof of *Titanic's* tank room

Figure 14 shows an elevation view of a single scaffold stowed on the aft roof of *Titanic's* tank room. Only one scaffold is shown because no more than one can be identified in a Cork Examiner photo taken aboard *Titanic* in Queenstown as seen in Figure 9.

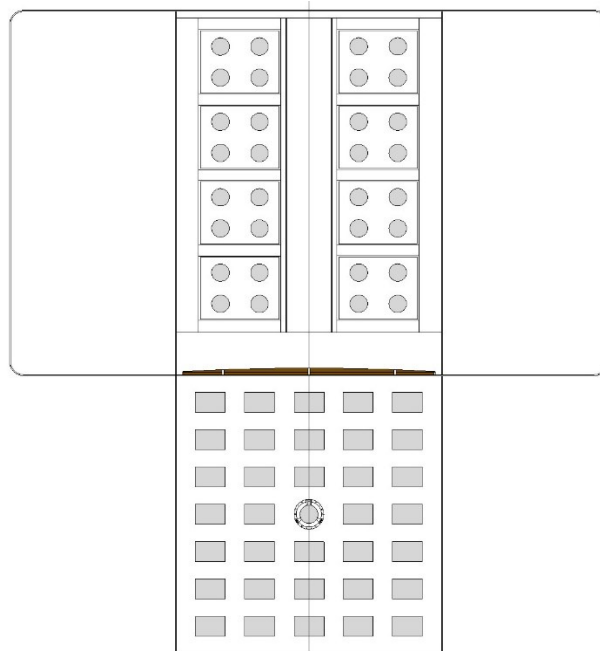
Plan view showing single scaffold stowed on roof of *Titanic's* tank room

Figure 15 shows a plan view of the roof of the tank room.
