Center Object on *Titanic's* Staircase Skylight Weather Covers

By Bob Read, D.M.D.

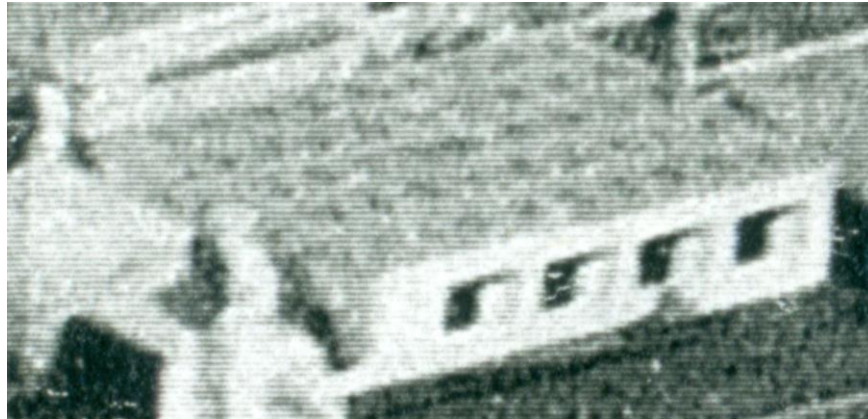
Figure 2 shows *Olympic's* forward staircase skylight weather cover. It can be readily seen why it has been difficult if not impossible to discern details of the center object of the skylight.

Olympic's forward staircase skylight weather cover

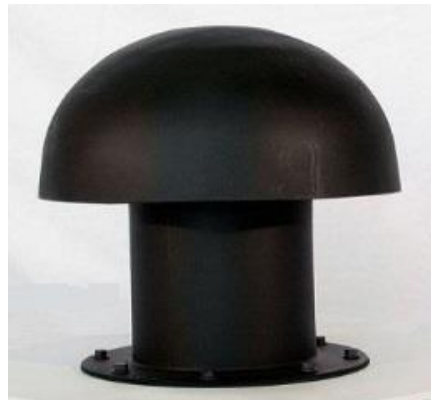
Figure 4

One problem which would have to be overcome with a scuttle is that it would have to be absolutely waterproof. The simplest way to accomplish this would be to utilize the method used by mushroom vents and have a domed cover. A representative mushroom vent is shown in Figure 4. The domed cap or cover of the vent is larger than the vent pipe to direct water away from the opening.

Typical mushroom vent

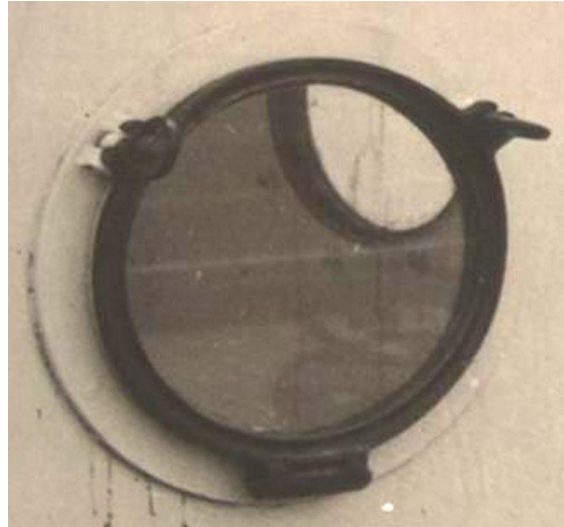
Since the scuttle cover couldn't be accessed from below then there would have to be some method for securing it. Any number of methods could be theorized but a common method in use at the time for other applications would be a hinged cover with securing "dogs" like a porthole. Figure 6 shows a hinged porthole with securing "dogs" on the side of the weather cover over the aft staircase dome on Olympic.

Hinged porthole on aft staircase weather cover

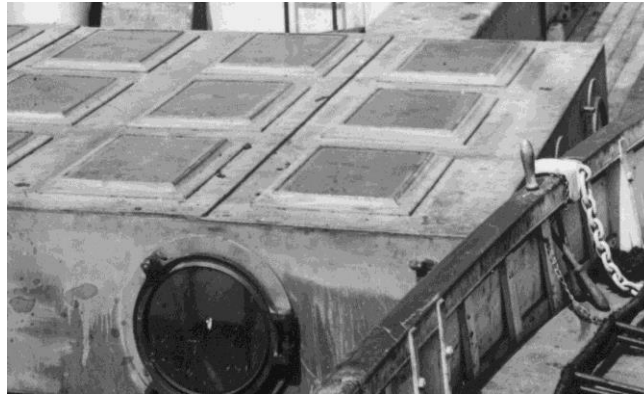
Having examined the plan and photo evidence and the prevailing theories, one other aspect of this scuttle with cover having a glass insert is the type of glass. In Figure 8 we can see a photo

of a similar type of weather cover on RMS *Oceanic*. As can be seen in the photo, the glass in the rectangular panes is frosted. This gave maximum diffusion of the light for even illumination of the dome below.

Skylight weather cover on *Oceanic*

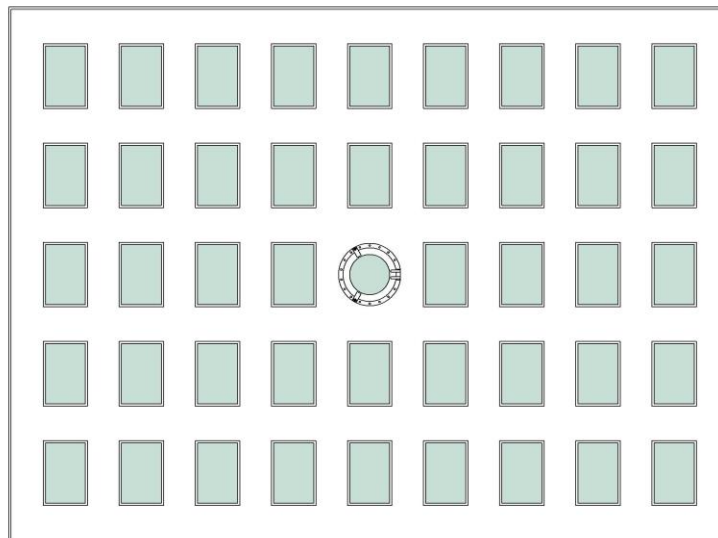
Having examined the plan and photo evidence to develop a unified theory for a scuttle on the staircase skylight weather cover drawings will illustrate the modified scuttle theory. Figure 9 shows a plan view of the forward staircase skylight weather cover with the scuttle in the closed position.

Forward staircase skylight weather cover
