Documentation of a New *Titanic/Olympic* Find: Support Stanchions Under the Poop Deck

By Bob Read, D.M.D.

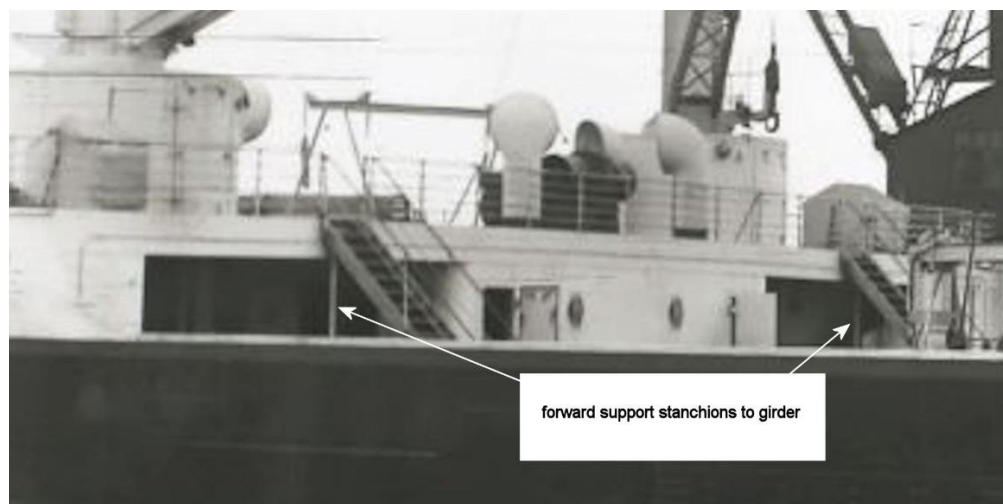
Figure 1

The first photo in which the original discovery was made is shown in Figure 1. Arrows point to the stanchions which were originally discovered.

Support stanchions under forward poop deck

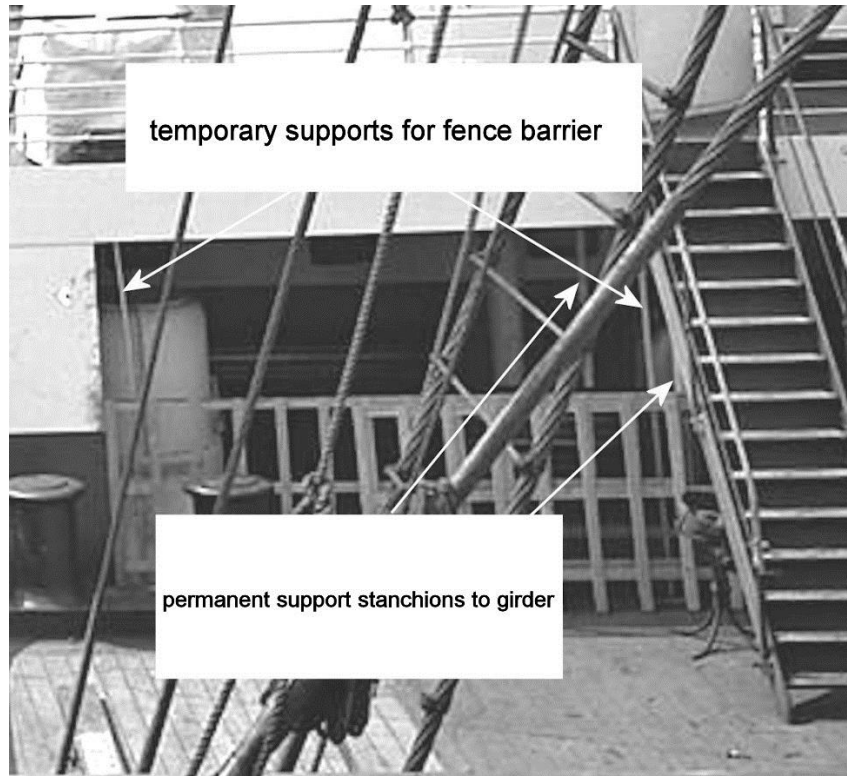
Figure 3 is another photo which shows the same structures from a slightly different angle.

Permanent support stanchions to poop deck girder
