Titanic's Aft B Deck Mystery Object

By Bob Read, D.M.D.

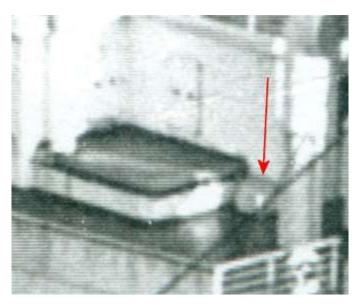
Photo evidence of this object is rather sparse. Most of our better photos are from *RMS Olympic*. Figure 1 show *RMS Olympic*. The object in question is aft of the port #4 hatch up against the deckhouse.

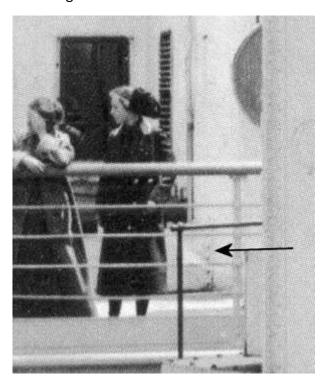
Figure 3 was taken aboard *RMS Olympic* in May 1912. Again it is an incomplete photo but it shows more of the object than Figure 2.

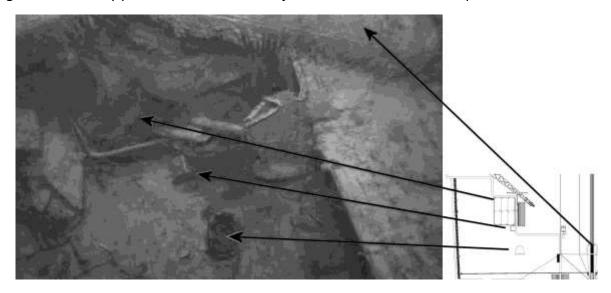
Figure 4 is the only photo we have of this object on Titanic. It is a wreck photo.

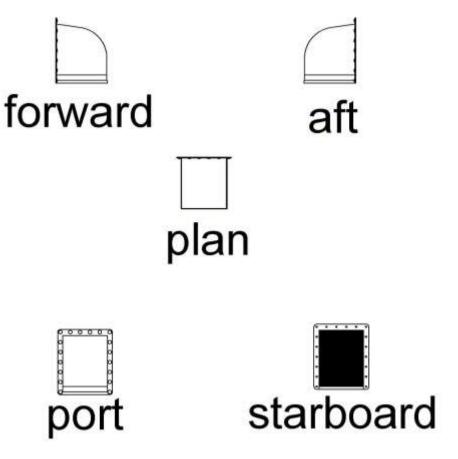
Figure 5

Not every photo we have of this object is included in this article. From an analysis of all the photos a multi-view drawing of the object is shown in Figure 5.

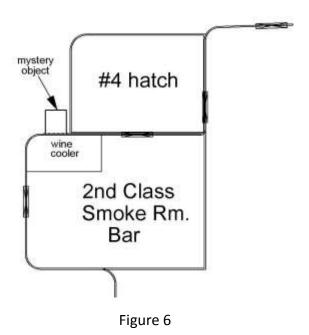
After evaluating and rejecting a number of theories about the function of the mystery object some of the same methods will be used to try to determine the function of the object. Directly inboard of the object in the 2nd class smoke room bar is a wine cooler. Figure 6 shows the 2nd class smoke room bar. Directly outboard is the port #4 hatch. The mystery object is located just outboard of the wine cooler.

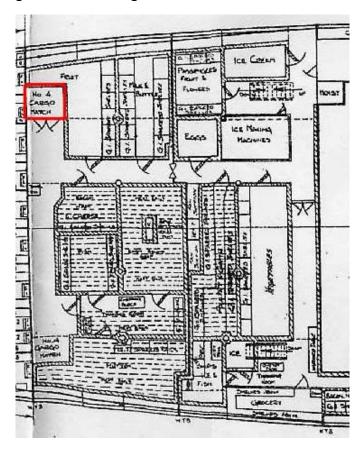
Most of the perishable food stores refrigeration rooms were located on G deck just forward of the #4 hatches. In Figure 7 we see the area of G deck where rooms were refrigerated for perishable cargo storage. In this drawing I have outlined the location of #4 hatch.

The reason the location of the areas where there is refrigeration is shown is that it is directly below the 2nd class smoke room bar. It would be very easy to run cold brine lines from this area on G deck up to the 2nd class smoke room bar. The question may be asked why didn't the cold brine pipes run up through the floor of the 2nd class smoke room bar instead of entering it from the port side? We don't have specific information about all the considerations which went into the run of the cold brine pipes. It may be that the location of the connections for the brine pipes might have required the pipes to enter from port.
