# Awnings Aboard *Titanic*

by Bob Read, D.M.D.

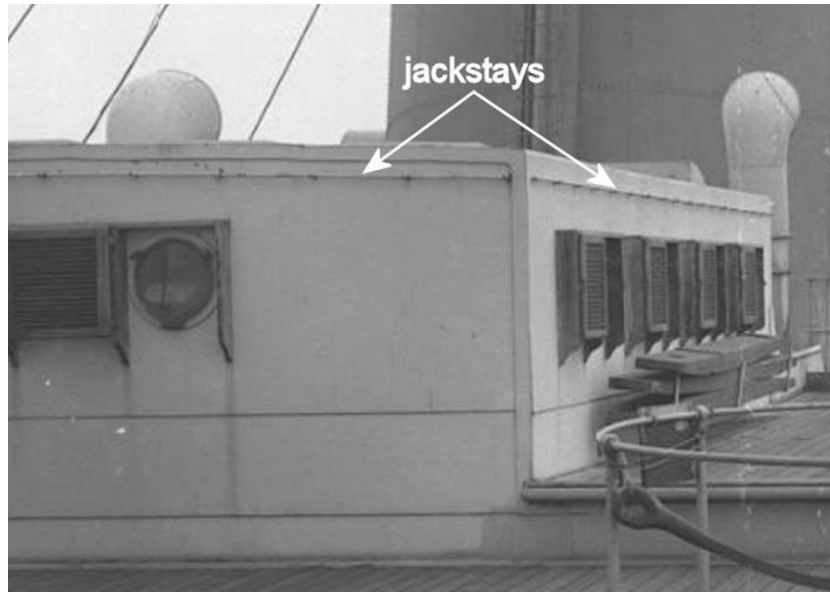
Figure 1

While analyzing awning coverage on the roof of the officers' quarters, I began looking at the weather cover over the dome of the forward first class staircase. From *Olympic* photos, we can see jackstays on the sides and the forward aspect of the cover. These can be seen in Figure 1.

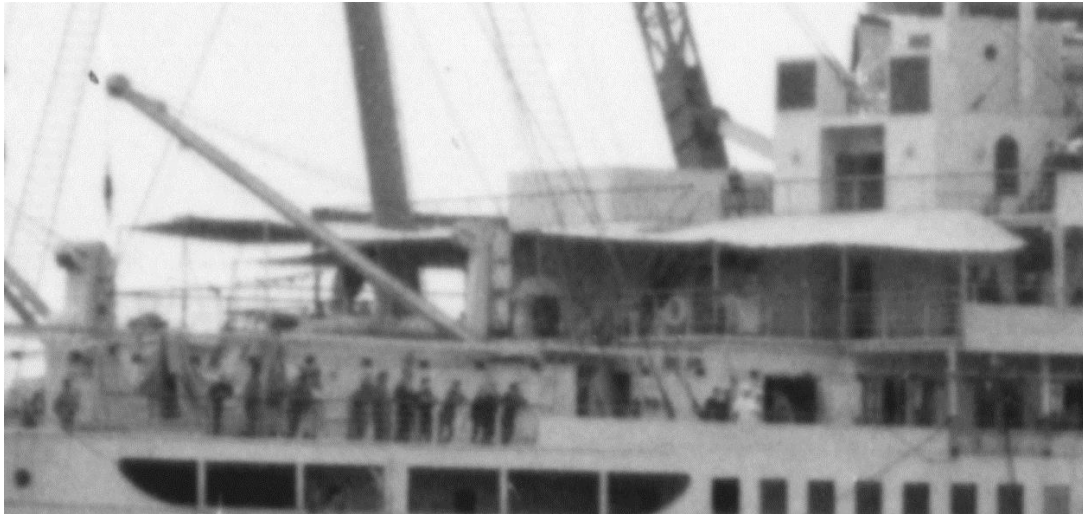
Figure 15

While we can't be completely sure that it represents the same awning coverage intended for *Titanic*, there are photos which show the awning coverage in this area on HMHS *Britannic*. One of the photos is shown in figure 15.

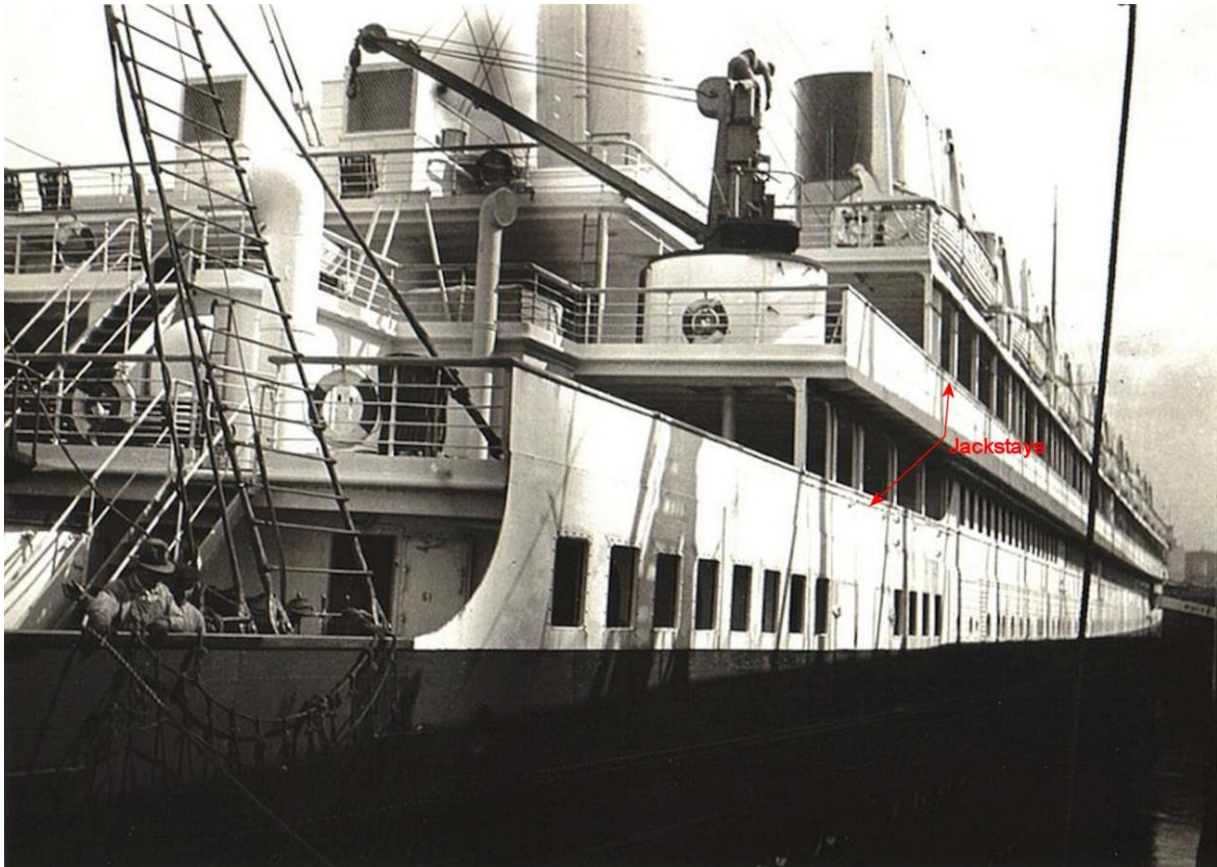
Figure 17

The third major areas of awning coverage aboard *Titanic* are the unscreened areas of the “A” deck and “B” deck promenades. Taking the “A” deck promenade first, provision for awning coverage was in three locations (p & S). First, below the caprail of the outboard side of the bulwark were jackstays. Very clear photos of these on *Titanic* are nearly impossible to find so first an example of these jackstays on *Olympic* are shown in Figure 17.

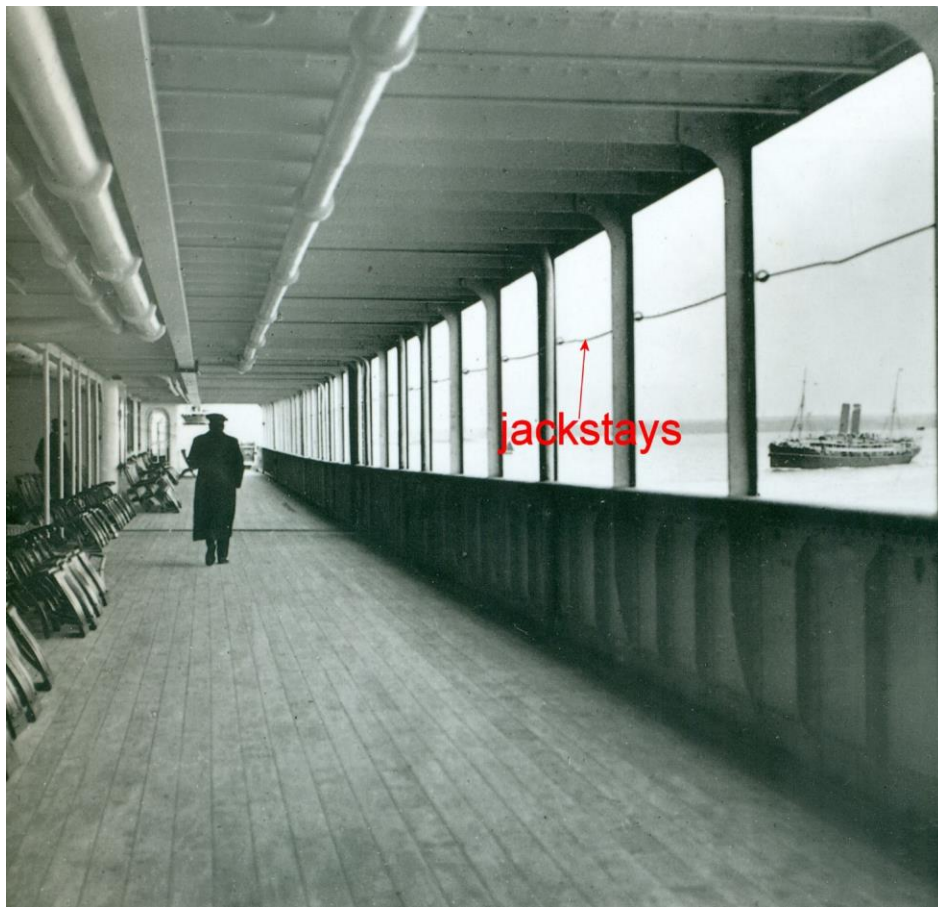
Figure 19

The next pieces of equipment provided for awning coverage on "A" deck are the jackstay wires which were rigged through eyes on the outboard "A" deck stanchions. These can be seen in Figure 19.

These “A” deck promenade awnings could be attached in two separate positions. The upper attachment point is under the boat deck where it meets the promenade stanchions. The lower attachment point could be in two positions. The first would be to the jackstay wire shown in Figure 19. The second would be complete coverage by attachment to the jackstays outboard below the bulwark caprail. In Figure 20 we see the only photo of *Titanic* with an awning rigged. This is the starboard forward unscreened area of “A” deck. The awning is attached to the underside of the boat deck where it meets the promenade stanchions and to the jackstay wire at its lower edge.
