Titanic's First Class Smokeroom Bar Windows

by Bob Read, D.M.D.

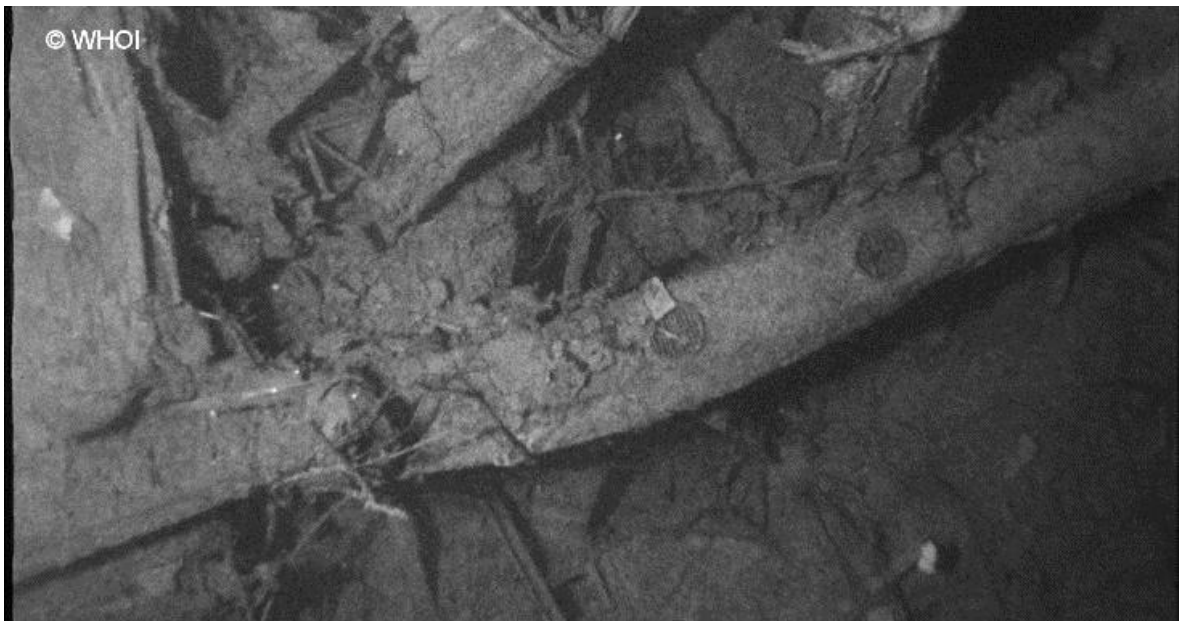
Figure 1

The first indication that there were windows on the aft face of the raised roof over the first class smokeroom was a photo taken in a 1986 expedition to *Titanic*. This photo is shown in Figure 1.

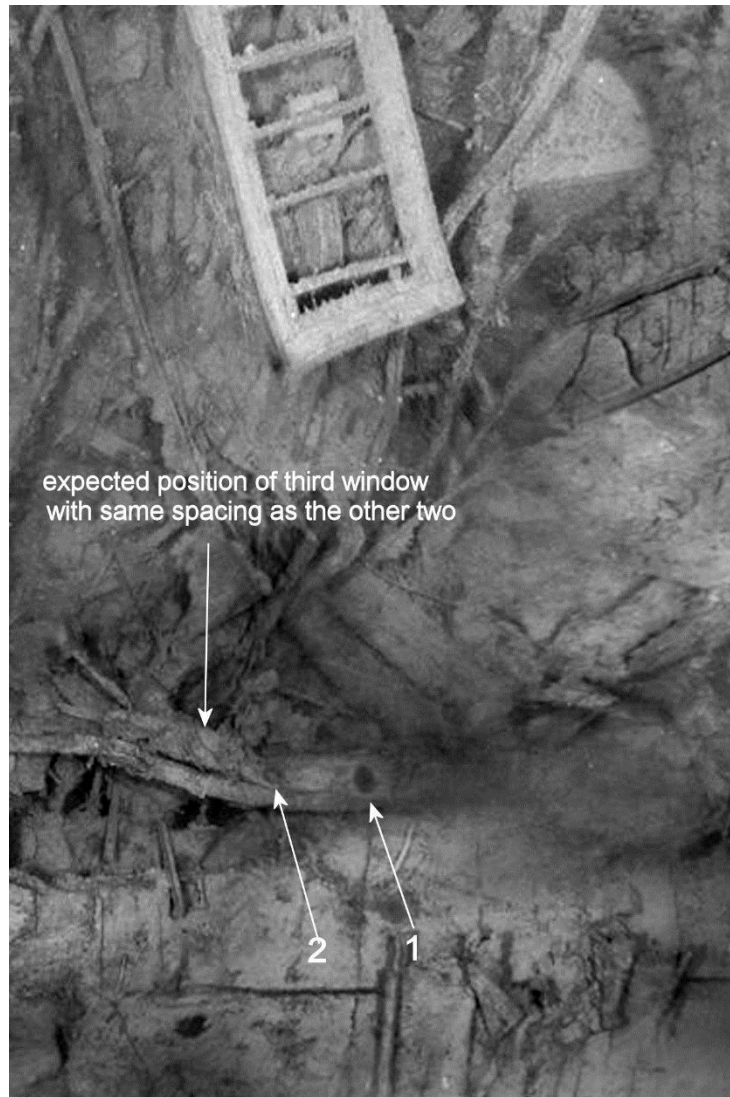
In 2010 a mosaic of the area was created. The pertinent area is shown in Figure 4

Again the two windows which were seen in the 1986 photo are identified. Also as in the 1986 photo, the area where one would expect to see a third window on the starboard side is indicated, but again there is no obvious window.

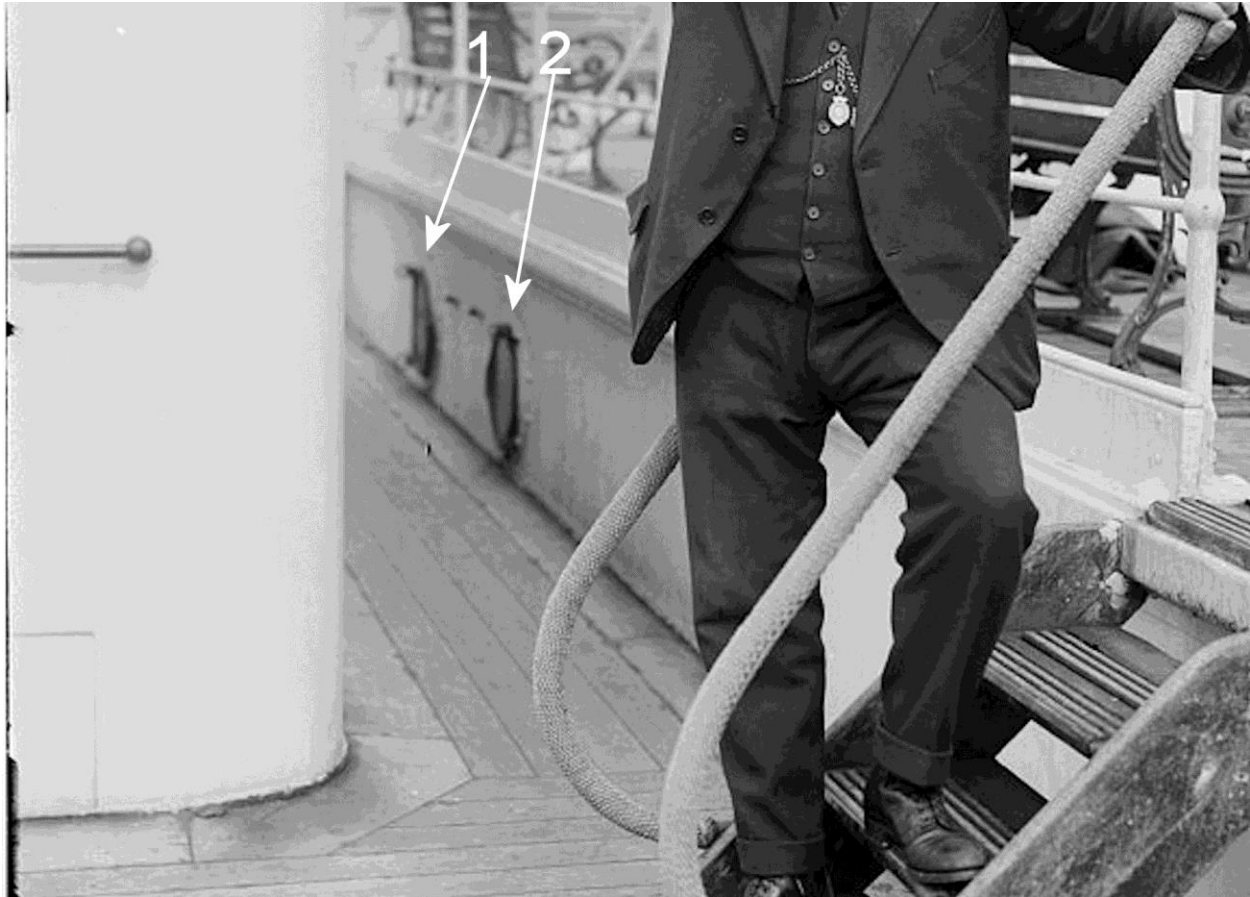
Figure 5

An *Olympic* photo surfaced a few years ago which re-ignited the debate. This photo is shown in Figure 5.

As you can see, it clearly shows only two smokeroom bar windows.
