Deckhouse Structures Aft of Titanic's Third Funnel

By Bob Read, D.M.D.

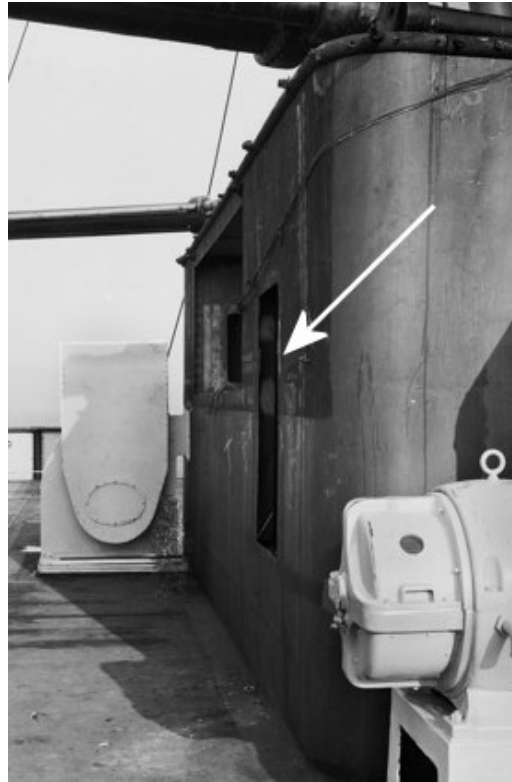
Figure 4

Olympic panel to pantry hoist gear

It can be seen that the opening is not a full-length door but rather a panel. It is thought that this panel was for ventilation purposes to keep the lift motor from overheating. It was originally thought that this would be just a simple steel panel. The 1913 photo in Figure 2 shows a latch plate in the location of this panel. Latch plates are used exclusively with wood doors. Further, it was thought that since this was a wooden door that it must have been changed from a metal panel to a full-length wooden door. The evidence which was discovered which brought new light to this panel is seen in Figure 6. This is from an aerial photo of Olympic in 1923. The boat deck doors in this photo are all painted a dark color. Fortunately, the panel can be seen clearly in this photo and it is not a full-length door. Therefore, the two things we can deduce from this are that this a panel, not a door, and that it is wood.

Figure 5 show this area on Olympic during fitting out.
