The Opening Windows of Olympic and Titanic's Boat Deck First Class Entrance and Gymnasium

by Bob Read D.M.D.

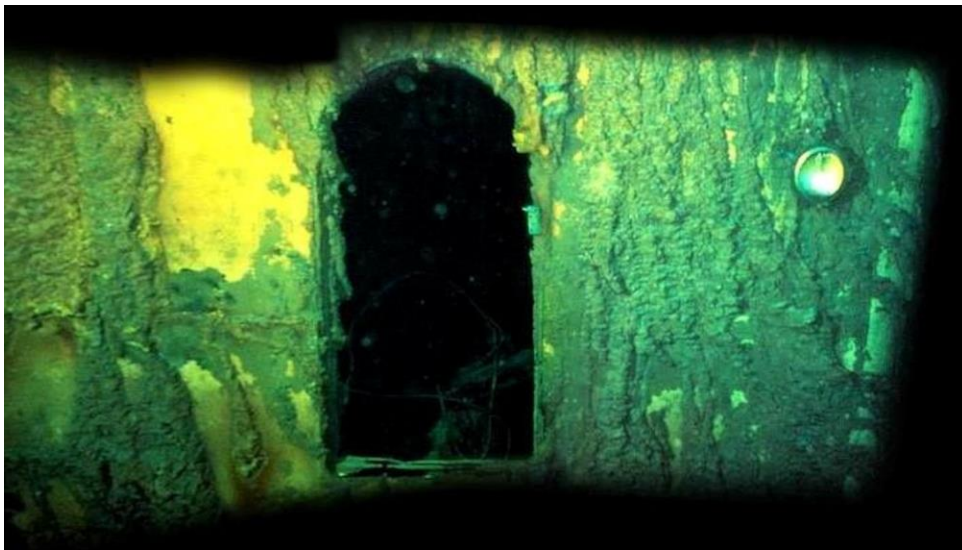
Figure 4 shows the opening for the aft facing Gymnasium window on Titanic. We are able to determine that the door opened to starboard because there is a hinge plate remnant on the starboard side of the window.

The opening window pattern for Olympic was relative easy to determine. The one area that did not have good photo coverage was the starboard side of the first class entrance. The first area which will be examined is the Gymnasium. We had seen from Olympic evidence that the aft facing Gymnasium window opened. It was unclear whether this window opened on Titanic until the Titanic wreck photo shown in Figure 4 was discovered.

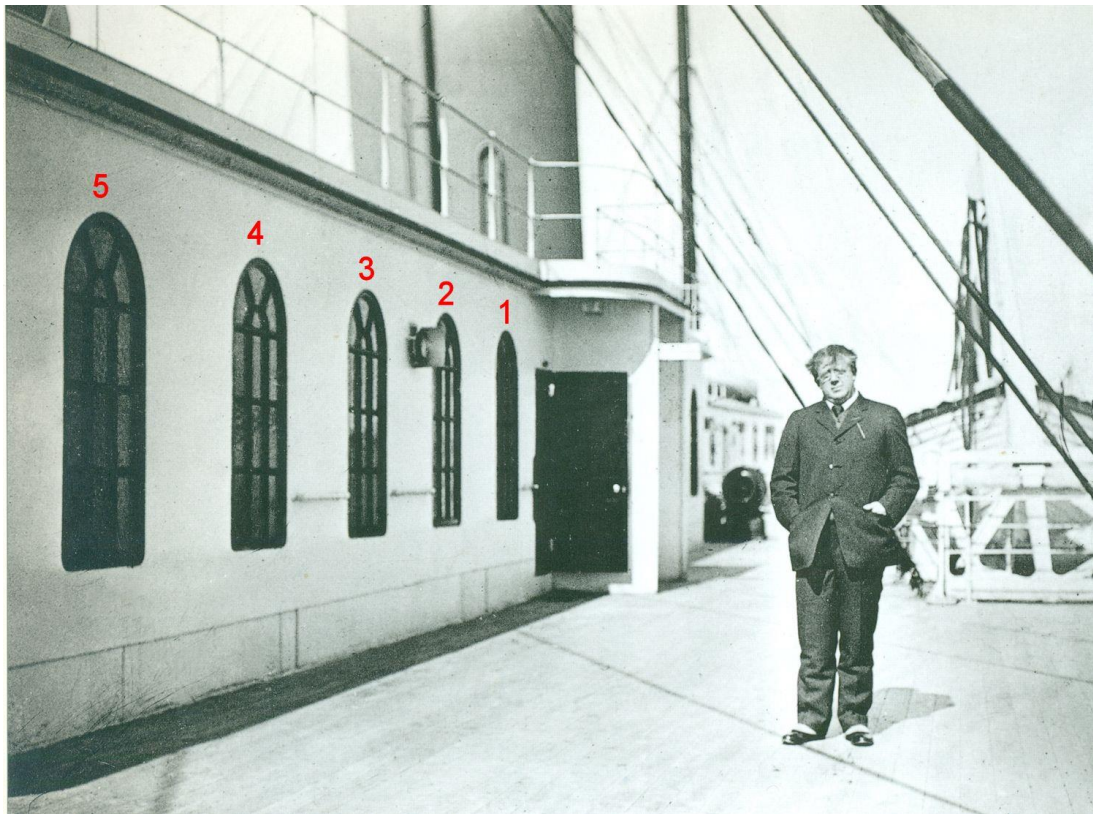
Figure 5

In this photo, we can only see windows 1-5. We will have to use another photo to supplement this one. To determine which windows opened we have to look at which storm rails are present and which are missing. Then by applying the general rules which were outlined previously, the only pattern where alternating windows could be opened are either windows 1-3-5, or windows 2-4-6. We can see that window 3 has storm rails on both fore and aft sides so that rules out the 1-3-5 window opening pattern. Next we have to test whether the 2-4-6 pattern would fit within the general rules previously outlined. In the 2-4-6 pattern, window 2 could open forward and window 4 could open aft. Since we can't see a storm rail between windows 5 and 6 we could postulate that window 6 could open forward. The only thing which could prevent this is if a bulkhead lamp were located between windows 5 and 6. To confirm the location of another bulkhead lamp, we will have to look at another Titanic photo.

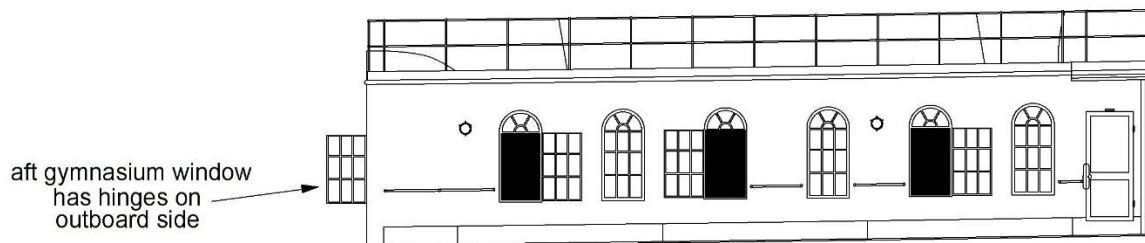
Figure9

To illustrate the opening patterns of the three locations of opening windows on Titanic the following drawings are offered. Figure 9 shows the opening Gymnasium windows.

Opening windows of Titanic's Gymnasium
