# New Evidence Which Explains the Functions of Titanic's Docking Signal Systems

by Bob Read

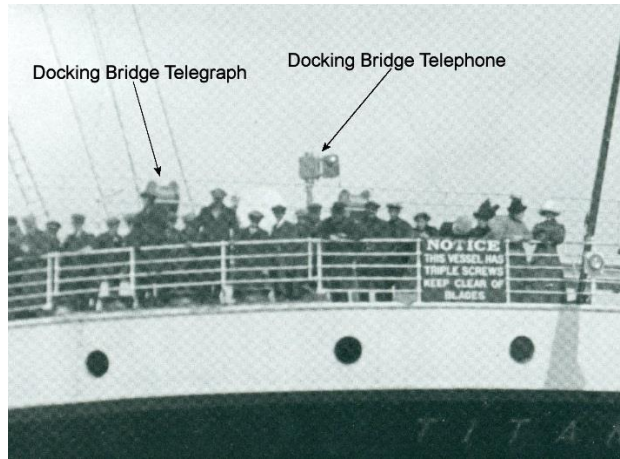
Figure 1 shows the location of the telephone and docking telegraph on Titanic's docking bridge. Figure 2 shows the starboard dial face of the docking telegraph. There were additional signals which could be transmitted by the docking telegraph which could not be signaled by the simple docking flag system or the docking lamp system. Figure 3 shows docking flags deployed aboard Titanic. Also visible in this photo are the docking lamps on the mainmast. We know that the lamps on the mainmast were for docking purposes because they are indicated on the Titanic Rigging Plan shown in Figure 4. Figure 5 shows a docking bridge flagstaff on Titanic which is stowed on the docking bridge. Figure 6 shows a higher resolution photo of the docking lamps of Olympic which were identical to those of Titanic.

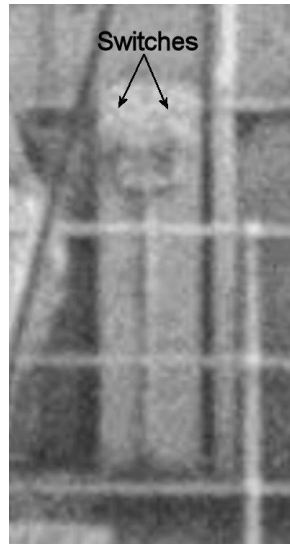
The docking lamps served the same purpose as the docking flags but they were used at night while the docking flags were used during the day. There are a few aspects of the procedures and functions of the docking lamps which are speculative at this point. After analyzing the sight lines on a plan view of Titanic, I believe that only the docking lamp on the same side as either bridge wing could be seen there. For the system to function as the flags, each lamp would have to be able to display either red light or white light. It is my belief that either there were red and white bulbs in the docking lamp or there were two white bulbs with one unfiltered and one behind a red filter. I also believe that the means of controlling these lamps was by means of a pair of switches mounted on a board on the docking bridge. Figure 7 shows this board on Olympic and these two switches mounted to the aft face. I believe that the port switch controlled the port docking lamp and the starboard switch controlled the starboard docking lamp. I believe that each switch had three positions, namely: 1. Red on and white off, 2. White on and red off, 3. All bulbs off. The docking lamp shone fore and aft so that not only would it signal the navigating bridge but the signal could be confirmed on the docking bridge.

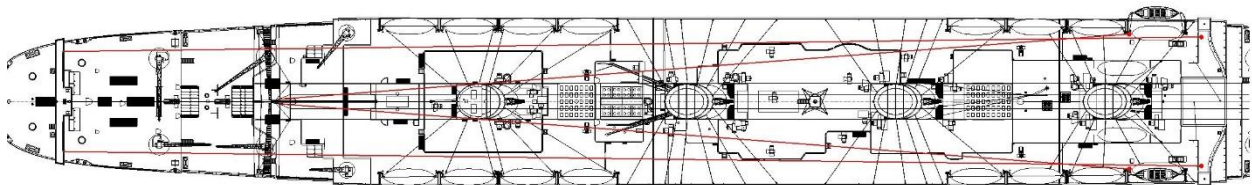
Figure 8

The lines of sight from the docking flags to the navigating bridge and from the docking lamps to the navigating bridge are slightly different. This difference can be seen in Figure 8.

The red lines on show the lines of sight. The line of sight from the docking bridge flag to the navigating bridge is slightly inboard of the wing cab. The lowest and most unobstructed line of sight was down the Boat Deck between the deckhouses and the lifeboats. The distance of this line of sight was roughly 638 ft.

The line of sight from the docking lamp to the navigating bridge area was somewhat different. The docking lamps were only used at night. A factor affecting the line of sight was the fact that when docking, the emergency cutters were swung inboard which would obstruct a line of sight to the wing cab. To overcome this, the nearest line of sight would be near the davit frame between the first and second lifeboats aft of the bridge wing. A lookout posted there could easily relay signals to the officer on the bridge. This sight line was roughly 500 ft. Since only one docking lamp could be seen by someone posted on either side of the navigating bridge, two lookouts would have to be posted to monitor these signals during night docking.

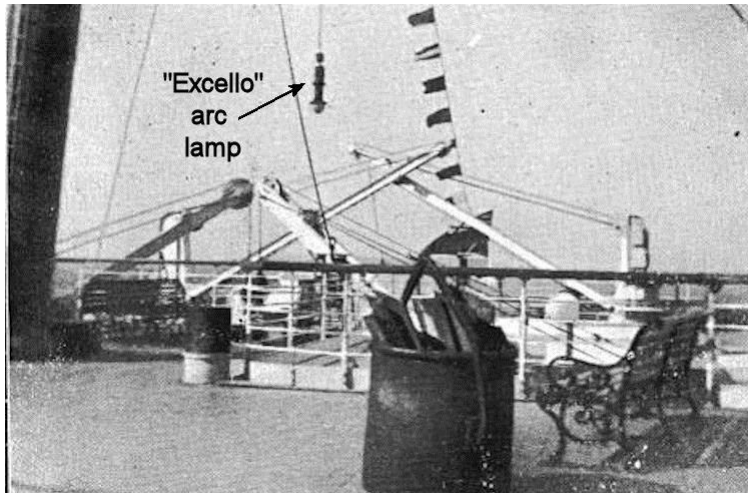
During the years before the discovery of the function of the docking lamps, a very prevalent line of thought was that the docking lamps were used to illuminate the aft cargo hatches during night cargo loading. The problem is that the docking lamps were relatively low power lights. Figure 9 show a photo taken aboard Olympic showing the "Excello" arc lamp which was used for night cargo operations or to illuminate other tasks.

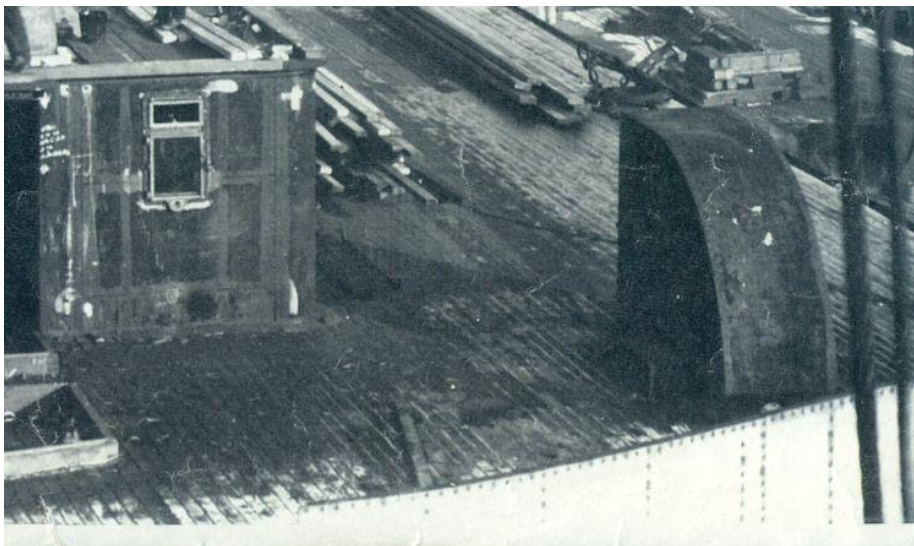
A second issue was raised by Ralph Currell. He speculated that Olympic's original crew stairway covers shown in Figure 10 were possibly cut down by removing the upper portion as shown in Figure 11 in order to improve visibility from the bridge wing to the docking flags.

I checked the line of sight on an elevation plan of Titanic and the height of the original stairway cover indeed could have been an issue in achieving an unobstructed view of the docking flags from the navigating bridge. The stairway cover didn't completely block the view of the flags but with the top of the cover removed the view would have been unobstructed. Titanic had its stairway covers modified during construction. The reason for the modification of the stairway cover may be speculative but it is the only explanation I have ever seen that has solid reasoning behind it.
