# The Discovery of an Opening in the Forward Outboard Boat Deck Bulwarks of the Olympic Class Ships

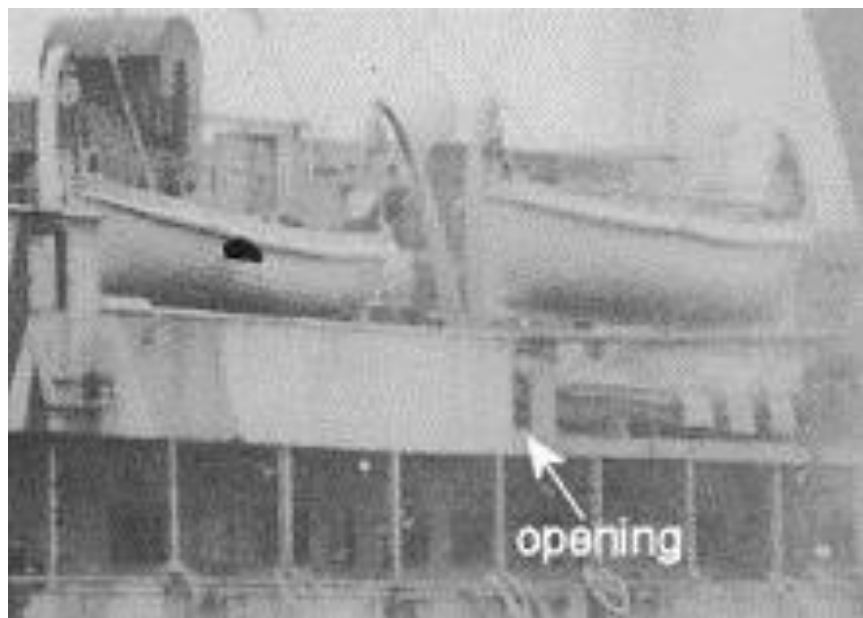
Figure 1

The results of this research started with what seemed like a fairly innocuous find. I was looking at a photo of wartime Olympic from late 1917 or 1918 shown in Fig. 1.

What I noticed was an opening in the bulwark indicated by an arrow in the photo. At first I thought maybe that the bulwark had just been shortened in length. It soon became clear that the bulwark continued aft of the opening. So what we are looking at is an opening in the bulwark where the original length of the bulwark remained unchanged.

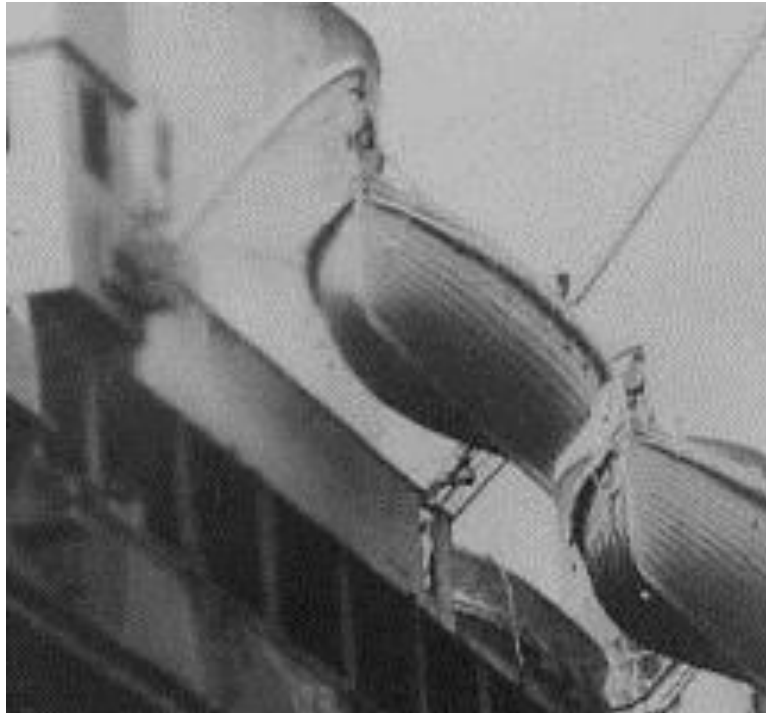
Figure 2

The first question that is raised is what is the purpose of the opening? A major clue was provided by another wartime Olympic photo shown in Fig. 2.

Here we see the sounding spar rigged directly above the opening. An initial theory was that the opening was somehow related to the sounding process. It was quickly discovered by looking at photos and plans that this opening seemed to be on an athwartship line to the Kelvin sounding machine.

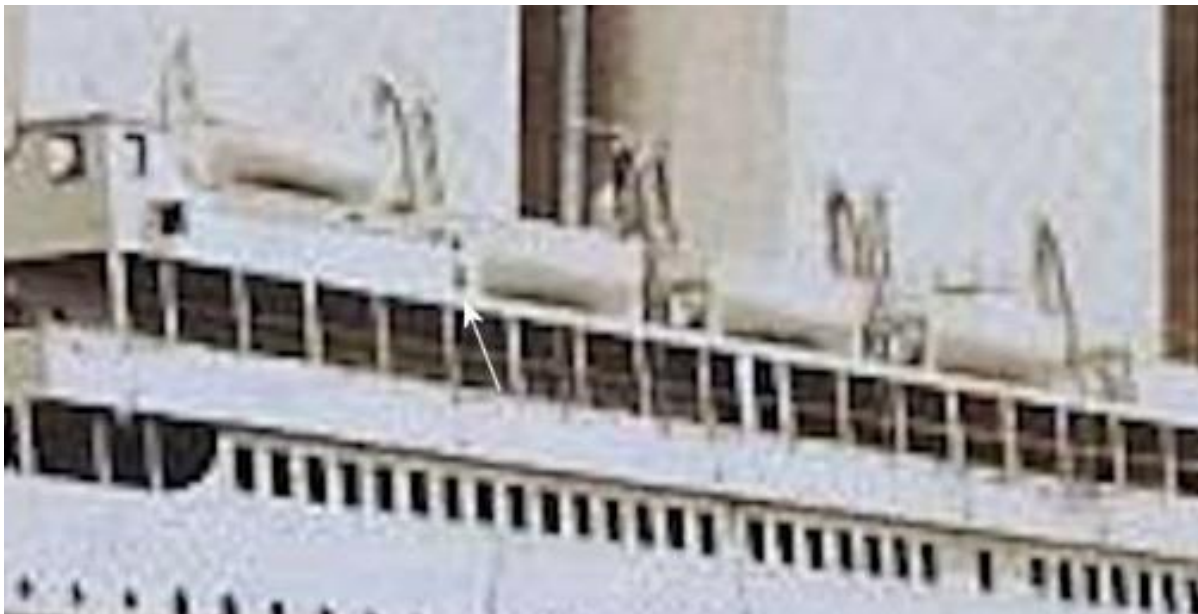
Figure 3

every photo of early Olympic this panel was in place so no opening was visible. Finally Ralph discovered a photo of Olympic from her earliest days with the panel removed. This is not a high resolution photo but it is possible to see the opening in Fig. 3.

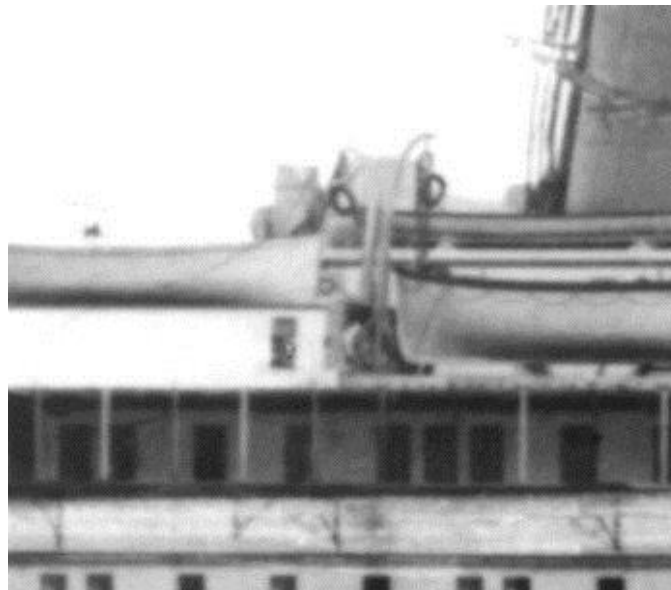
Figure 4

Since we now had evidence of the presence of the bulwark opening going back to Olympic's earliest days, the next question was did it apply other Olympic class ships? We turned next to Titanic to look for proof. We found it in the Titanic fitting out photo seen in Fig. 4

The panel is removed and the opening can clearly be seen. In Titanic's sea trials photo seen in Fig. 5 it appears that the panel may be in place but does not have a fresh coat of paint like the surrounding bulwark.

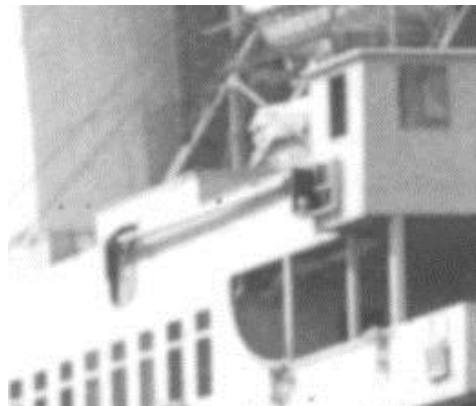
Figure 6

We then turned to Britannic. We were not able to find a photo of this opening. However it is my opinion that the relation of this opening to sounding procedures would mean that Britannic would have this opening. In Fig. 6 we see Britannic's sounding spar in the same location as both Olympic and Titanic's. Even though the boat deck structures were quite different, the sounding spar was positioned in the same place on all the ships of the Olympic Class.

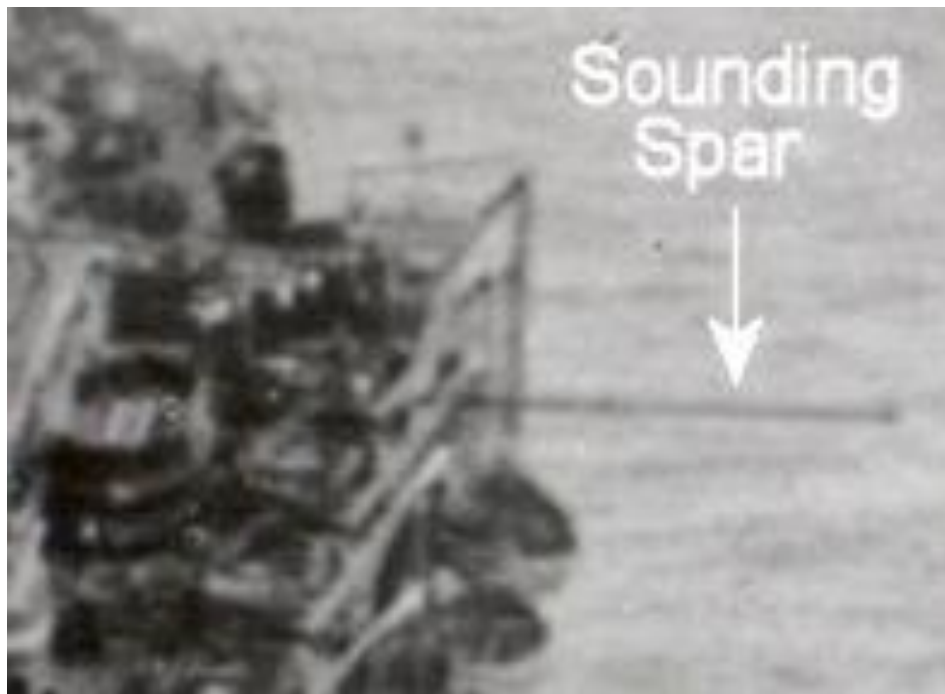
Figure 7

In order to take into account the procedures and set-up of the Kelvin sounding machine, [The 1907 Seaman's Manual-Sounding Technique](#) was consulted. From this reference we learn the sounding machine was to be bolted to the deck in a fixed location. We also find that the sounding line was to be unrestricted from the sounding machine to the block at the outboard end of the sounding spar. From most photos where the sounding spar is rigged, it appears to be lifted to an approximately 45 degree angle. From the manual we find that this was only a temporary position. For taking soundings the spar was to be parallel to the surface of the water. It was also to be at a right angle to the fore and aft centerline of the ship. The only known photo of the sounding spar in its operational position is on Olympic shown in Fig. 7.

Since the sounding line was to be unrestricted from the sounding machine to the block at the end of the sounding spar, we can now see why the bulwark opening was necessary. The sounding line came off the reel of the sounding machine at a height of roughly 36 in. The bulwark outboard of it was 48 in. high. Since blocks could not be used to redirect the sounding line over the bulwark, an opening had to be made to allow unrestricted travel of the sounding

line to the block at the end of the sounding spar. From the location of the opening and the sounding machine in photos, it was possible to locate the permanent position of the sounding machine fairly closely.

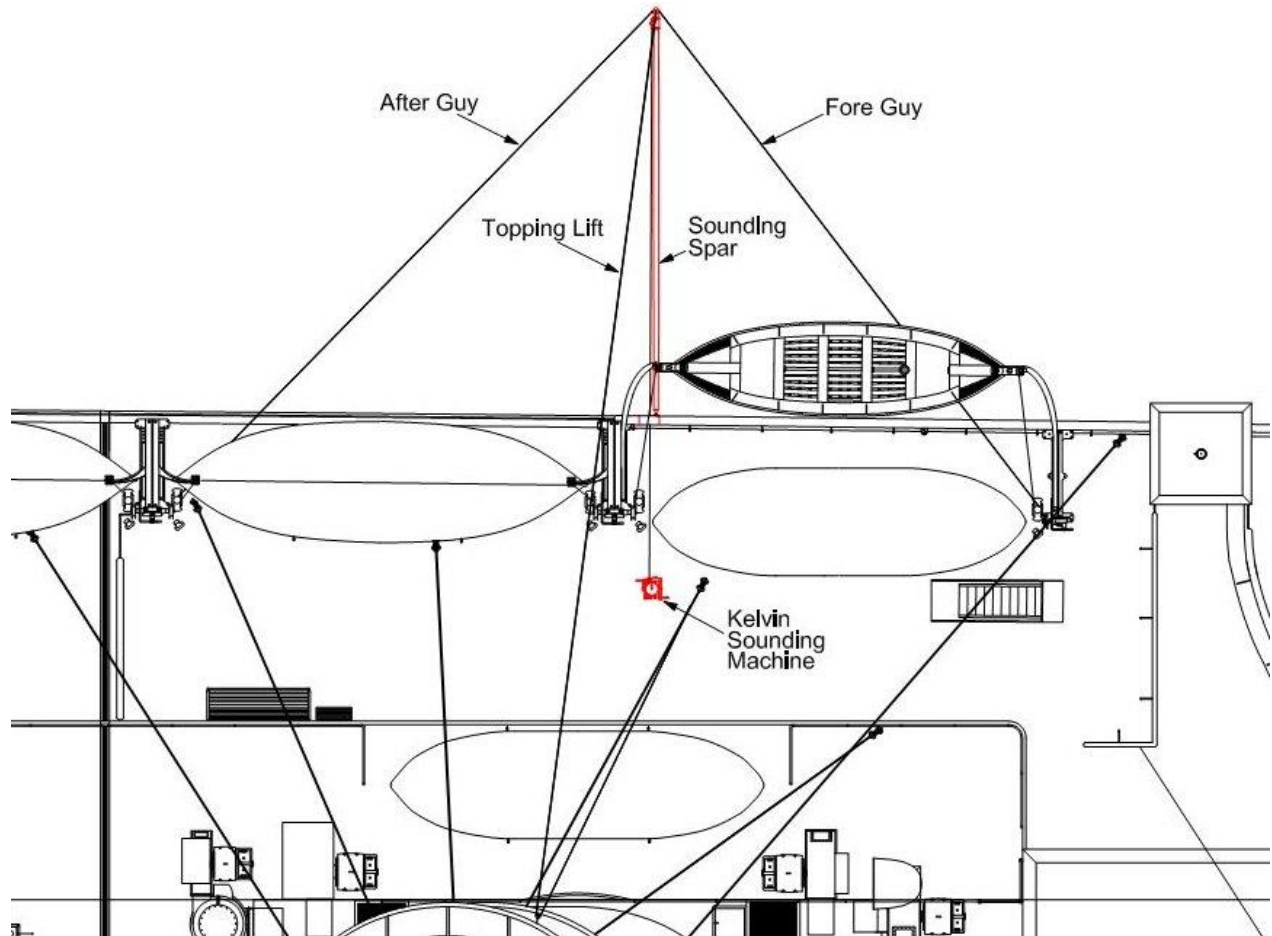
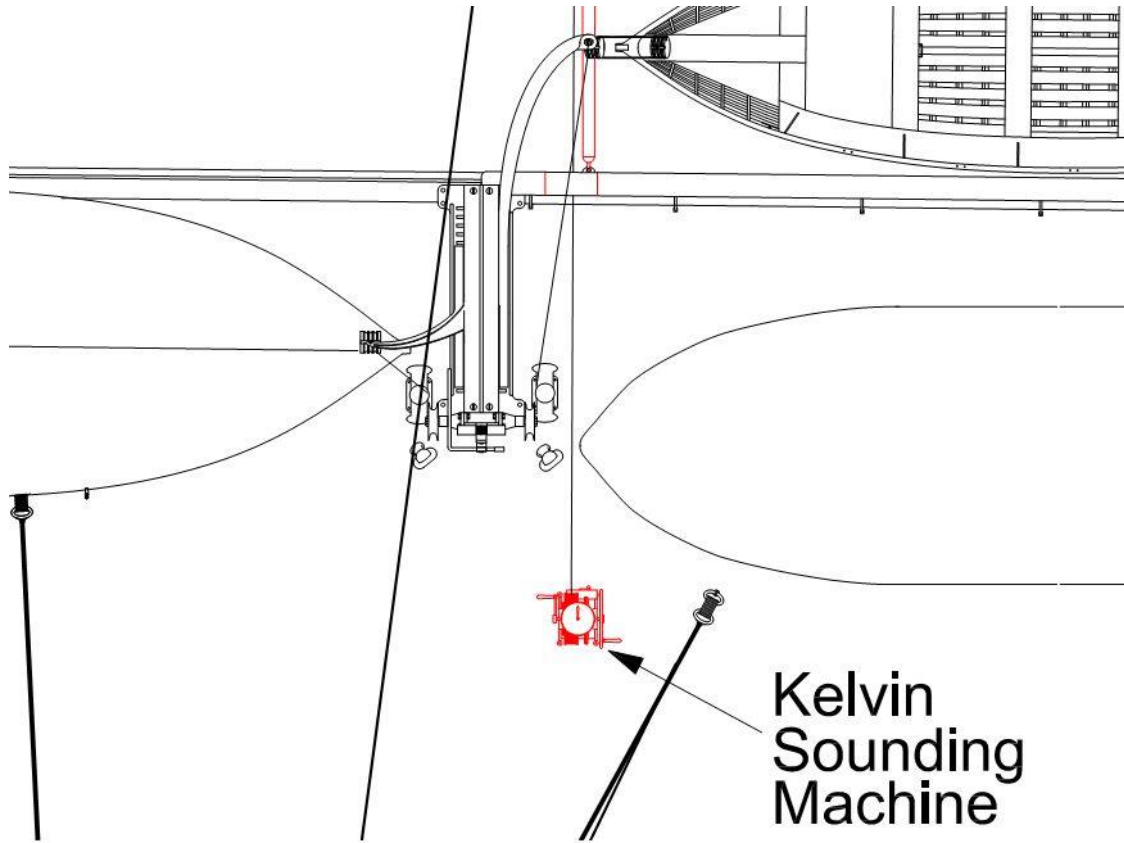
Figure 8

After analysis of plans and photos of Olympic and Titanic, it was possible to make drawings of the set-up of the sounding machine, associated equipment, and the bulwark opening. Fig. 8 shows a plan view of the area. Fig. 9 is a cropped close-up of Fig. 8.

Measurement of actual photos was used to determine the dimensions of the bulwark opening. As nearly as could be determined, the opening was approximately 36 in. high x 20 in. wide. The aft edge of the opening was approximately 22 in. forward of the aft end of the bulwark. The top of the opening was approximately 7-1/2 in. down from the top of the teak rail atop the 4 ft. high bulwark.

The inboard end of the sounding spar had a gooseneck fitting which fit into a socket on the bulwark above the opening and toward the forward edge. The sounding spar was held in position by three lines: the fore guy, the after guy, and the topping lift. No photos of these lines in their operational positions were available so we speculated that the fore and after guys were belayed to boat bitts with about a 45 degree angle to the sounding spar. Per the manual, the topping lift was to have as great an angle possible to the sounding spar. This was accomplished by having the topping lift utilize one of the painter's line blocks at the top of the first funnel.

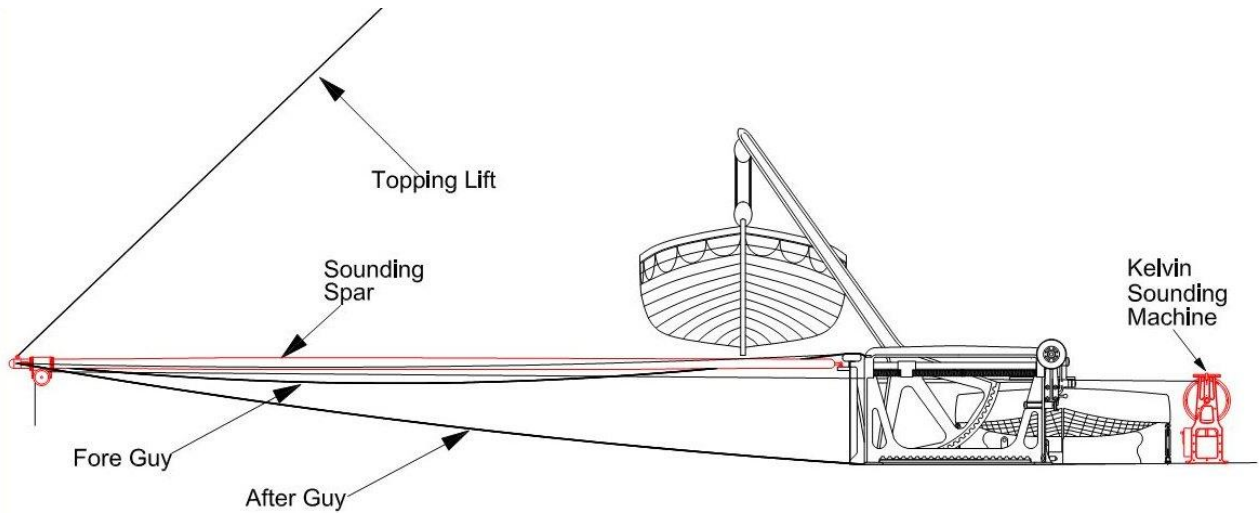
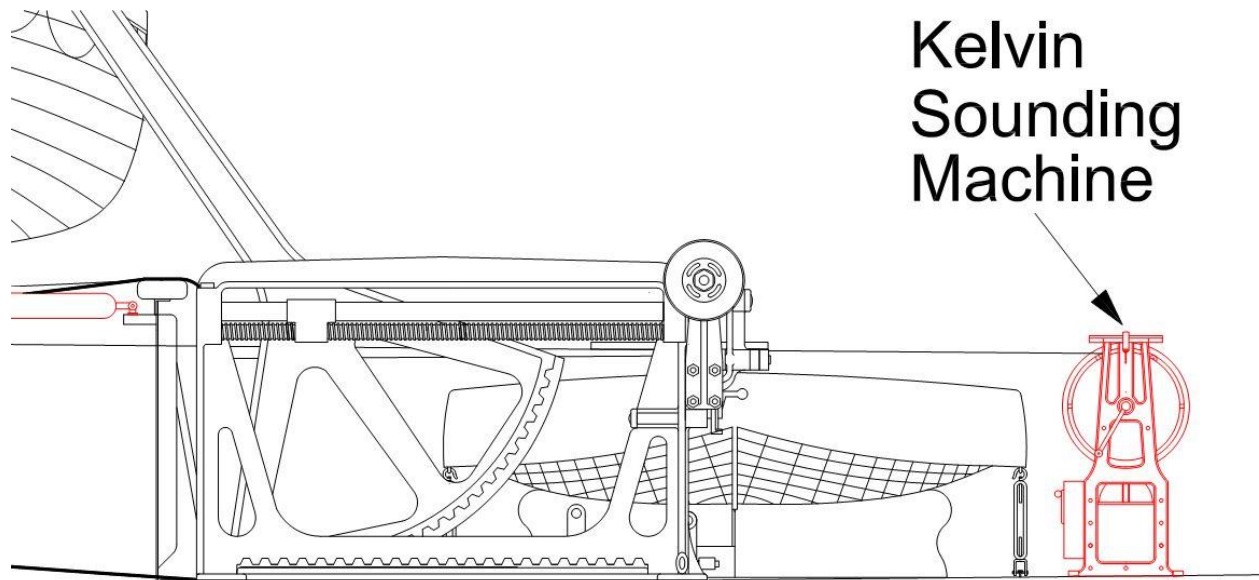
Figure 10

Fig. 10 is an elevation taken from aft looking forward. Fig. 11 is a cropped close-up of Fig. 10.

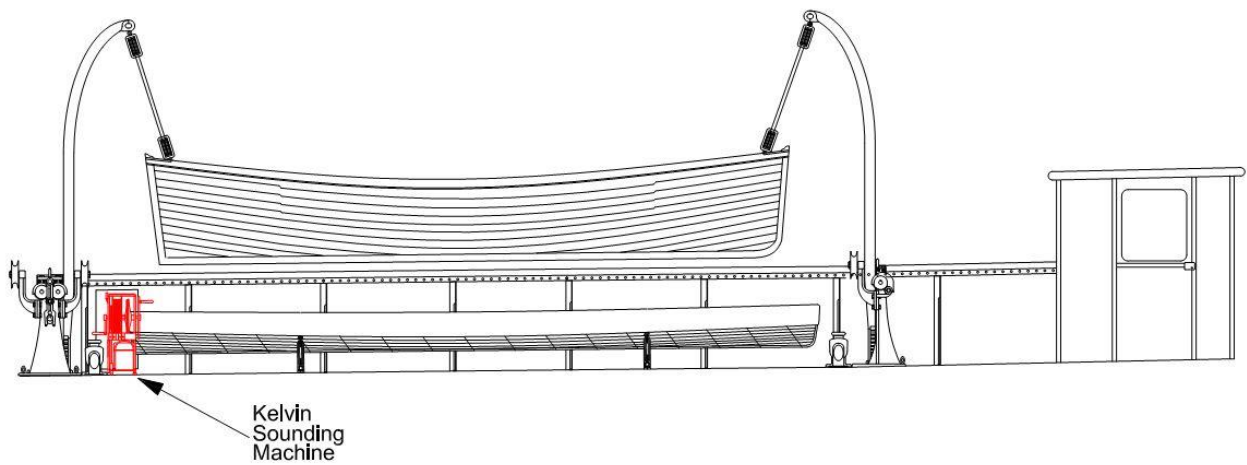
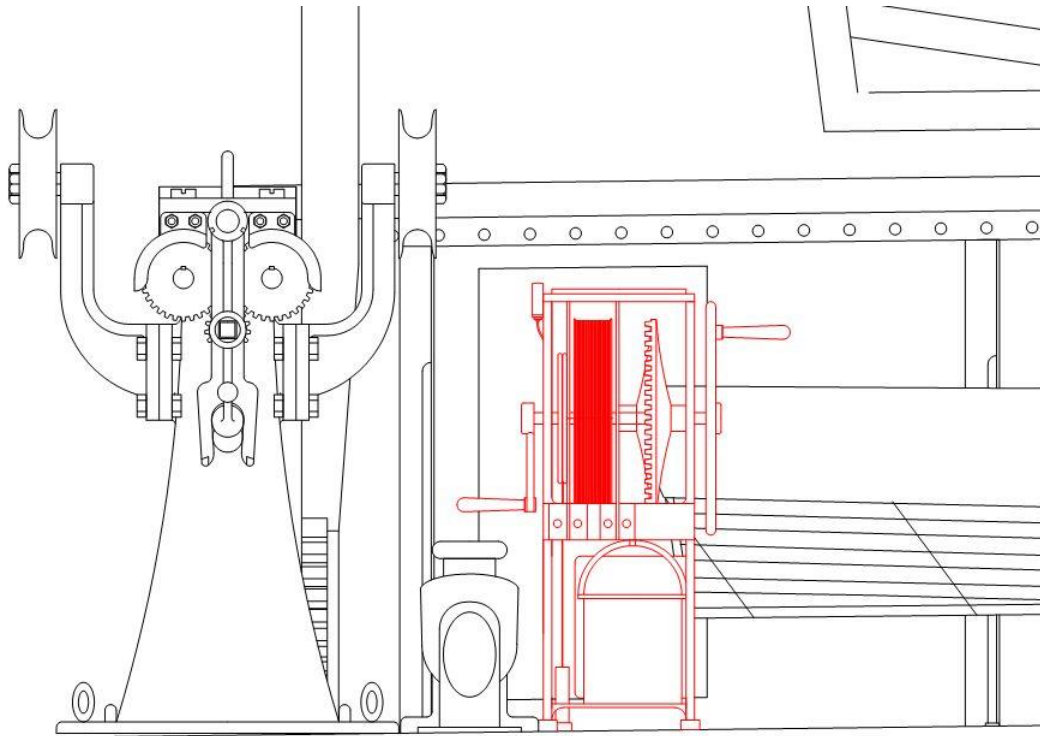
Figure 12

Fig. 12 is an inboard elevation of the area looking outboard. Fig. 13 is a cropped close-up of Fig. 12.

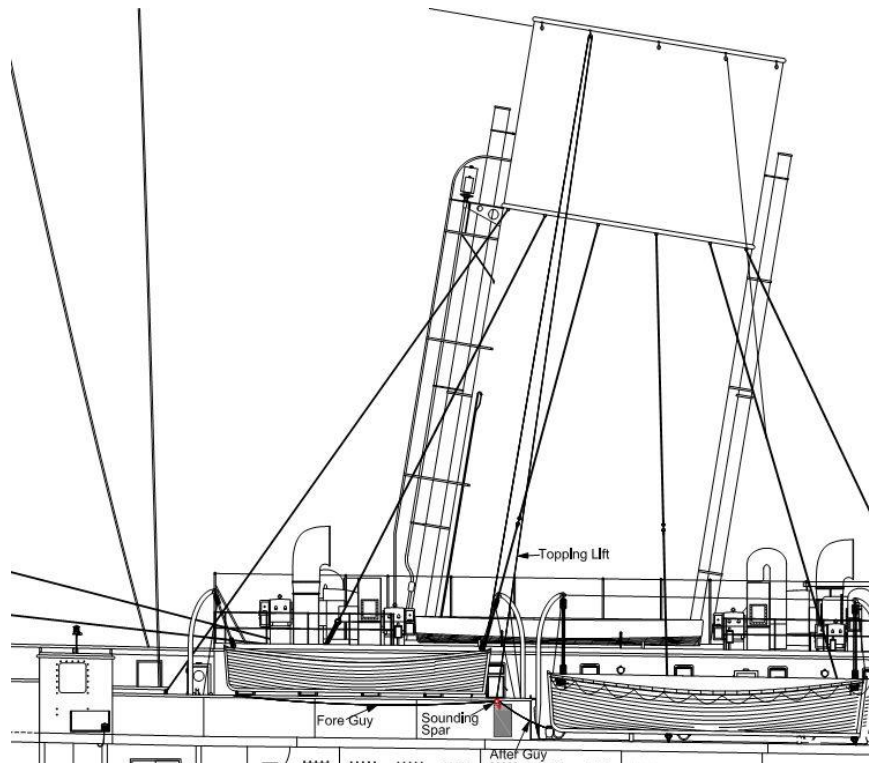
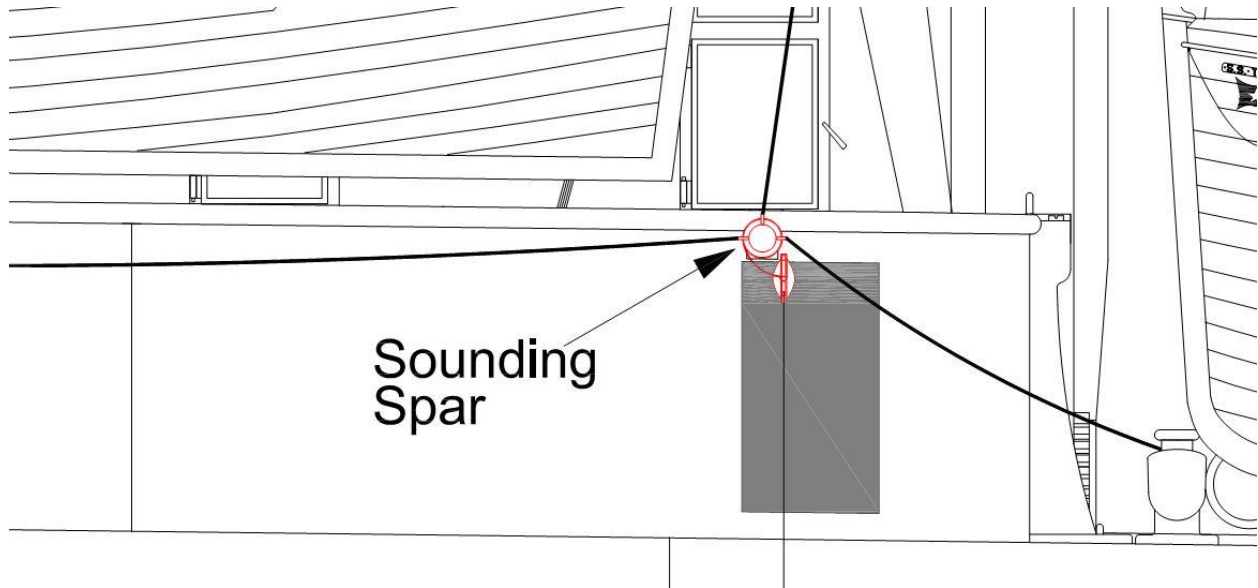
Figure 14

Fig. 14 is an outboard elevation of the area. Fig. 15 is a cropped close-up of Fig. 14.

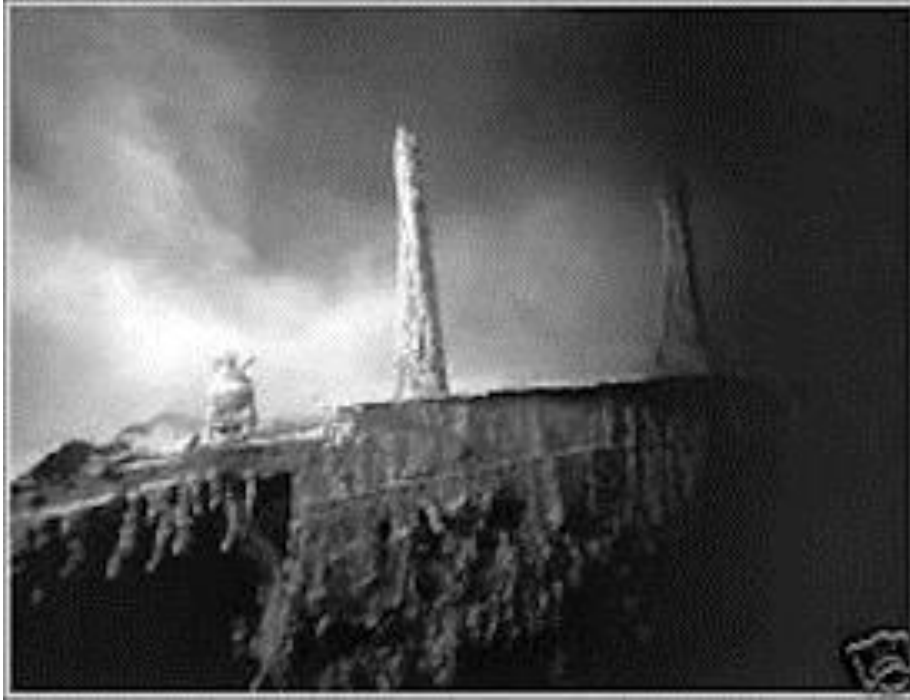
Figure 16

The third "discovery" was actually made by Ken Marschall since it appeared in his book from the early 1990's: **Titanic: An Illustrated History**. This is the discovery that that unlike bulwarks in other parts of the ship, the bulwark near the emergency cutters had stays on every stiffener. No early photo of Olympic or Titanic could be found to confirm this. The photo in Fig. 16 shows two adjacent stiffeners of this bulwark which were still standing during early expeditions to the Titanic wreck. Both of these adjacent stiffeners have stays. On the boat deck we would have expected to see a stay on only one of the adjacent stiffeners.
