Application of Paint to *Titanic's* Hull

By Bob Read D.M.D.

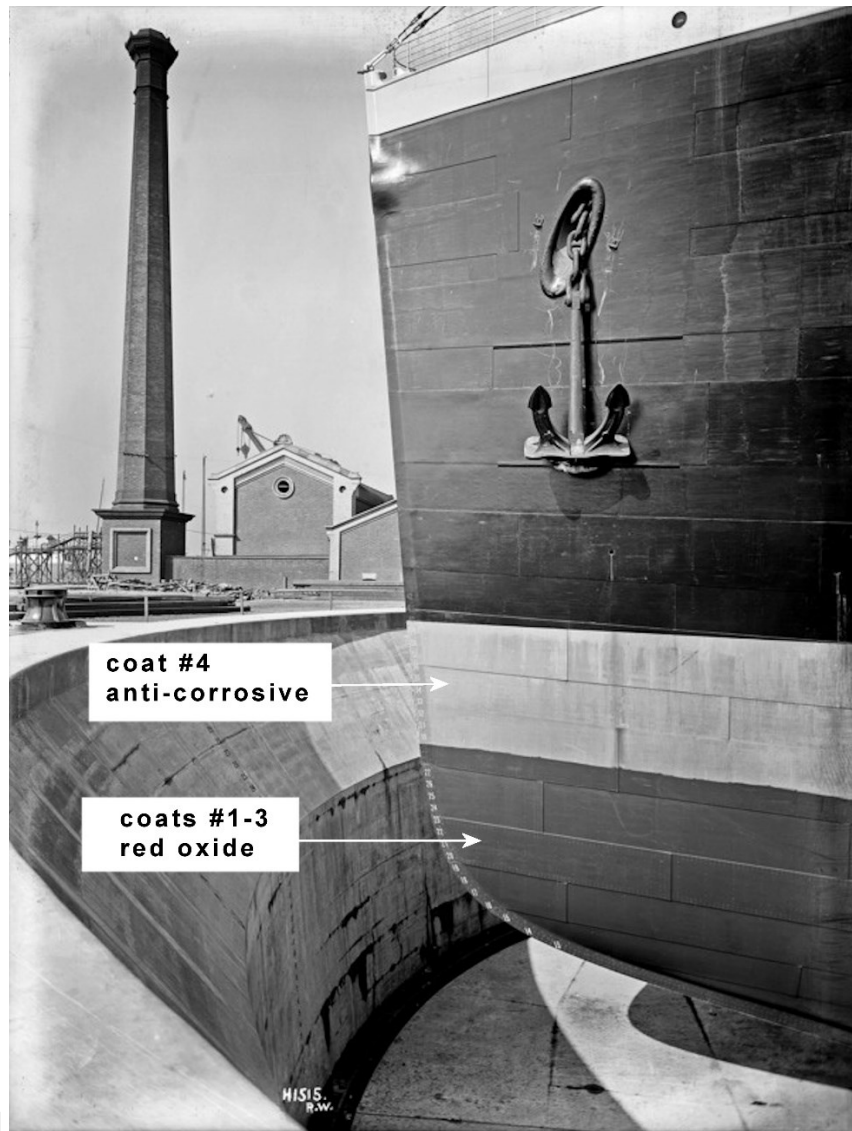
In Figure 2 we see a quite light upper coat near the waterline and a lower very dark coat. In Figure 3 we again see the quite light coat near the waterline but below it we now see a paint coat that is darker than the light waterline coat but lighter than the very dark lower paint coat shown in Figure 2.

In Figures 2 and 3 we can identify three distinct shades of paint coats on *Olympic's* lower hull. Of the five coats of paint applied to the lower hull, the first three coats are specified as red oxide. In figure 4 we see a colored drawing with a red oxide color on the lower hull. If we convert this drawing to simulate a black and white photo taken with an orthochromatic filter which is the same as used by the photographer in Figures 2 and 3, we see that the red oxide becomes quite dark.

In the photos of *Olympic* in drydock shown in Figures 2 and 3, we are able to reasonably identify the relative lightness and darkness of the three types of paint coats applied to the lower hull. The darkest coat is the red oxide primer which represents the first three paint coats applied to the lower hull. The lightest coat is the anticorrosive paint which is applied next after the red oxide coats. The intermediate shade of paint is the antifouling paint which is the last paint coat applied to the lower hull before the ship leaves the drydock and enters service. From this analysis, we can conclude that the antifouling paint is not a dark red color but rather is like the color proposed in the earlier linked research article about *Titanic's* antifouling paint.

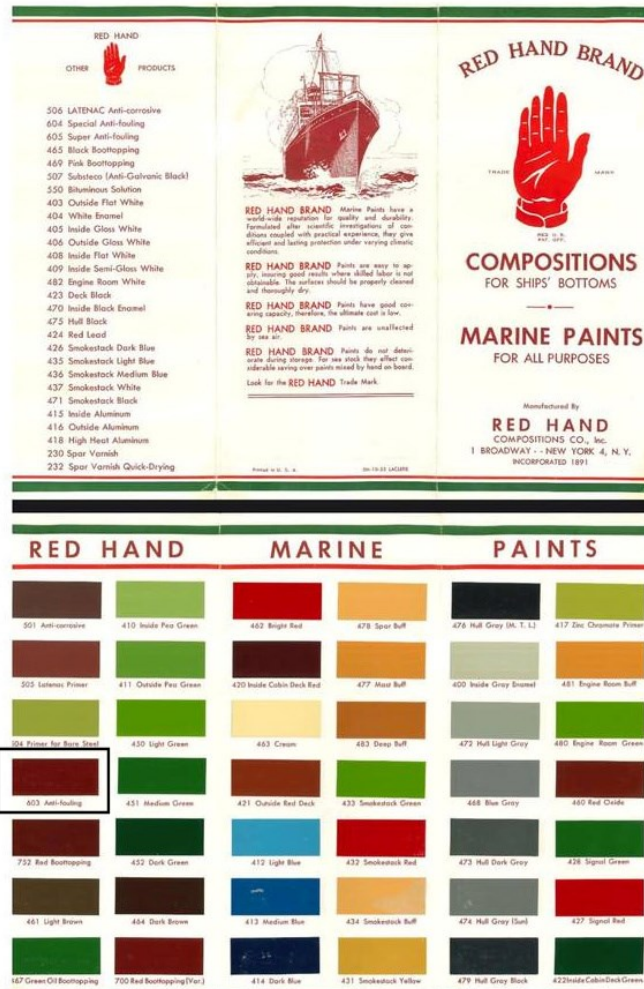
In a recent online Titanic forum post it was asserted that the color of Titanic's antifouling could be a much darker color. The reason for this assertion was that on a color brochure of the Red Hand Compositions Co. (formerly Suter-Hartmann & Rahtjens) a color sample is shown which was assumed to be the antifouling color used on Titanic. Figure 7 shows the Red Hand paint color brochure with the antifouling color sample outlined.

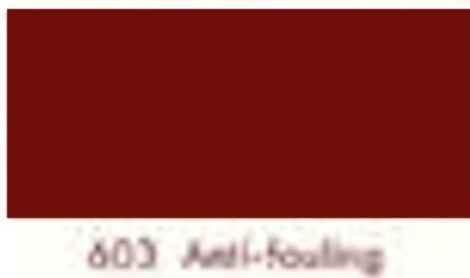
Figure 8

An enlargement of the antifouling color sample is shown in Figure 8.
