The Usefulness of *Olympic's Color Photos*

By Bob Read, D.M.D.

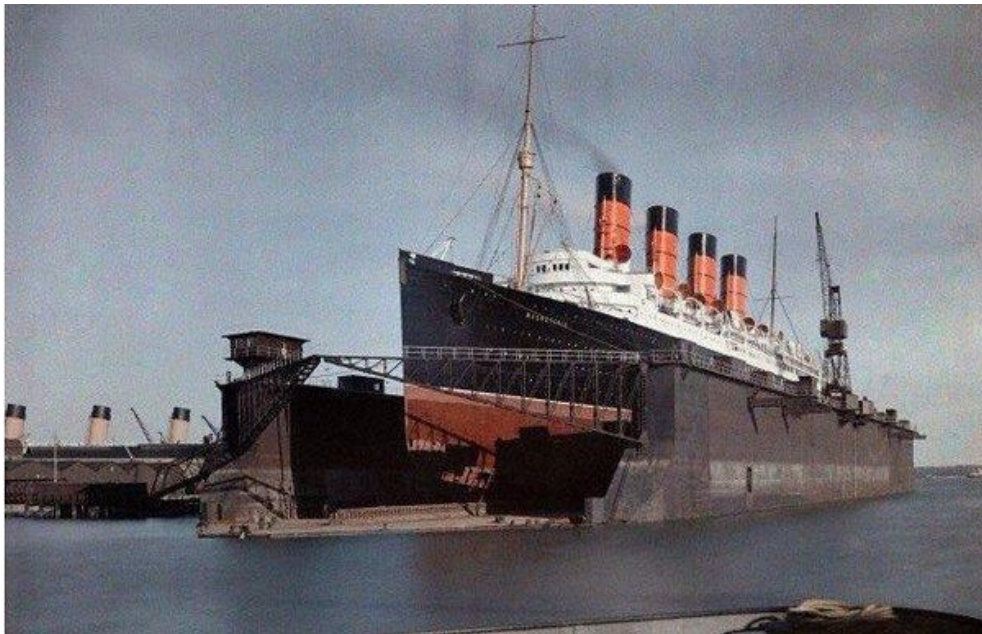
The first photo which has been known for a number of years is a photo taken by Clifton Adams in 1928. The main subject of the photo is RMS *Mauretania*. Off in the distance, the funnels of *Olympic* can be seen. This is an autochrome photo which has been converted to a digital medium for use on the internet. This photo is shown in Figure 1.

Autochrome photo of RMS *Mauretania* with RMS *Olympic* in background

The first photo of *Olympic* in the background shown in Figure 1 has a number of problems. *Olympic* is so far in the background that each funnel is only represented by a few pixels. One can get a general sense of their color but that’s about all. The other problem with this photo taken in 1928 is that there is evidence that the original “White Star buff” color of the funnels may have changed during a modernization of her livery in the 1920s. This subject is discussed here: [The Case for More than One Formulation of White Star Buff](#). Other than the very limited information about the color of her funnels, this photo offers nothing more about *Olympic*.

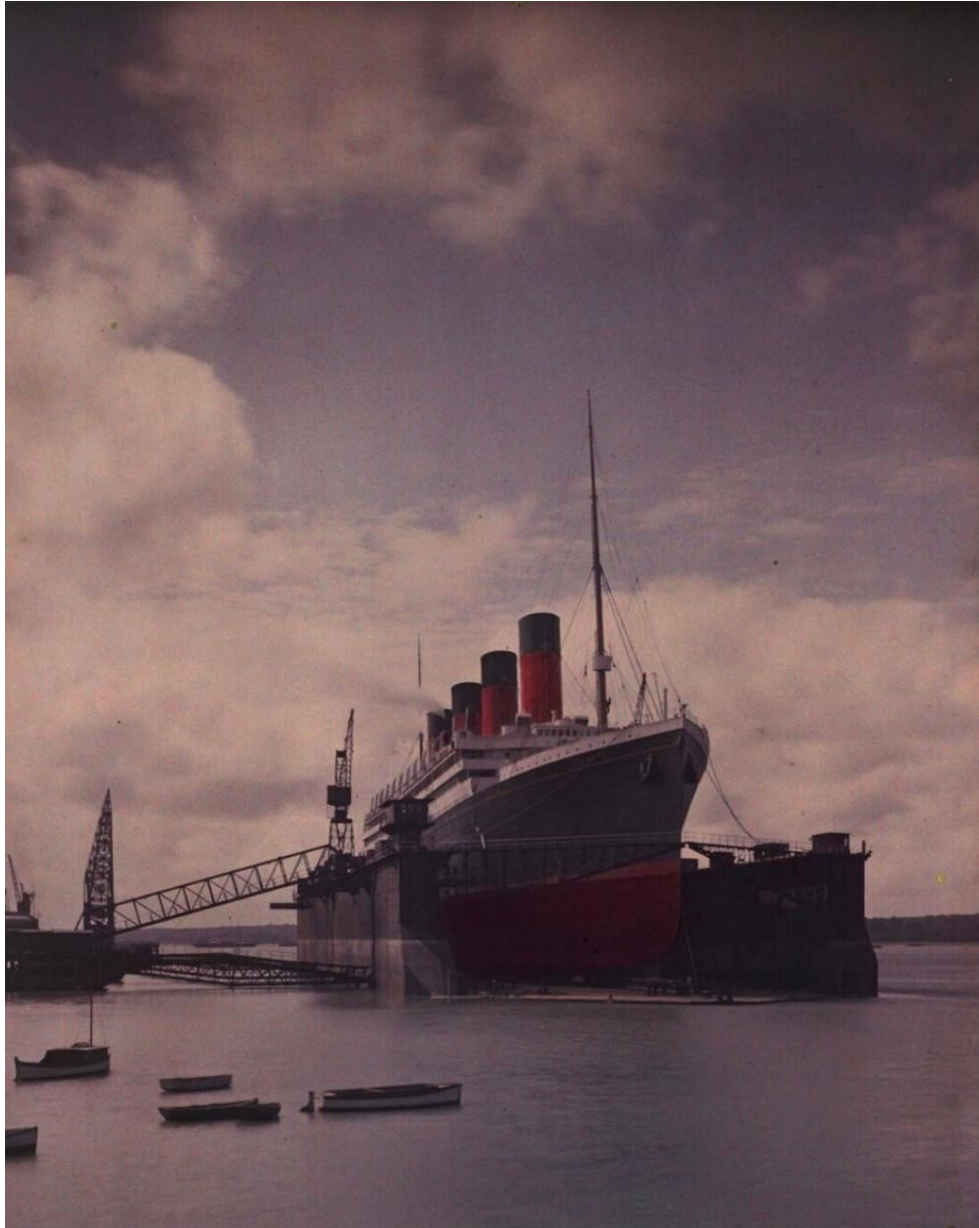
Figure 2

The second *Olympic* photo is also by Clifton Adams taken in 1928. In this photo, *Olympic* is shown in the Southampton floating drydock. Like the first photo, this is also an autochrome photo. The authenticity of this photo was in question until recently but thanks to *Titanic* researcher Boris Mileski, it was found in the National Geographic archives. What makes this photo unusual is that appears underexposed and therefore quite dark. Additionally, it is evident that some sort of red coloring has been added to the photo. It is unclear why this coloring was added to the photo. It is also unclear why such an inaccurate color was added to the funnels. This photo is shown in Figure 2.

Autochrome photo of RMS *Olympic*

The second photo of *Olympic* in the floating drydock has even more limitations. The first is that it is a rather dark photo. The second is that the funnels and the lower hull are nearly completely covered by a red color which was added to the photo. The only thing which is not covered in these red areas is a small area antifouling paint at the bow. Is this the true color of the antifouling paint used on *Olympic*? The first question which we don’t have an answer for is whether the Suter-Hartmann & Rahtjens antifouling paint was still used on *Olympic* in 1928. We simply don’t know. Even if it was, to attempt to get a true color, the brightness of the photo would have to be adjusted along with the color balance. These are subjective operations which would still produce a speculative result. Additionally, the conversion of this photo to a digital version would have introduced some of the limitations previously discussed. Therefore, this photo has little or no value in clearing up ambiguity about *Olympic*’s original colors.
