# The Case for an Aft Placement of the Chart Table in *Titanic's* Chart Room

By Bob Read, D.M.D.

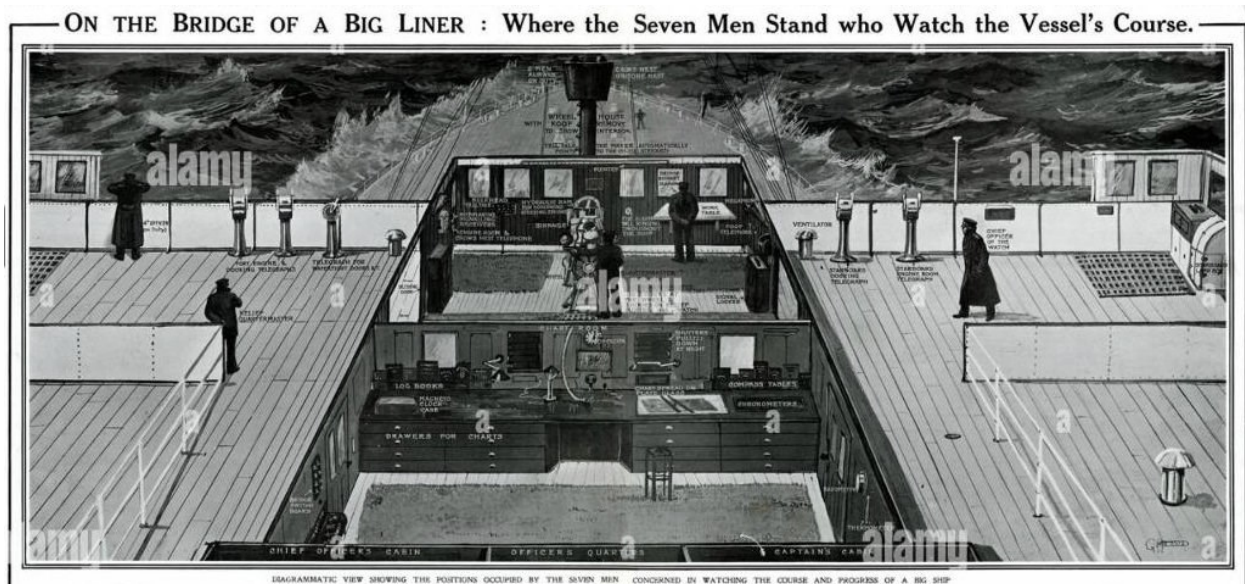
Figure 2

### Drawing of a generic ocean liner's bridge and chartroom layout

In the drawing, the chart table is against the forward bulkhead of the chart room. It is able to be placed against the forward bulkhead because there are also windows on the forward bulkhead of the chart room.

There are two primary pieces of evidence which have been offered for the forward placement of the chart table. The first is a drawing of the bridge of an unidentified ocean liner. This drawing is shown in Figure 2.

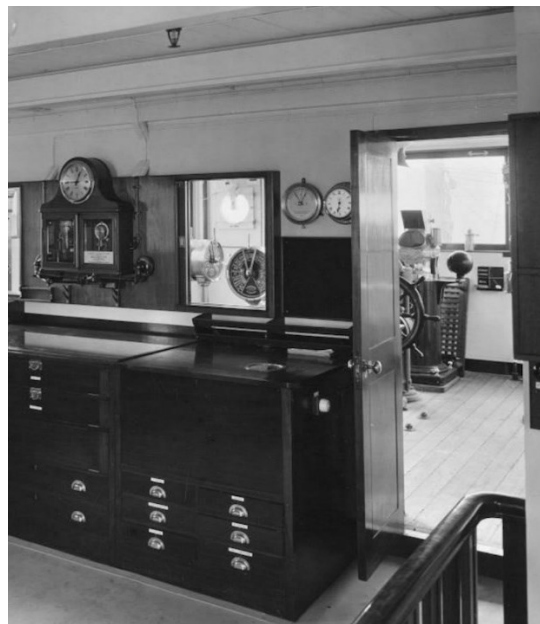
Figure 4

Example of a ship with a chart table on the forward bulkhead of the chart room

The other items of evidence offered are a number of photos of ships other than *Titanic* which have chart tables on the forward bulkhead of their chart rooms. One example is shown in Figure 4.

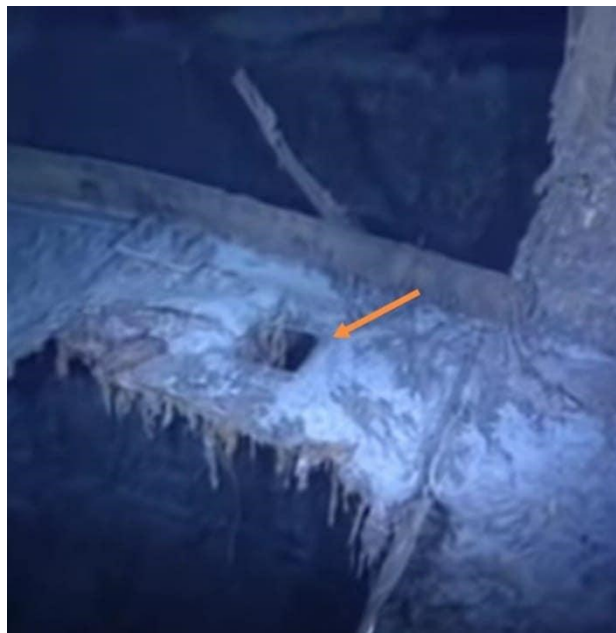
Photo of location of prismatic skylight over chart room on *Titanic's* wreck

Verification of this prismatic skylight on *Titanic's* wreck is shown in Figure 7
