# The Controversy Over the Paint Remnants on *Titanic's* Recovered Officers' Quarters Window

By Bob Read, D.M.D.

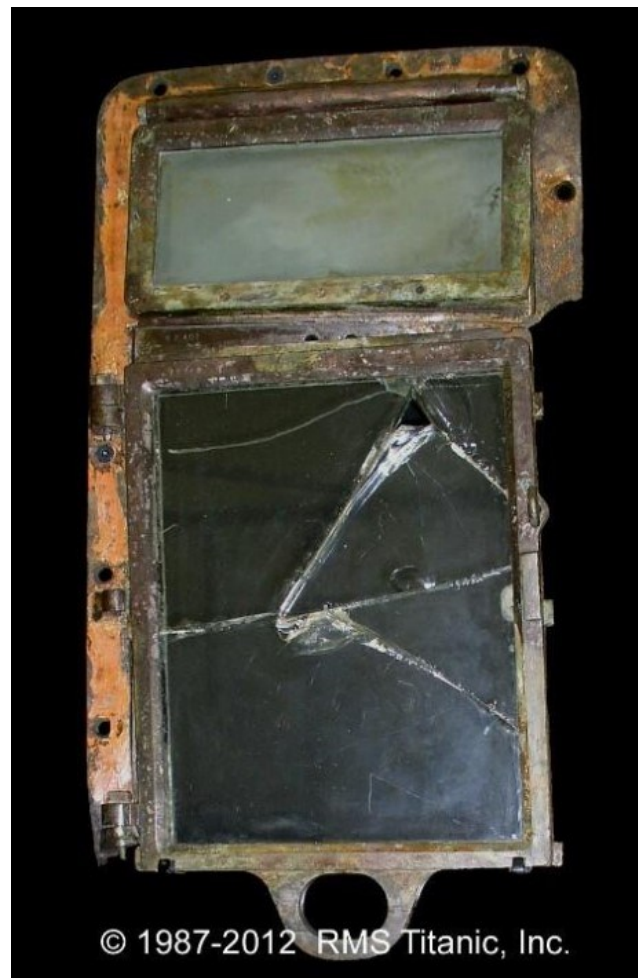
Figure 1

*Titanic's* recovered officers' quarters window

To establish the frame of reference for those who are not familiar with this debate, let's first show *Titanic's* recovered officers' quarters window in Figures 1 & 2.

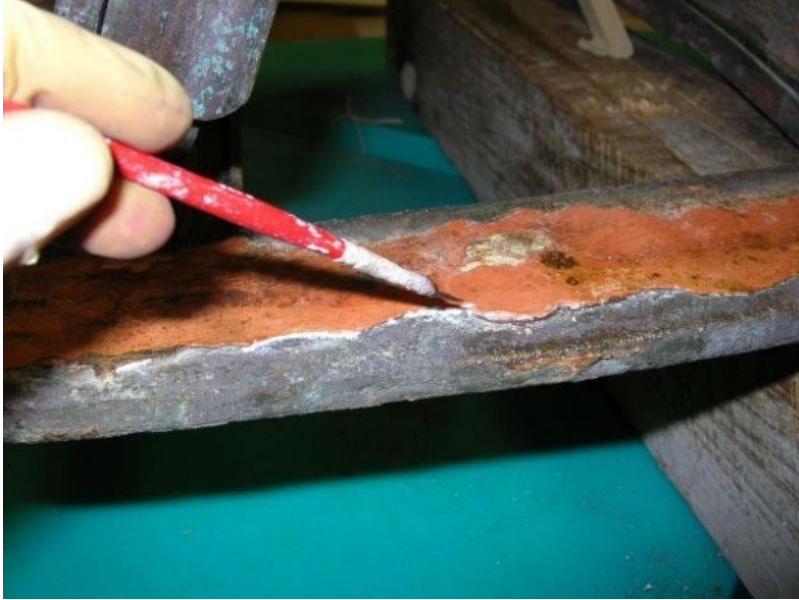
Figure 2

### Close-up of adhering paint on *Titanic's* officers' quarters window

There is no paint left on the window except for a rust-colored paint remnant. This is the remnant of paint which we will consider. I believe these remnants are the same color as "dark mast" which was discussed in this article: ["Dark Mast" Article](#).

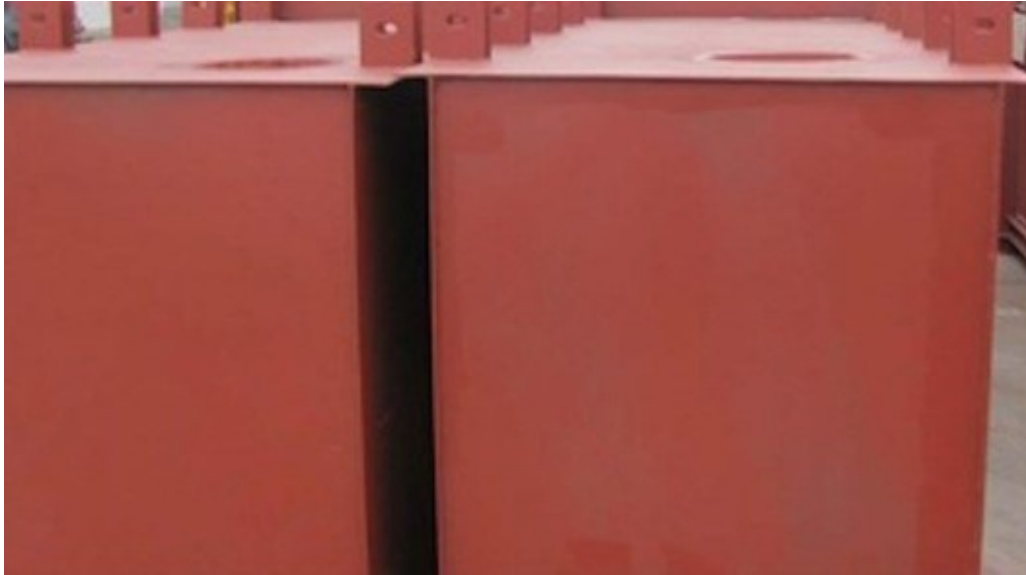
For reference purposes, Figure 3 represents the most common shade of red oxide paint.

### The most common shade of red oxide paint

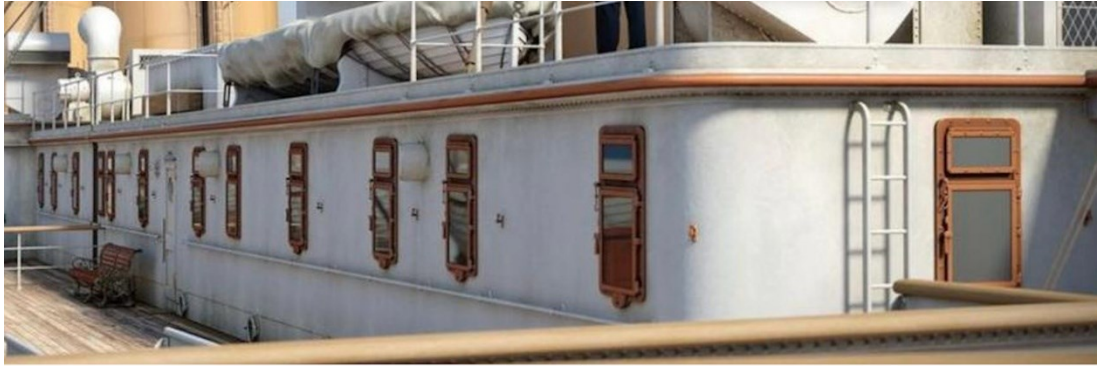
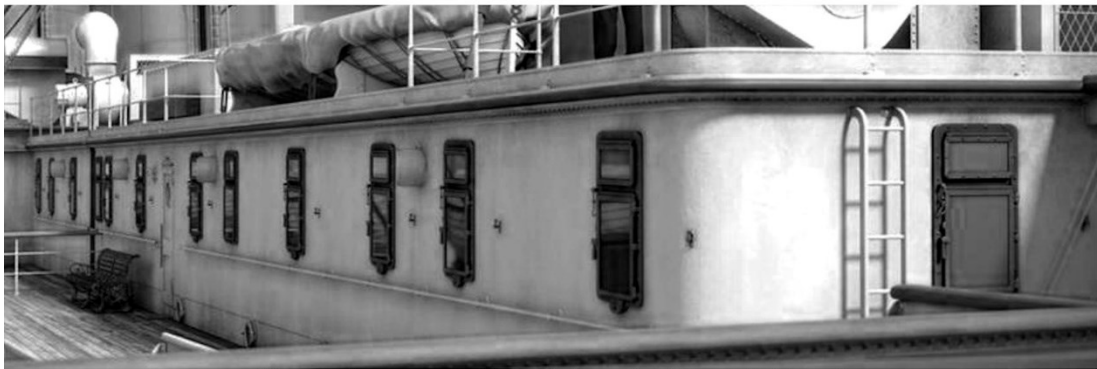
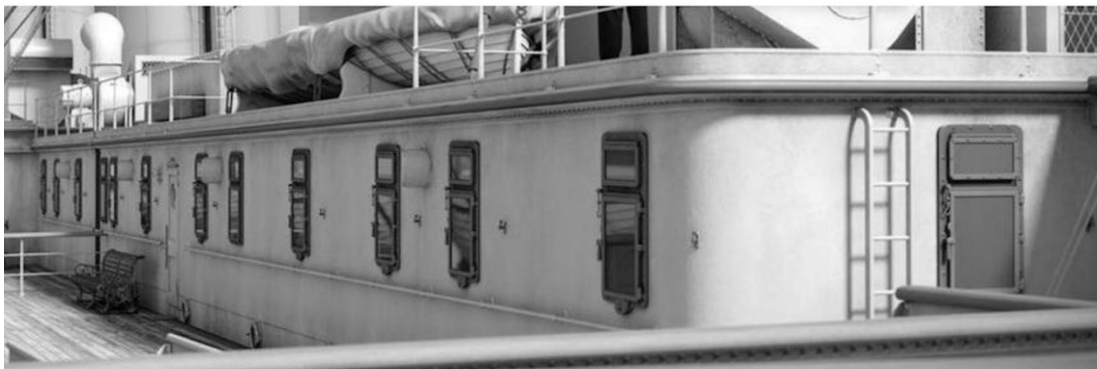
### Comparison of different types of photographic film

This digital image was made by digital artist Vasilije Ristic. The first black and white image below the color image is a representation of how an orthochromatic black and white film image would appear. The bottom image is a representation of how modern panchromatic black and white film would appear.

The black and white photos taken of *Titanic* were taken with orthochromatic black and white film. Some of the characteristics of this type of black and white film are that it makes reds, yellows, and oranges appear very dark and it makes blues look very light. Modern panchromatic black and white film does not have these drawbacks. Figure 4 shows a digital image of *Titanic's* officers' quarters with the window frames painted with the "dark mast" color.

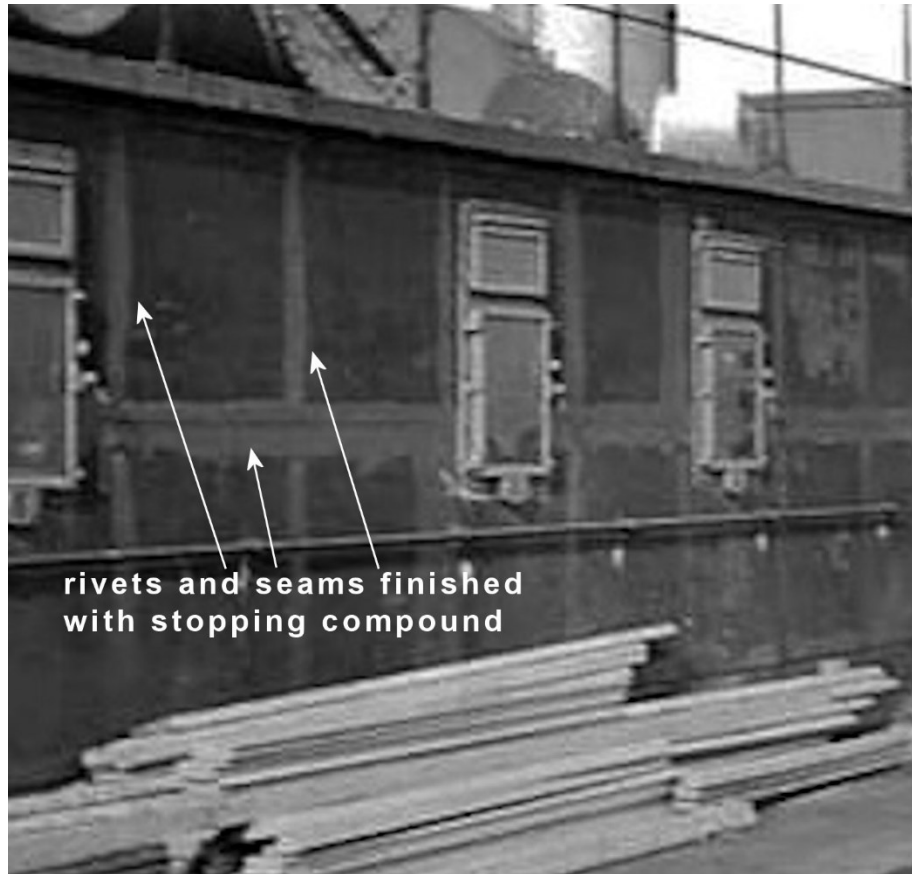
### Stopping compound used over rivets and seams on *Olympic*

Stopping compound was used over flush riveted iron rivets to create a smoother surface for painting. When iron rivets were flush riveted, the hot rivet was set with hammers then cut off with a chisel and hammer. Then what was left was further hammered flat. This procedure can be seen in this video where *Olympic's* deck plates are being flush riveted. The link is: <https://www.youtube.com/watch?v=qLY-ZESyXkA> The riveting procedure is shown at time mark 5:21.

The next theory which is employed to explain the paint remnant on the recovered officers' quarters window is the "stopping compound" theory. Stopping compound was a putty-like material that was mixed with red oxide then applied over butt joint deckhouse plating seams and flush rivets on the deckhouses. This theory holds that this compound was used to smooth over either bolts or rivets used to attach the officers' quarters windows to the deckhouse bulkheads. A problem similar to the red oxide theory is that we find no color coat paint remnants adhering to the theorized stopping compound. As with red oxide, since the officers' quarters windows were brass and did not rust, there was no need for a red oxide component in the stopping compound. Figure 5 shows stopping compound used on Olympic's officers' quarters deckhouse.

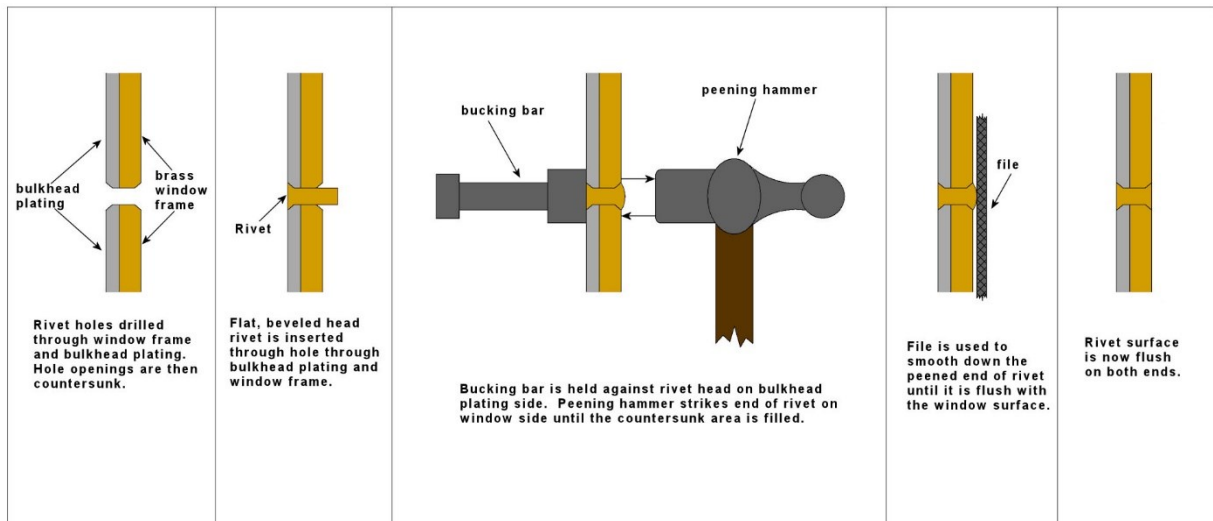
The difference with the officers' quarters windows is that since they were cast brass, I believe they were fastened with brass rivets that were riveted **cold** with hammers due to the soft nature of brass rivets.

## Procedure to flush rivet officers' quarters window frames

Figure 6 shows the procedure which would be used to flush rivet brass rivets through the brass windows and the steel bulkhead plating.

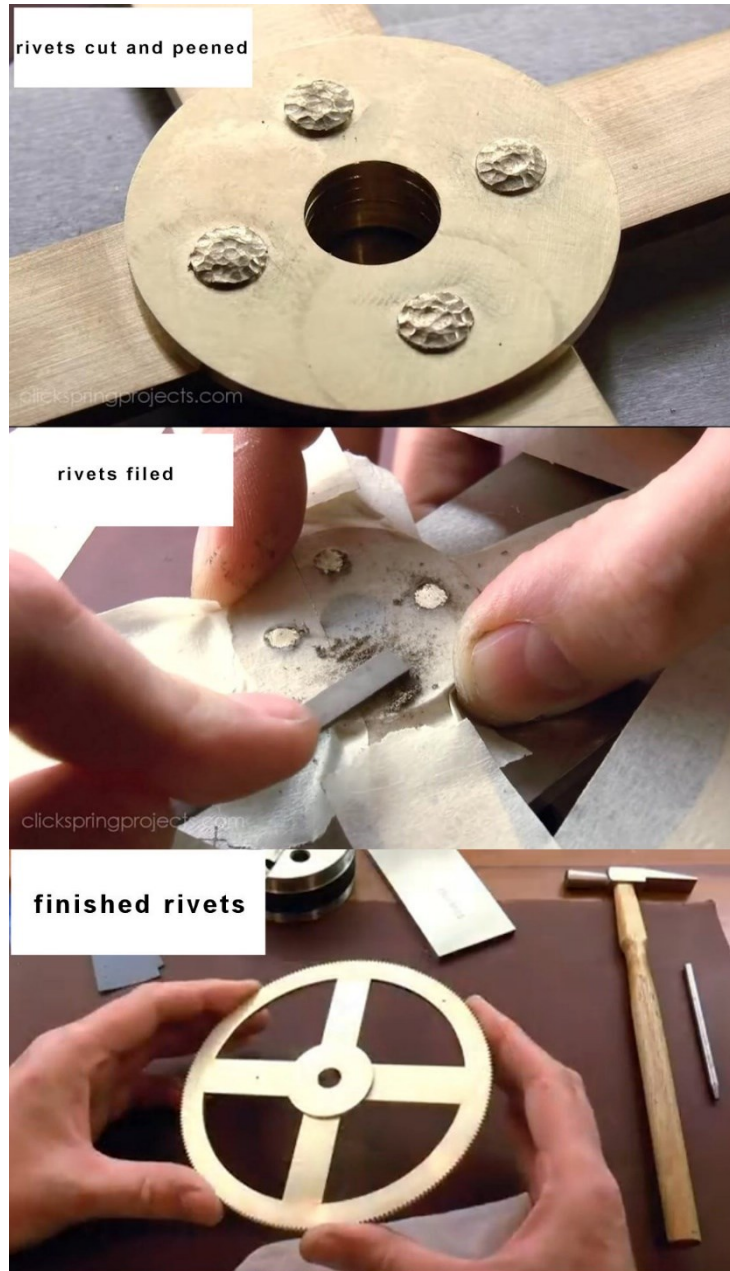
Unlike iron riveting, the use of brass rivets with brass window frames allowed for a greater degree of finishing which was not possible at the time with iron rivets. Figure 7 shows how finely brass rivets can be finished using peening, filing, and abrasive stone finishing albeit at a somewhat smaller scale than on the window frames.

### Finishing brass rivets

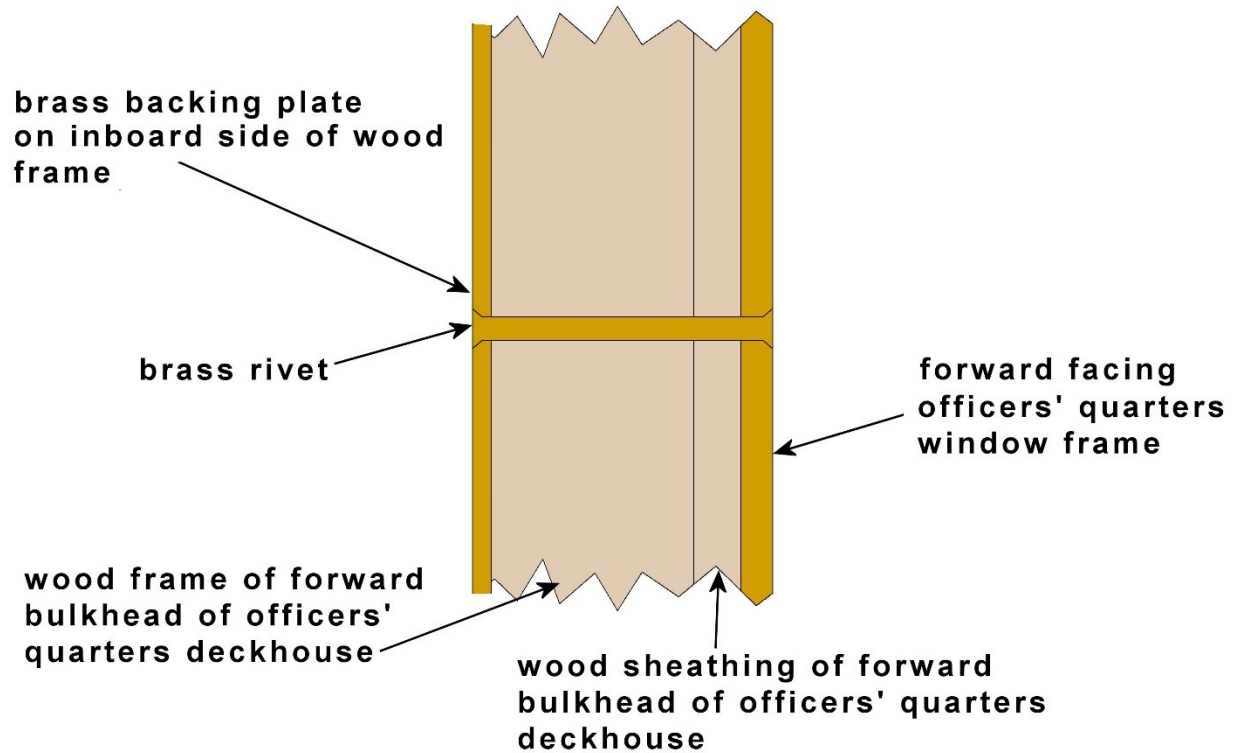
One objection which has been raised about brass riveting has to do with the forward-facing officers' quarters window on *Titanic*. This bulkhead on *Titanic* was wood rather than steel. The objection is that brass rivets couldn't have been used with a wood framed and sheathed bulkhead. On the contrary, this would have presented no obstacle to the use of cold brass rivets.

Figure 8 show how brass rivets could be used with a wood framed and sheathed bulkhead.
