# The Case for *Titanic's* Deck Bench Ends Being Unpainted

By Bob Read, D.M.D

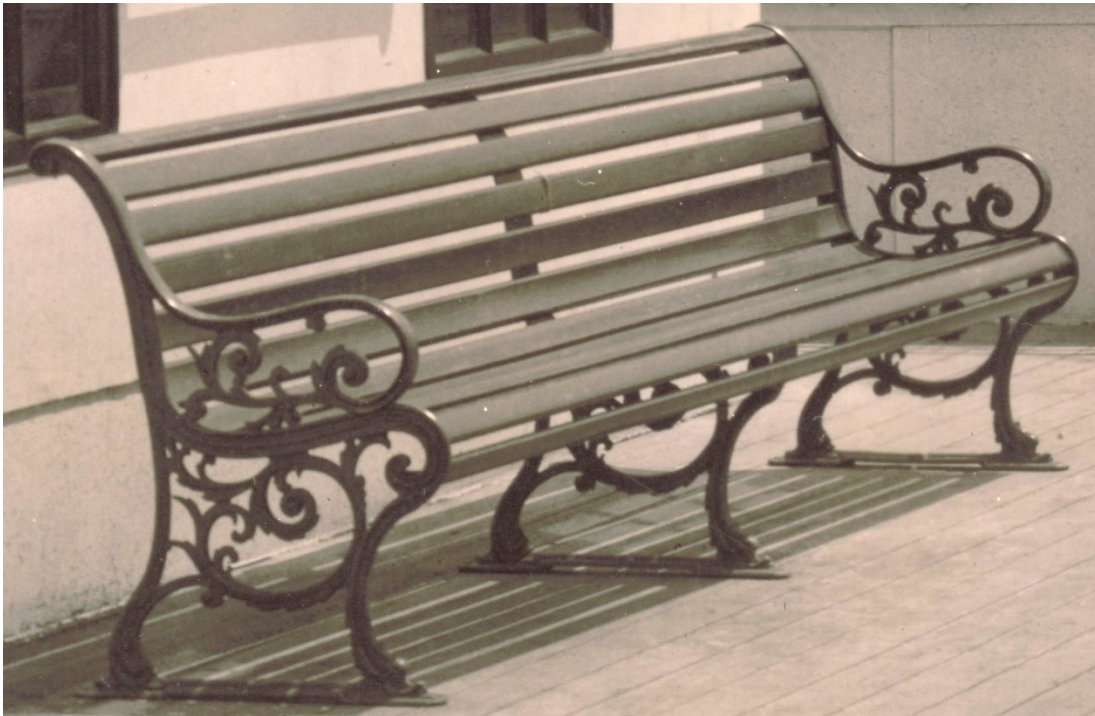
Deck bench on *Olympic* (1911) identical to those of *Titanic*

Figure 1 shows an early (1911) photo of one of R.M.S. *Olympic's* deck benches.

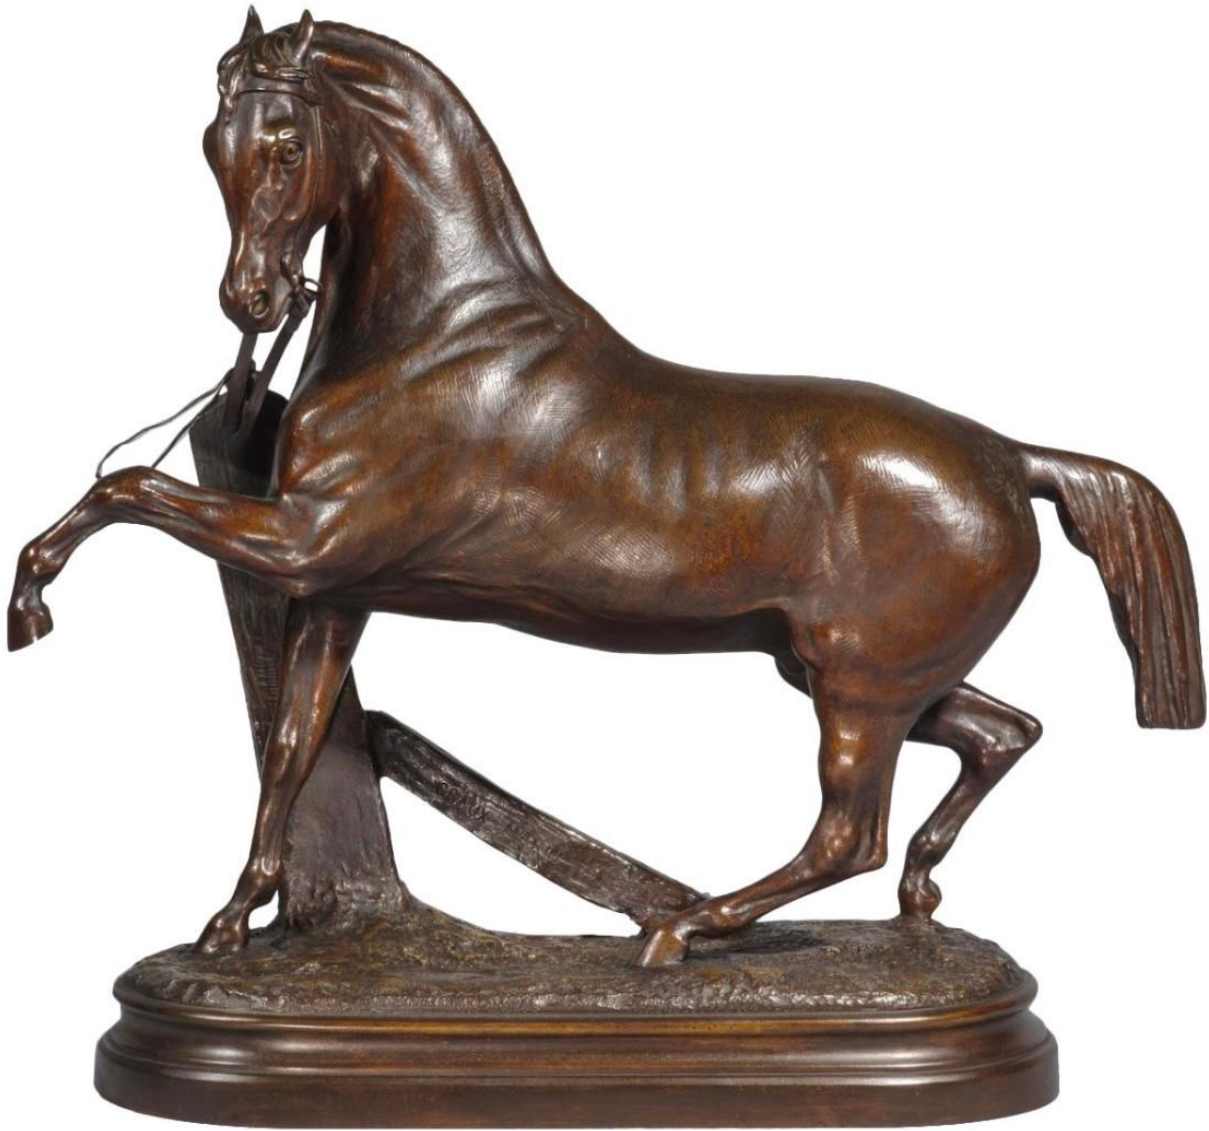
Figure 5

### Bronze statue with brown patina applied

It is possible that the bench ends were treated with heat and chemicals to created a brown patina like that on the bronze sculpture in Figure 5.

After this treatment, wax is applied to seal the patina to help retard further oxidation. While the patina was durable, it could be scratched. An alternate explanation for the “paint chips” is that we are looking at scratches or scrapes on the patina. Just as paint chips could be painted over, patina scratches could be restored. An example of damage to a patina and its restoration is shown in Figure 6.

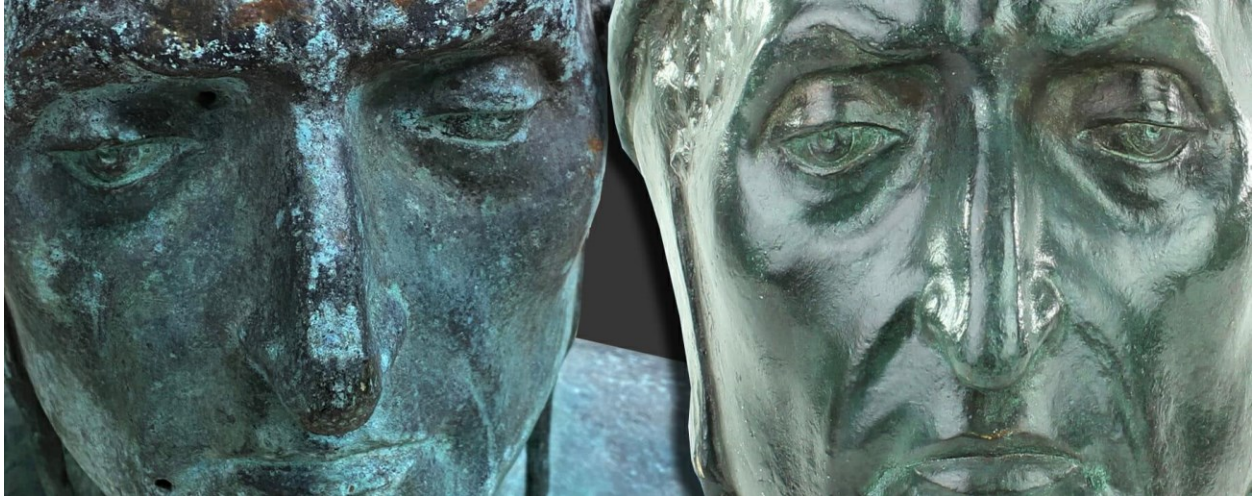
Figure 6

Damage to a bronze patina (left) and its restoration (right)

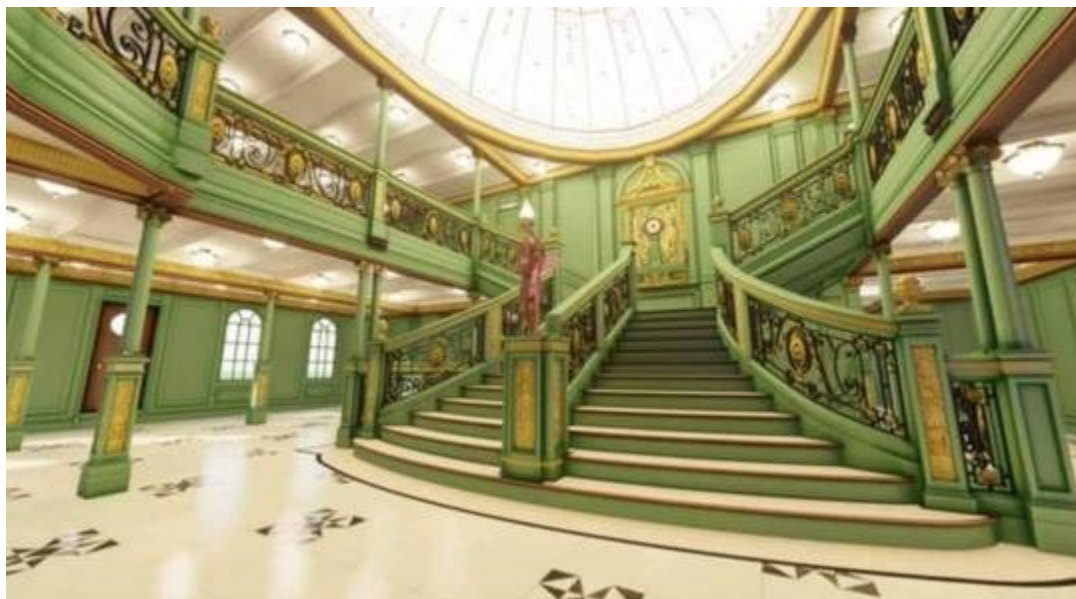
Figure 7

### *Olympic*’s grand staircase painted green during her 1933/34 refit

The 1935 *Olympic* Auction catalog lists the deck bench ends as being “painted”. The question is whether the painted ends in 1935 are reflective of their original appearance. During *Olympic*’s 1933/34 refit the woodwork of her grand staircase was painted over with an avocado green paint as shown in Figure 7.

This departure from her original appearance was an attempt to give *Olympic* a more modern appearance. The question then must be asked, to what lengths would they go to make *Olympic* appear more modern? If they would paint over the beautiful woodwork of the grand staircase, is it too much to believe they would paint the deck bench ends? In my opinion, I believe they would have. **Therefore, to use the post-refit appearance of the deck bench ends to define the original appearance is unwarranted.**

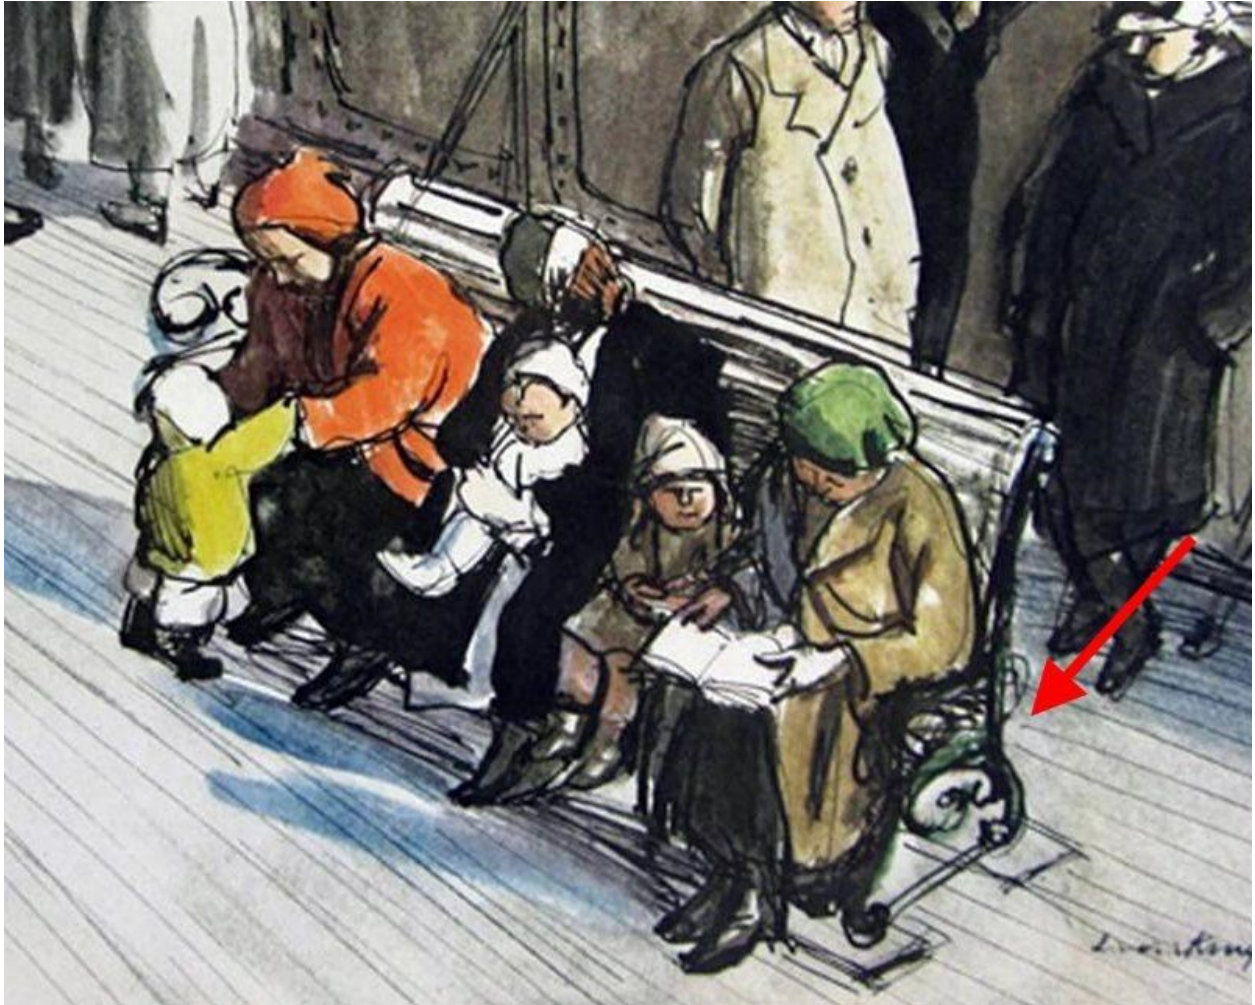
Figure 8

### Drawing used as “evidence” of painted bench ends

One other item of evidence which has been put forth as “evidence” of the bench ends being painted is the drawing shown in Figure 8.

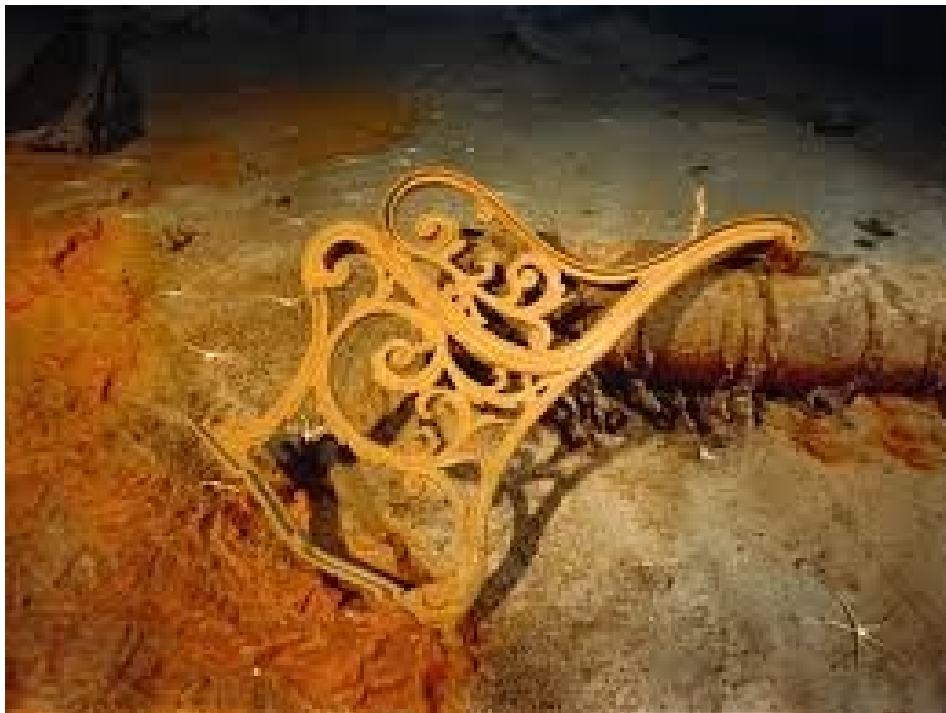
Deck bench end at *Titanic* wreck site with no apparent paint remnants

It has been said that items recovered from the wreck *which have been put on display* have few, if any, paint remnants. While this may be true, any examination of the wreck shows much paint still intact on deckhouses and the hull. Figure 9 shows a deck bench end at the wreck site. One will notice there is no apparent paint remnants.

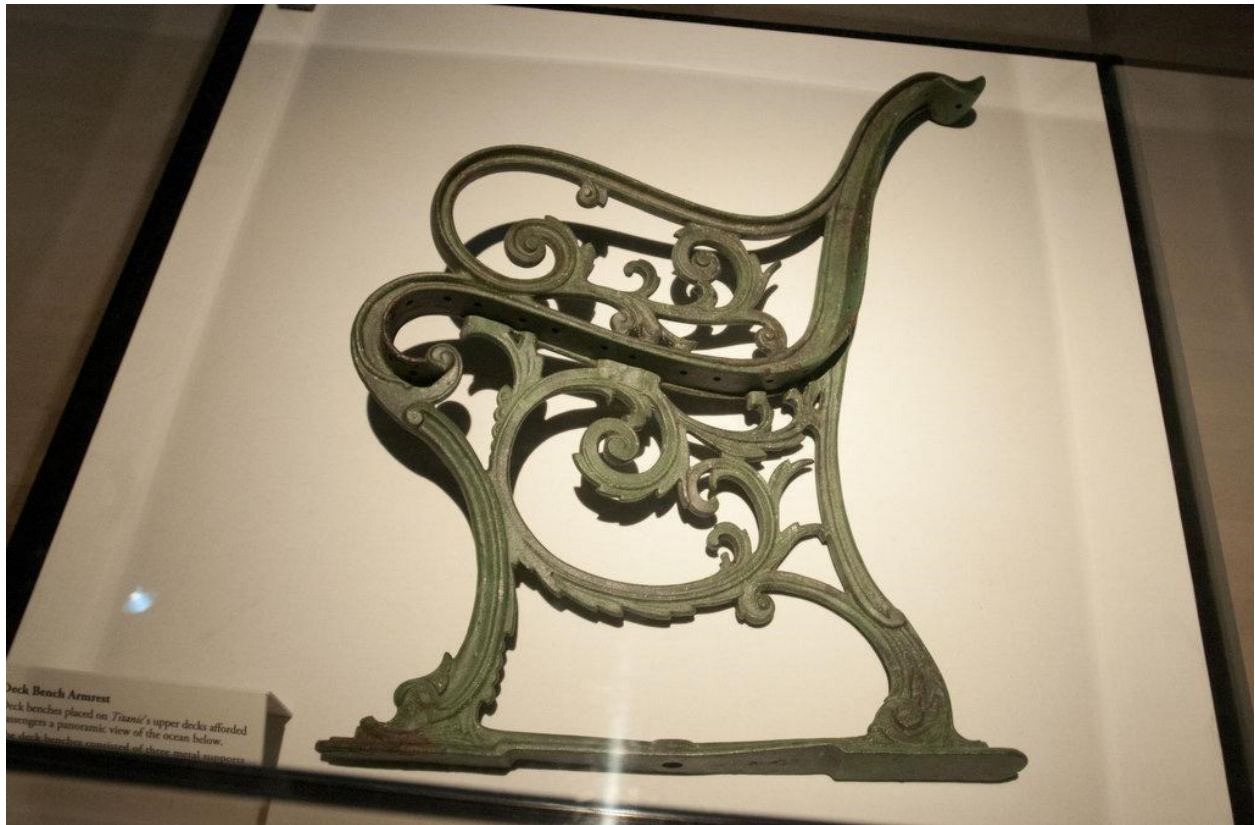
Deck bench end recovered from *Titanic* wreck site with no apparent paint remnants

Figure 10 shows a recovered deck bench end with a uniform patina with no apparent paint remnants.

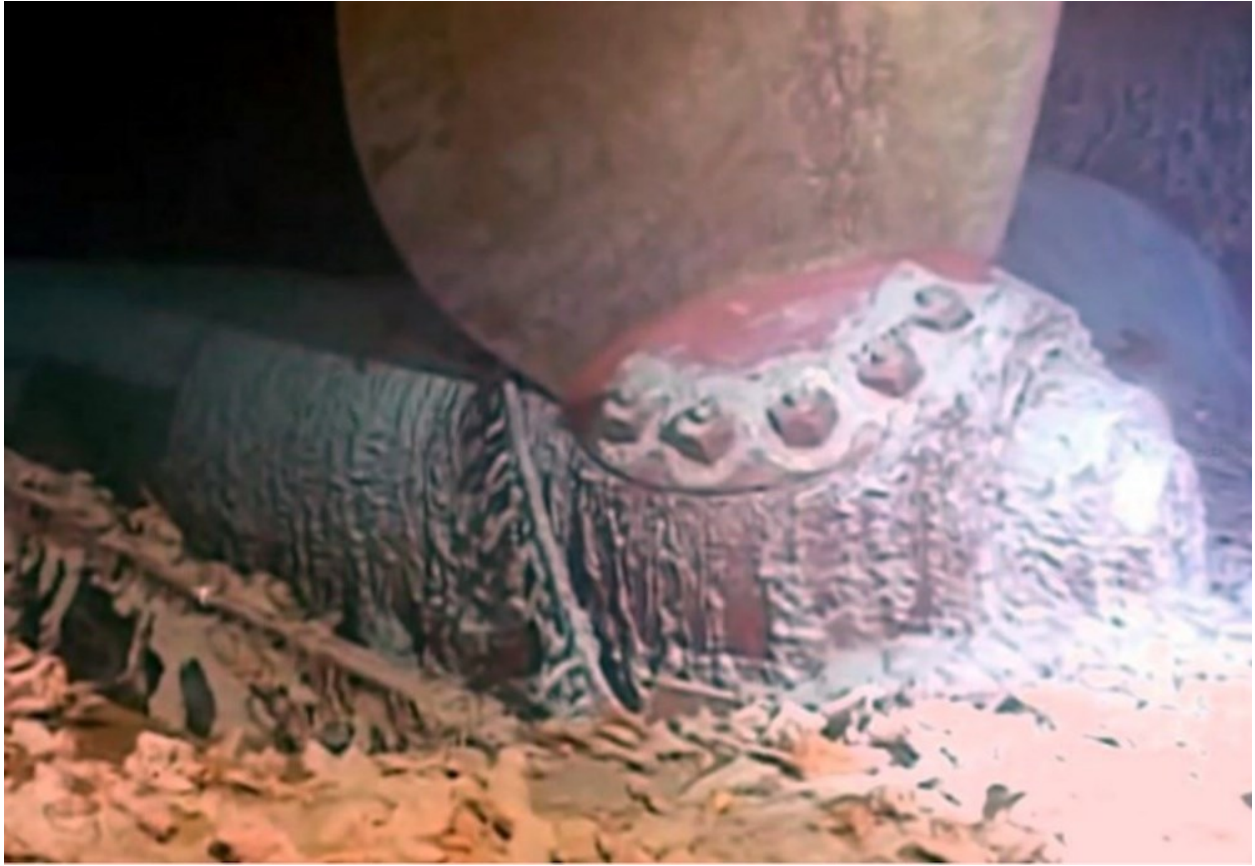
### Antifouling paint remnant at base of *Titanic's* bronze propeller

It is not as if paint is incapable of adhering to bronze for long periods underwater. Figure 11 shows one of *Titanic*'s bronze propellers with antifouling paint still present on the base of the propeller.

It could be argued that the paint still present on *Titanic's* bronze propeller was subjected to much more extreme forces than the deck bench ends yet, it still adheres.

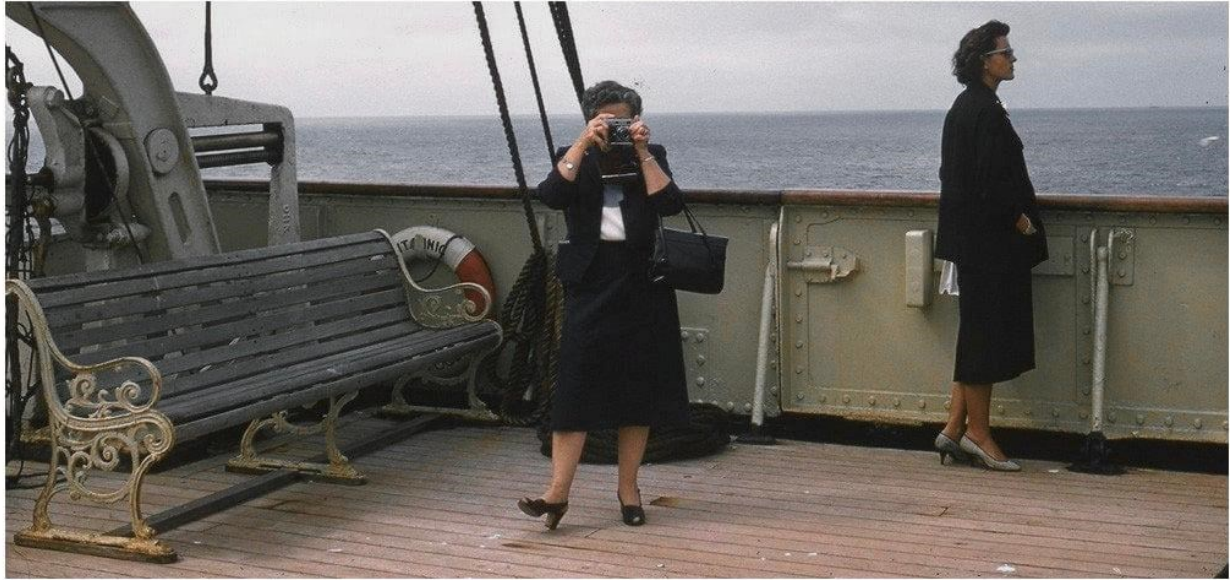
Figure 13

Photo taken aboard MV *Britannic* in the 1950s showing an unpainted deck bench

## The MV *Britannic* Evidence
