Shell Plating at the Midline of *Titanic's* Stern Counter

by Bob Read D.M.D

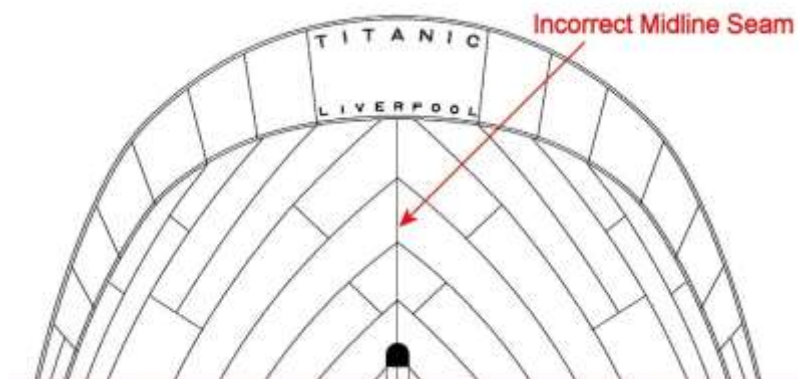
The inaccuracy I have seen in models is that in the plating the midline of the stern counter, modelers have applied plates to both the port and starboard sides and have created a visible fore and aft flush midline butt seam. These plating butt junctions on the model form an unstaggered seam from strake to strake the length of the stern counter. In most models I've seen with this feature, it seems to be confined to the plating area of the stern counter below the lower knuckle. This arrangement is not correct. I will show why it is not correct and then demonstrate the correct plating. Figure 1 shows in red where this incorrect midline seam is located on models.

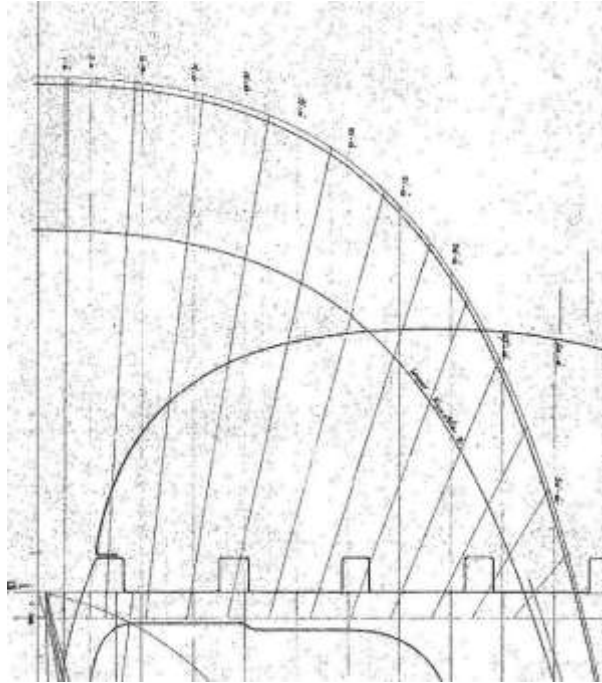
In order to answer questions about the plating of the stern counter, one has to first understand the underlying framing. For every other part of the hull strength girder, all the frames are *perpendicular* frames. Perpendicular frames are set perpendicular to the keel. The stern counter is framed with *cant* frames. Cant frames attach to web frame 148A and are set at angles forming a fan shape. Figure 2 shows the disposition of the cant frames on one side of the midline on the 400/01 half breadth plan.

There are a total of 24 cant frames for the stern counter. Twelve are set on the starboard side of the midline and twelve on the port side. An important detail which should be noted is that there is *no* midline frame structure.

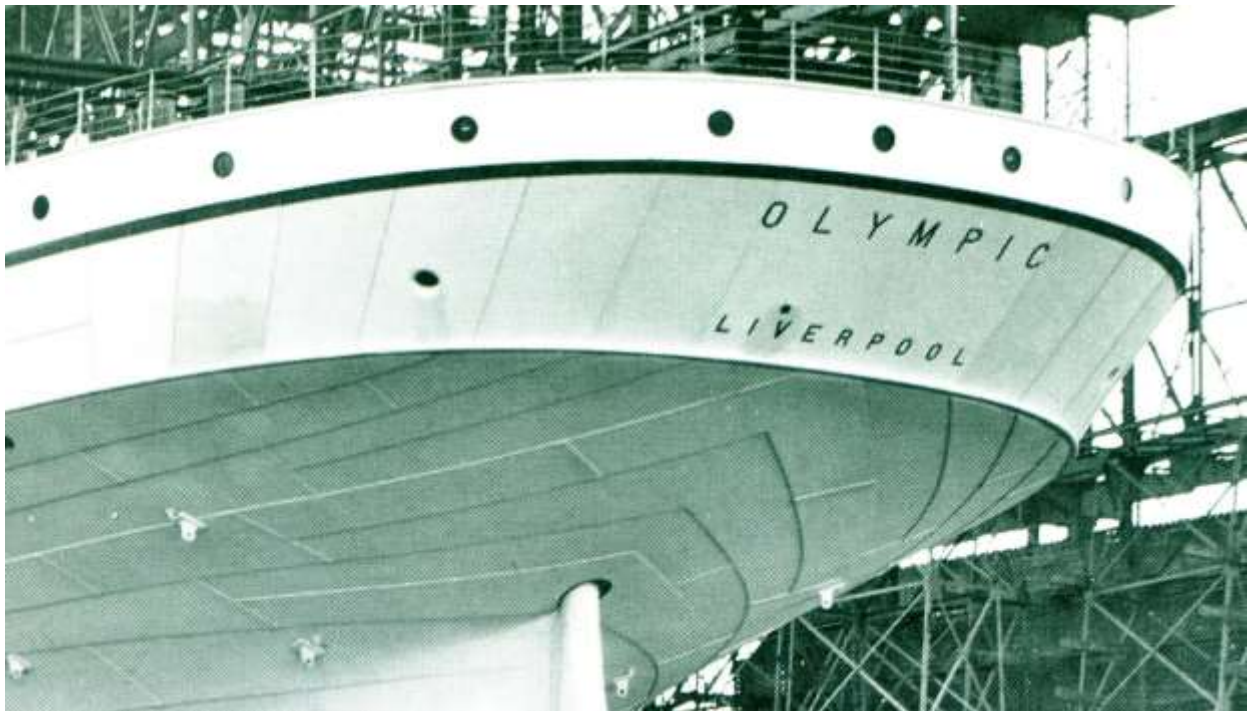
Since there is no underlying midline strength structure like a sternpost extension to which the plates were attached, we now have to look at how the midline plating was actually accomplished. Figure 4 shows what may be our best photo of the arrangement of the stern counter plating of the *Olympic* class ships. It show *Olympic* prior to launch.

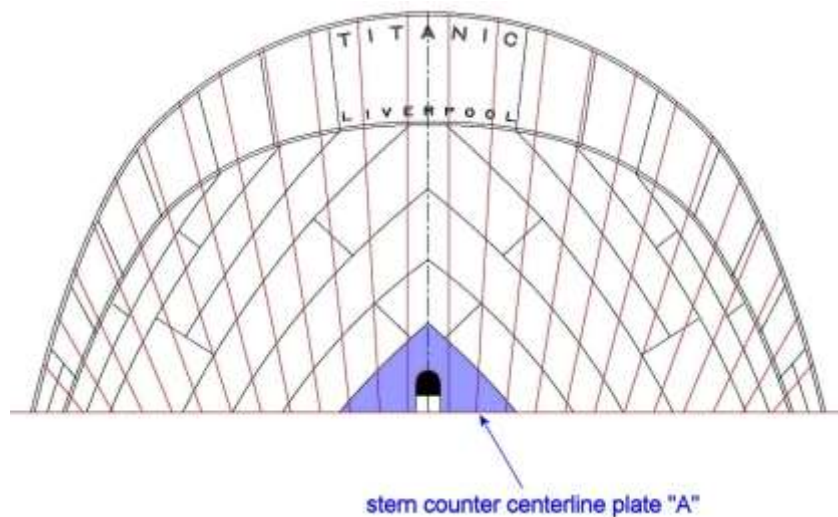
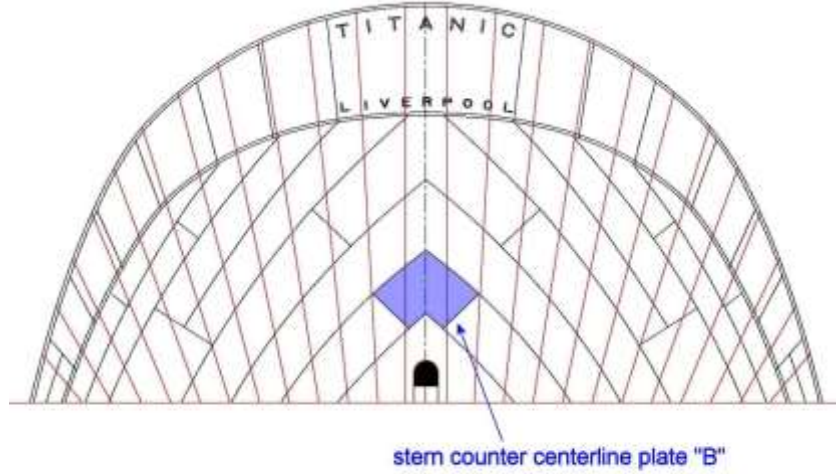
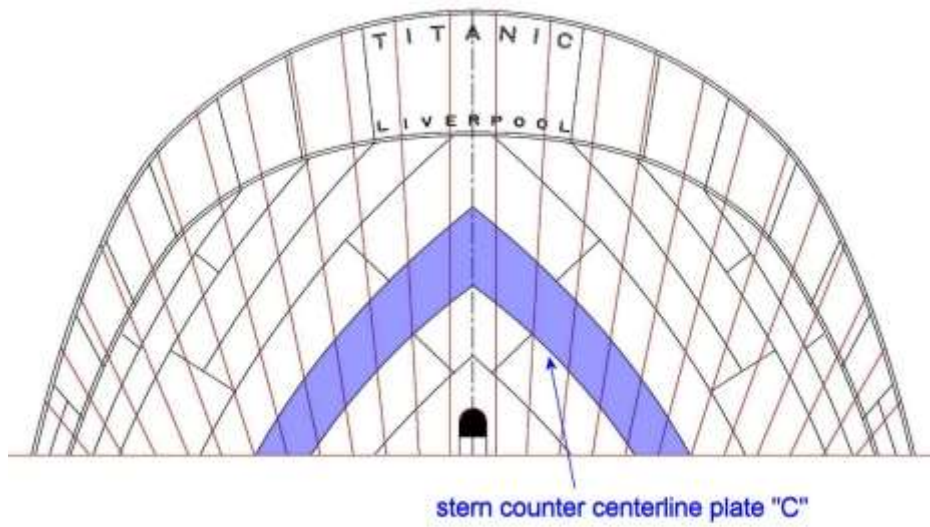
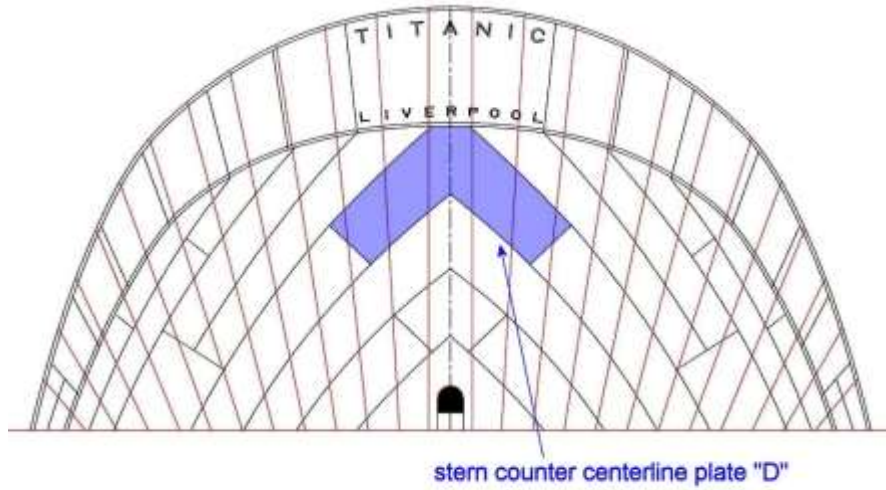
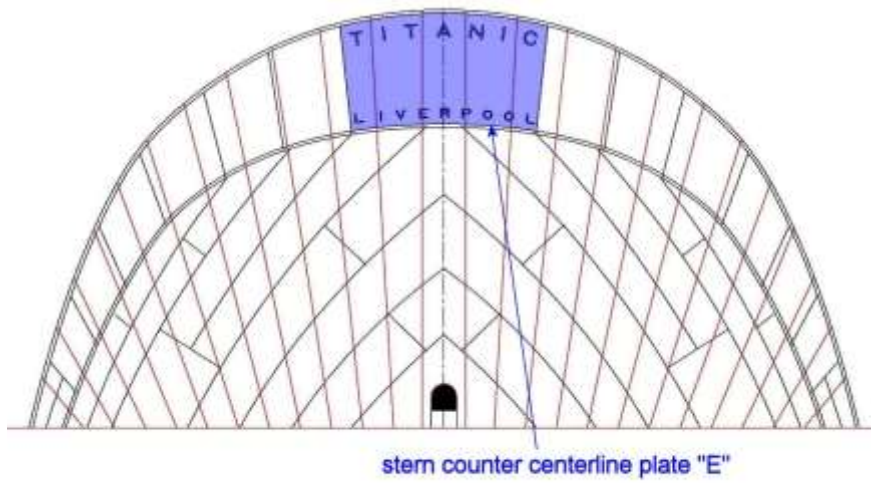
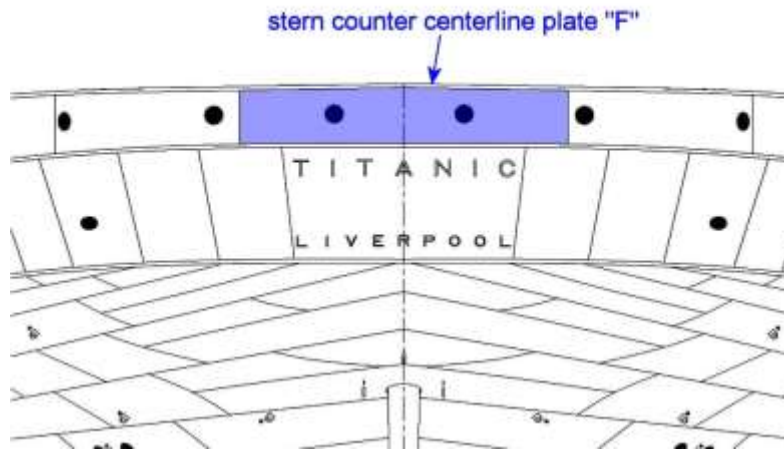
In Figures 5-10 we see the extents of each midline plate starting at the lowest and nearest to frame 148A up to the poop deck level.

These plates have been arbitrarily designated as plates A-F. Each plate crosses the midline. Some of the plates have forward extents which extend forward of frame 148A. These plates are only shown up to where they cross frame 148A. This arrangement satisfies the rule that plate junctions are staggered from strake to strake. Figure 11 shows a comparison of the incorrect visible midline counter seam and the correct arrangement with no visible midline seam.

As one looks at the plates which cross the midline, some of them like "C" are quite large. There is some thought that single plates this large either could not be manufactured or that their manufacture would have been either impractical or not cost effective. There is a possibility that multiple plates could have been used to produce a plate like plate "C". If multiple plates were used, they were not joined by simple butt lap joints. They would have to have been joined by internal butt straps or possibly forge welding. Such joints would be practically invisible in all but the closest photos. Even though the joints would not be readily visible, they would still have to conform to plating conventions where plate joints were staggered from strake to strake. Whatever methods were used to manufacture the plates which crossed the midline, there was no visible seam in the midline of the stern counter.
