Titanic's Watertight Door Tell-Tale Indicator: Reconsidering the Evidence

By Bob Read, D.M.D.

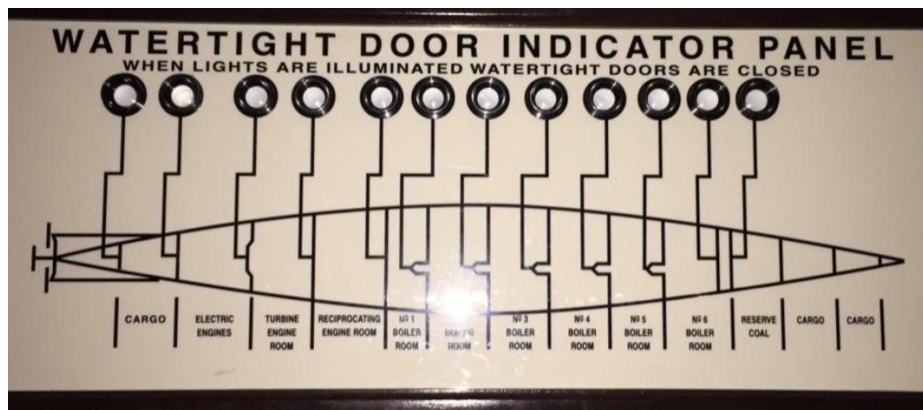
Figure 1

Since the release of James Cameron's *Titanic* movie in 1997 there have been discussions about whether *Titanic* had a watertight door tell-tale indicator or not. The indicator in the movie looked like that in Figure 1.

Watertight door tell-tale indicator from *Titanic* movie (1997)

It can be seen from this description that this instrument is unlike that in either Figures 1 & 2 or the description in Senator Smith's question to quartermaster Olliver. It may very well be that the reason that quartermaster Olliver and 3rd officer Pitman testified that they had not seen a watertight door tell-tale indicator is because they had not seen an instrument as described by Senator Smith or one which may have been in common use at the time. They may have not been aware of this instrument because it was not something which was within their usual responsibilities and that it differed substantially from those in common use.

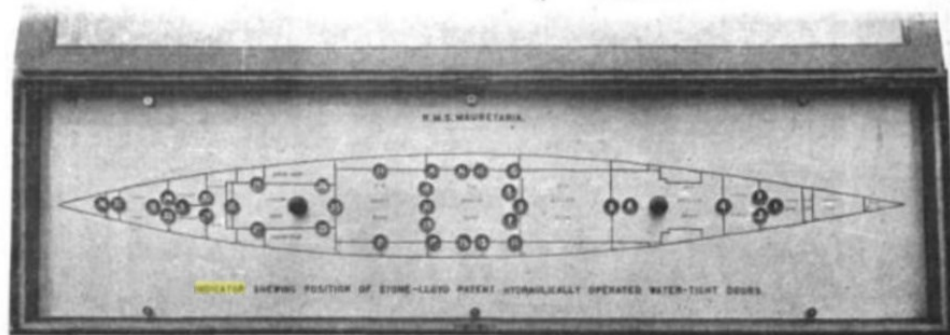
Most likely, the design of this movie prop was taken from actual designs used by other ships at the time. Figure 2 shows the actual watertight door tell-tale indicator from RMS Mauretania.

Watertight door tell-tale indicator from RMS Mauretania

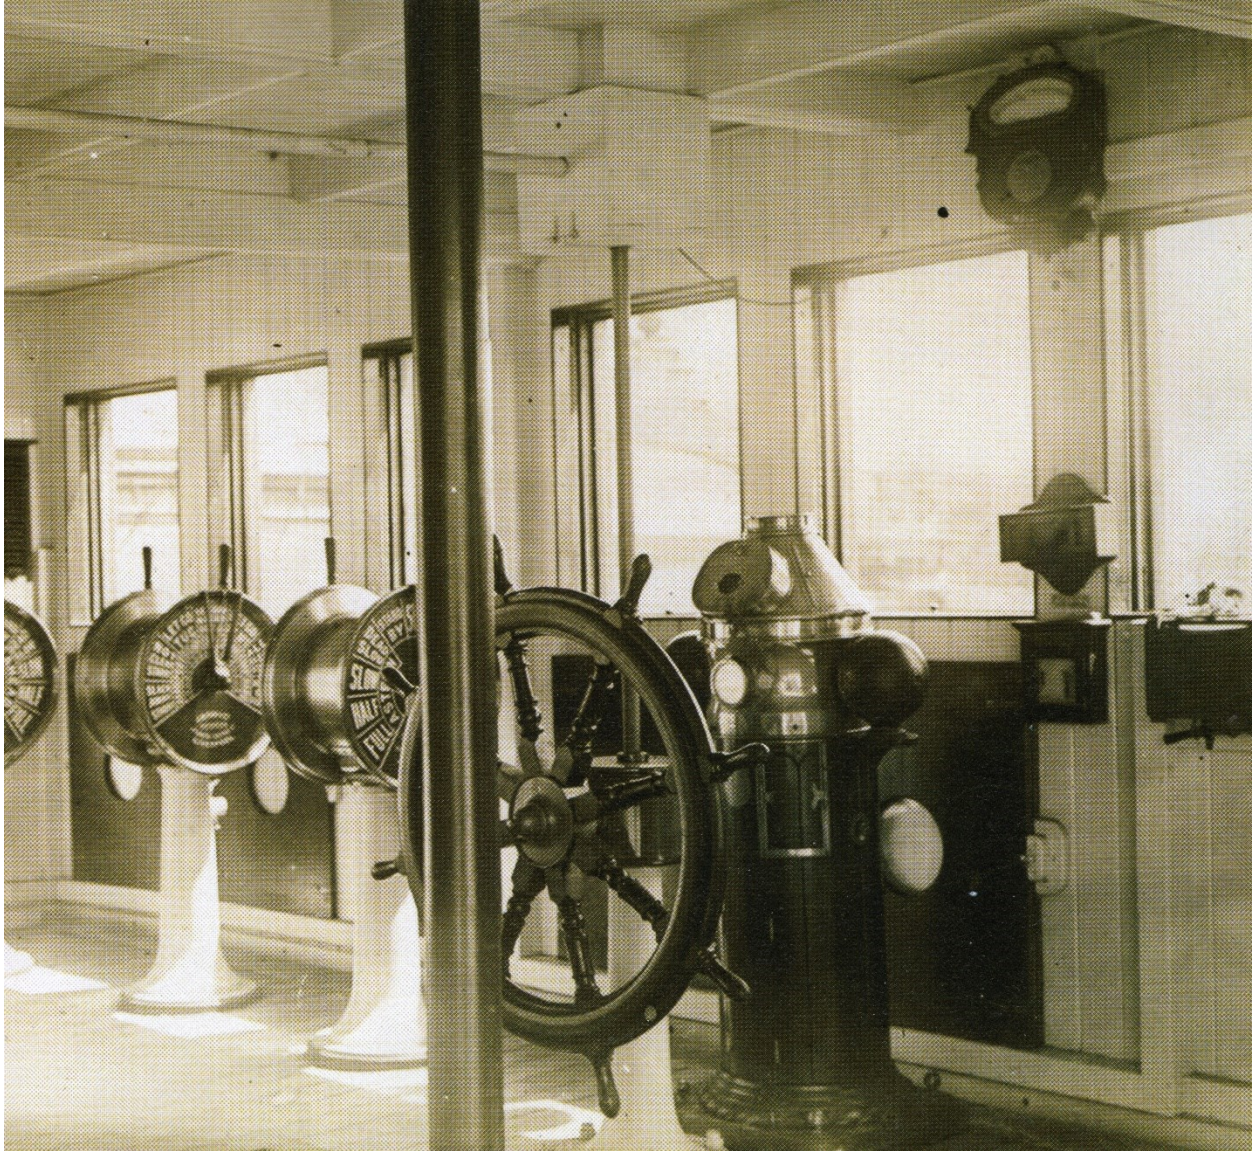
Figure 5

Photo of *Olympic's* bridge taken May 25, 1912

To the far right in the photo is a box-like structure with a handle on the lower side. This would match various descriptions of the watertight door actuator. The handle when rotated counterclockwise would engage the watertight door circuit. Just to the left of this structure is another box-like structure which I have never seen positively identified. I believe that it could match the description of *Britannic's* watertight door tell-tale indicator. Figure 6 is an enlargement of these structures in the photo which are identified as to what may well be their proposed functions.

The next question is whether there is any evidence which could possibly support an instrument as described in the Engineering article which was installed aboard *Britannic*. On *Olympic's* first voyage following the *Titanic* disaster, Senator Smith visited the ship in New York and conducted interviews with several of the crew. He also toured the ship. The date was May 25, 1912. On this date a number of photos were taken aboard *Olympic*. Pertinent to this investigation is one photo taken of *Olympic's* navigating bridge. This photo is shown in Figure 5.

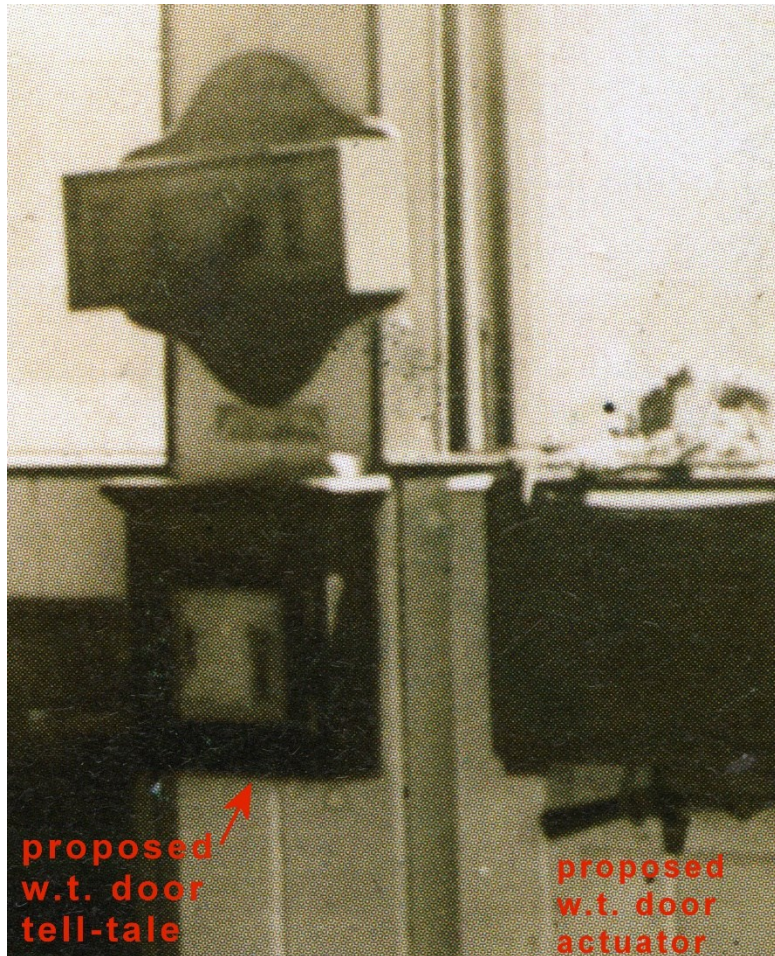
Figure 6

Enlargement and identification of proposed watertight door control instruments

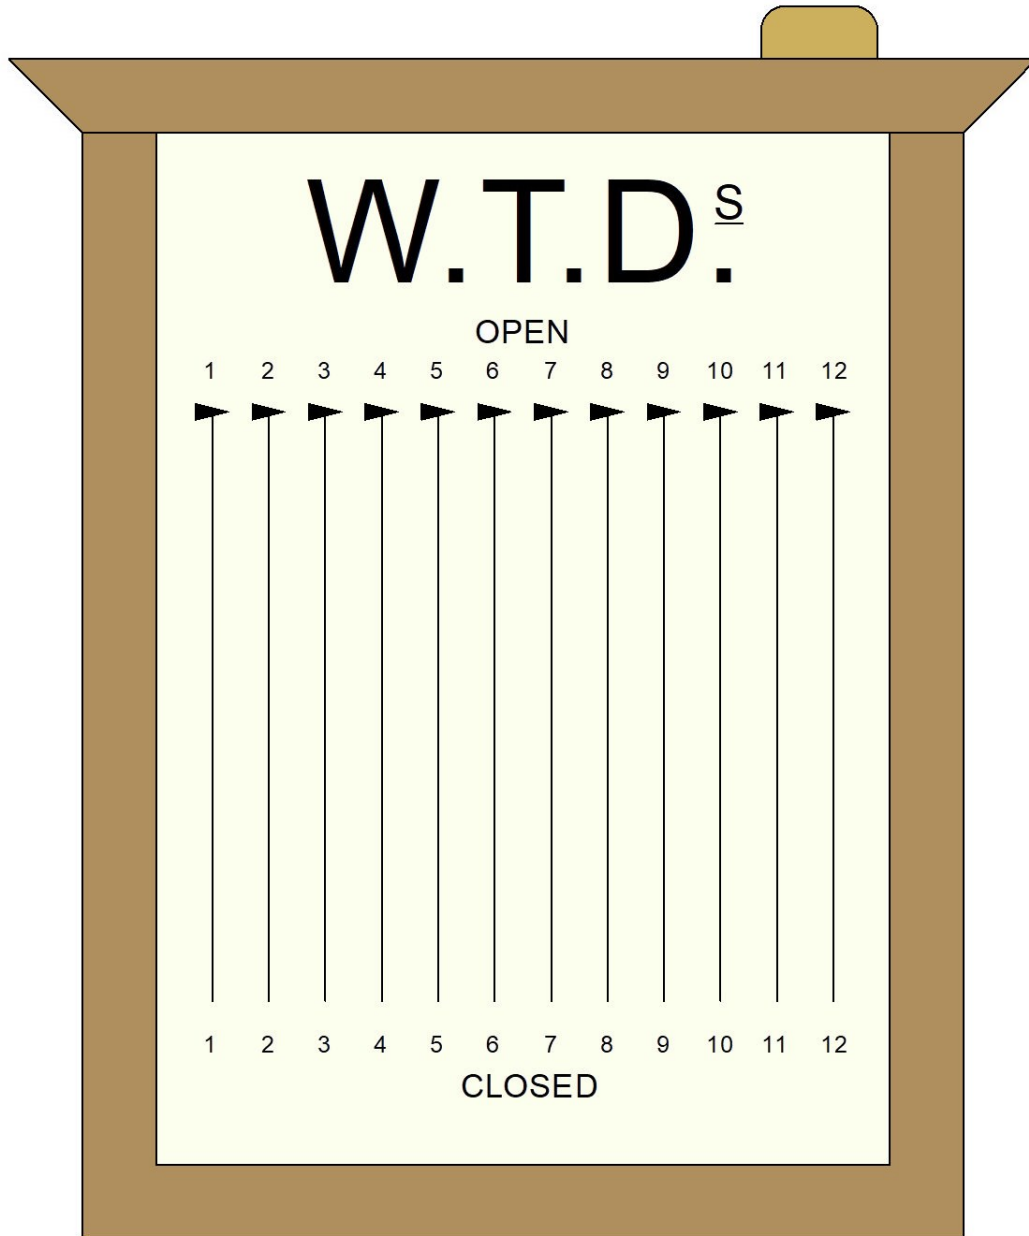
Using the description in Engineering of the particulars of *Britannic's* watertight door tell-tale indicator, I have made a scale drawing in Figure 7 which matches the size of the instrument in the photo. I also show the indicators described in the article and how they might look.

Proposed configuration of watertight tell-tale indicator described for *Britannic* which corresponds to instrument in *Olympic* photo

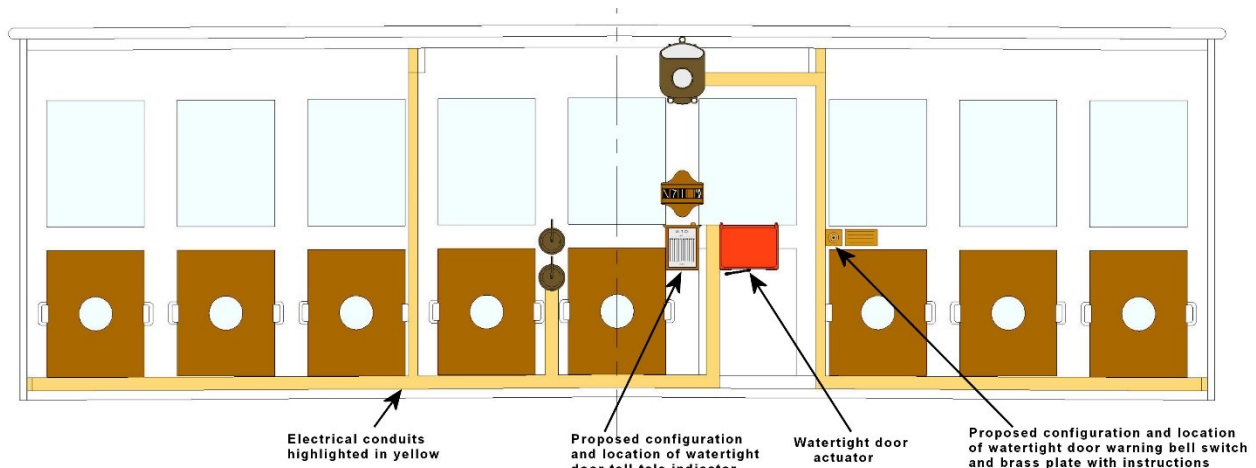
Figure A1

Instead of a long explanation, the answer to this objection will be illustrated in Figure A1.

May 25, 1912 appearance of Olympic's forward bridge bulkhead Titanic configuration assumed to be identical.

Objection: *The proposed configuration and location for the watertight door tell-tale indicator in this article must be wrong because it fails to account for the watertight door warning bell switch. This switch could not be located to the right of the watertight door actuator when looking forward because it would be blocked by an electrical conduit on the forward bulkhead of the navigating bridge.*

The objection suggests that what this article proposes as the watertight door tell-tale indicator is actually some sort of device for sounding the warning bells prior to using the watertight door actuator.
