An Examination of the Early R.M.S. *Olympic* Fidley Ventilation System Controversy

By Bob Read, D.M.D

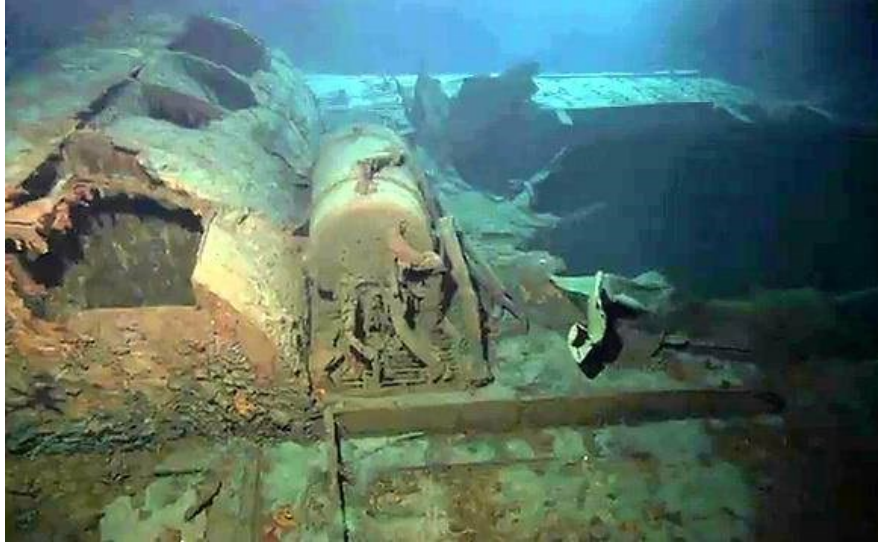
Figure 17

Freshwater tank sitting atop fidley grating on *Titanic* wreck
