# The Case for Restaurant Galley Skylights on *Titanic*

By Bob Read, D.M.D.

There has been much debate about whether *Titanic* had restaurant galley skylights on the forward roof of the deckhouse under the fourth funnel like her sister *Olympic*. This article will examine and make the case for restaurant galley skylights on *Titanic*.

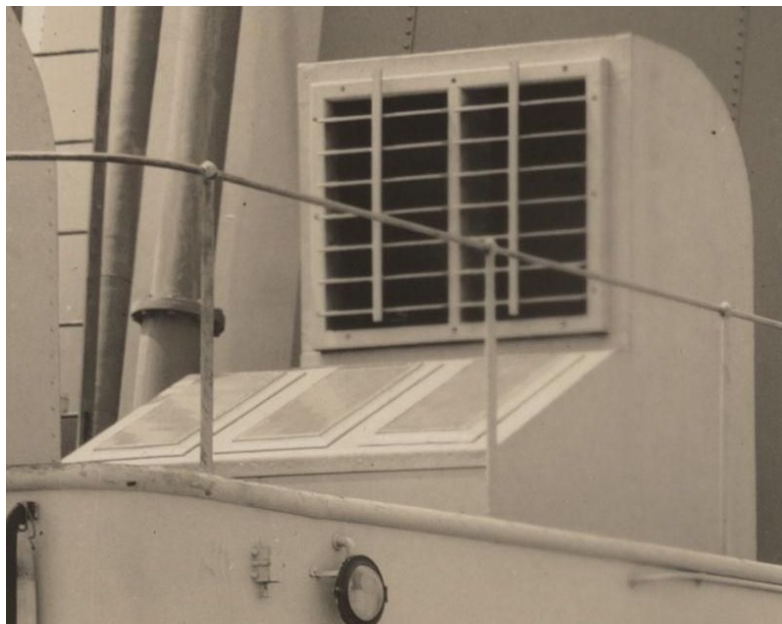
From the beginning, *Olympic* had skylights over the restaurant galley on “B” deck. The early skylights had an air intake on their aft sides which ducted into the light and air trunk to the restaurant galley. Figure 1 shows this combination skylight/natural draft ventilator.

## Combination skylight/ventilator over early *Olympic*'s restaurant galley

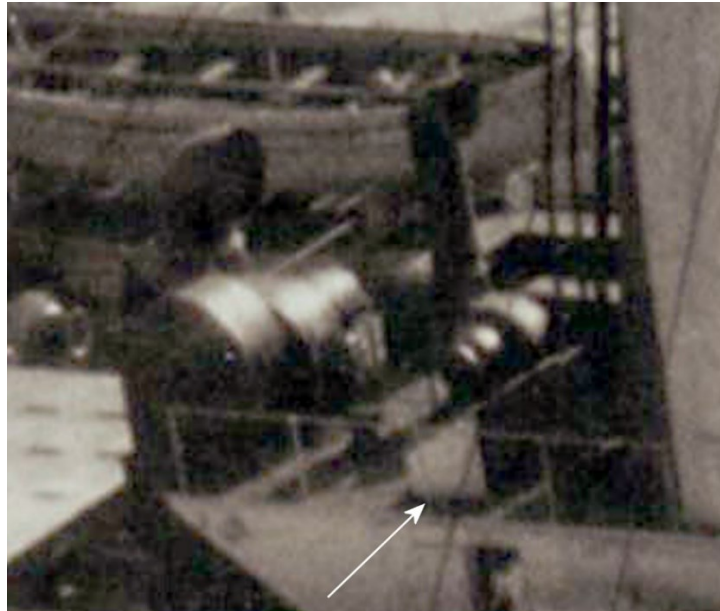
Figure 2

skylights. The air intakes of the skylights were eliminated and a single 20 inch suction ventilator was added on the starboard side. Figure 2. Shows the modified port skylight on *Olympic in 1918*.

### Restaurant galley skylight on HMT *Olympic* in 1918

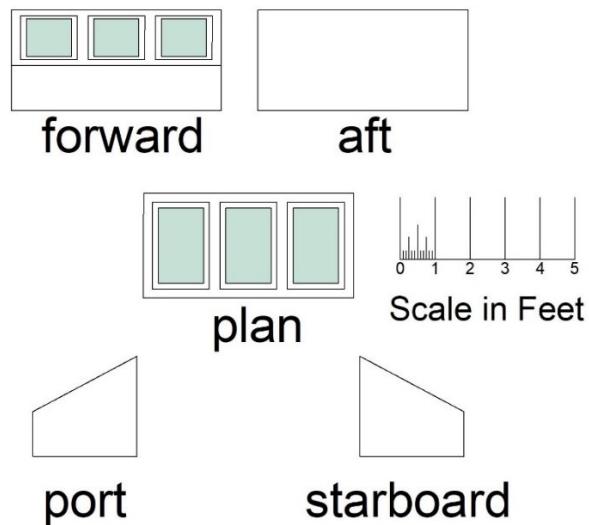
The ventilator and skylight configuration forward of the fourth funnel in 1918 was the same as it was after the 1913 refit. Figure 3 is a multi-view drawing of one of the replacement restaurant galley skylights. These skylights were steel and were non-opening.

Multi-view drawing of restaurant galley skylights
