# The Configurations of *Titanic's* Fidley Vent Covers

By Bob Read, D.M.D.

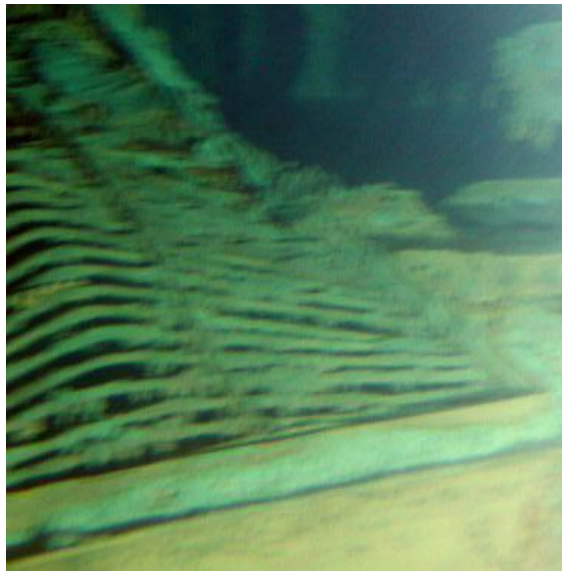
Bent bars of one of *Titanic's* fidley covers

The difference between covers and gratings is one of function. The main similarity is that both allow air to pass through them. The difference is that a grating is strong enough to support foot traffic. A cover in the case of *Titanic's* fidley covers appears not to be made to support foot traffic. Rather than being made up of heavier iron bars like the catwalks in the engine room, the diameter of the bars was such that they were closer to being screens. Figure 4 shows how the bars in one of the covers on *Titanic's* wreck have bent. This would suggest that the fidley covers were not suitable for regular foot traffic.

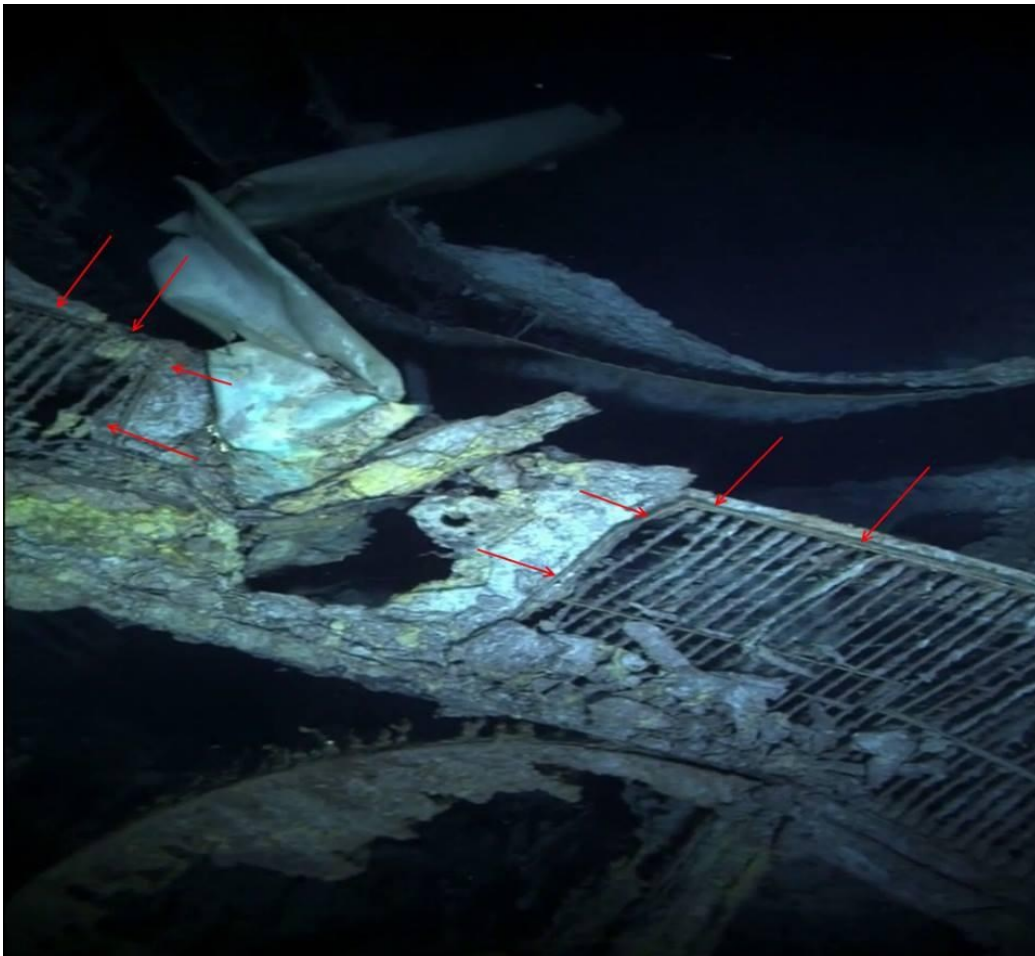
Figure 7

Fidley cover #1FP and #1FS

The two fidley covers #1FP and #1FS are shown in Figure 1. These two covers have four right angle corners. As shown in Figure 7. Cover #1FP has a hatch on its aft port side.

Reliability: Completely reliable. With photos showing the port cover in its entirety, the starboard cover is identical except for the absence of a hatch.

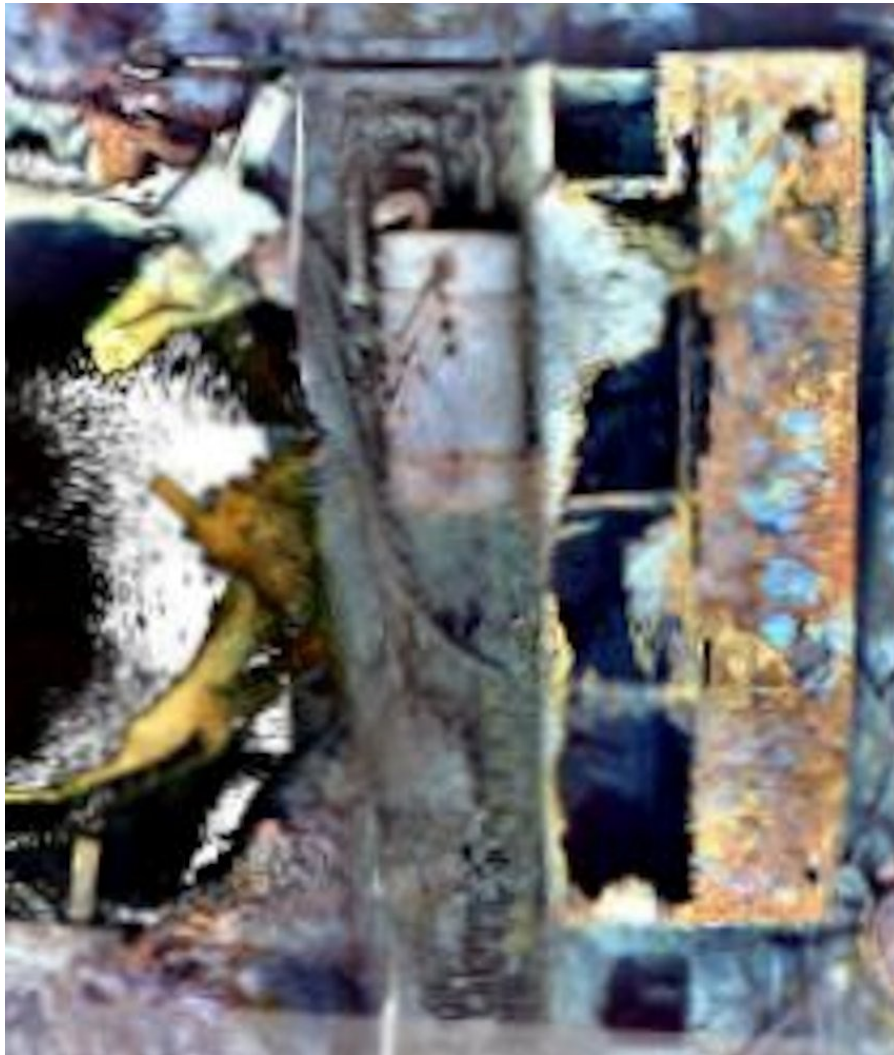
Figure 8

Fidley covers #1AP and #1AS mostly obstructed

The two fidley covers aft of funnel #1 are shown in Figure 8. These two fidley covers #1AP and #1AS are obscured by a water tank on the starboard side and debris on the port side.

Reliability: Mostly unreliable. Not enough of the fidley covers are visible enough to show whether they are completely rectangular or whether they have beveled corners on their forward inboard sides. There is a high-resolution photo showing the outboard end of the port fidley which shows a hatch on the ouboard forward side. I am not at liberty to share this particular photo.

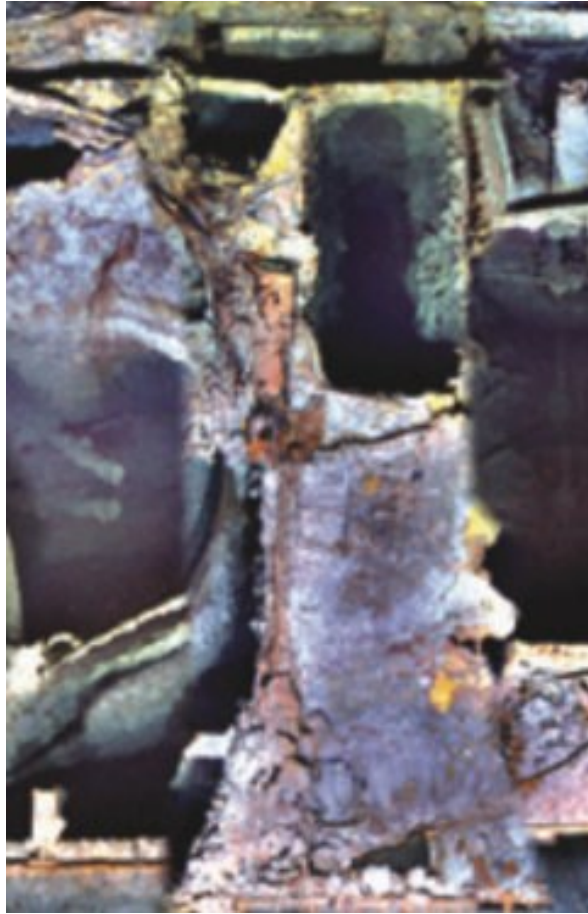
Fidley #2AP (obscured) and #2AS (missing)

Fidley cover #2AP is partially visible in Figure 10 but the cover #2AS is missing.

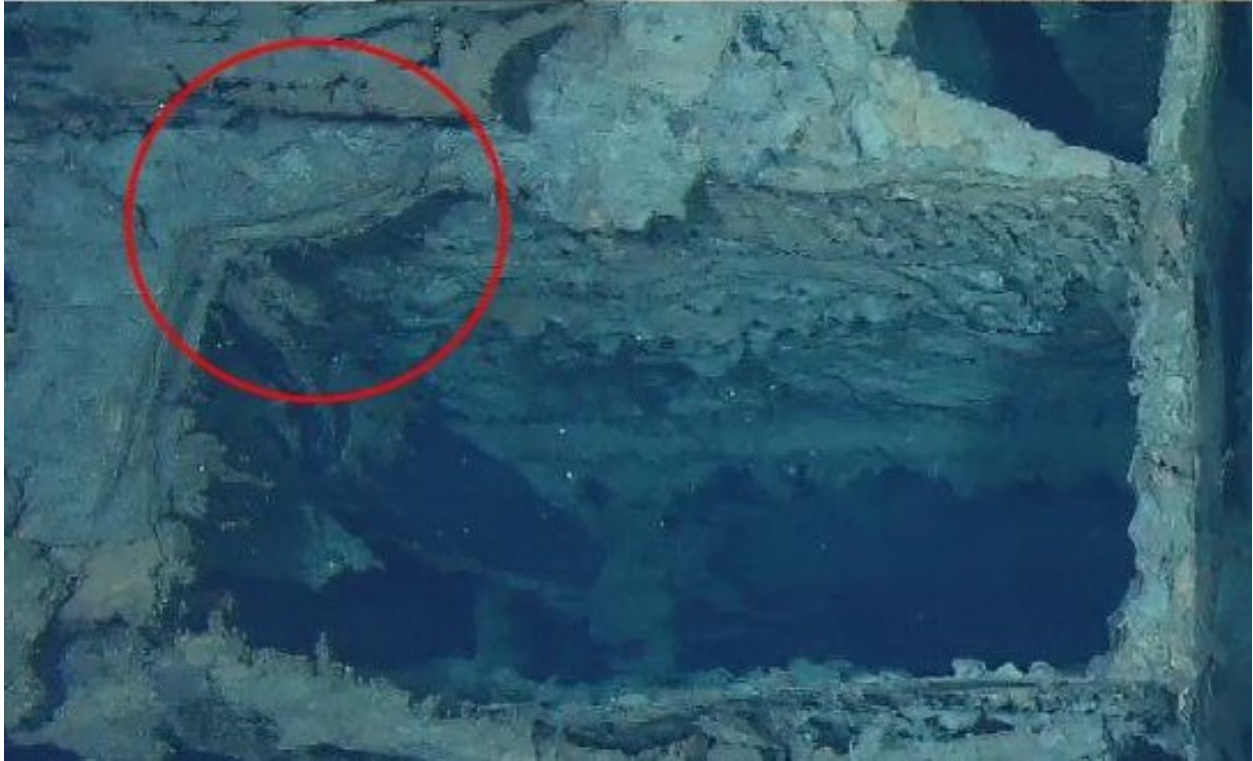
Figure 11

Opening for missing cover #2AS with what appears to be a beveled corner (circled in red). Photo courtesy of Cyril Codus which was posted in a Facebook Titanic forum.

There is however, a high-quality photo which shows the outline of the #2AS missing cover. This appears to show a beveled forward inboard corner. Because of damage, the bevel appears to be curved but the intact forward covers of funnel #2 which have beveled corners are not curved.

Reliability: Fairly high. The damage to the open fidley duct precludes absolute certainty but it appears more likely than not that the inboard forward corner of the missing cover would be beveled.
