A Larger Radius Corner of *Titanic's* Roof of the First Class Lounge

By Bob Read, D.M.D.

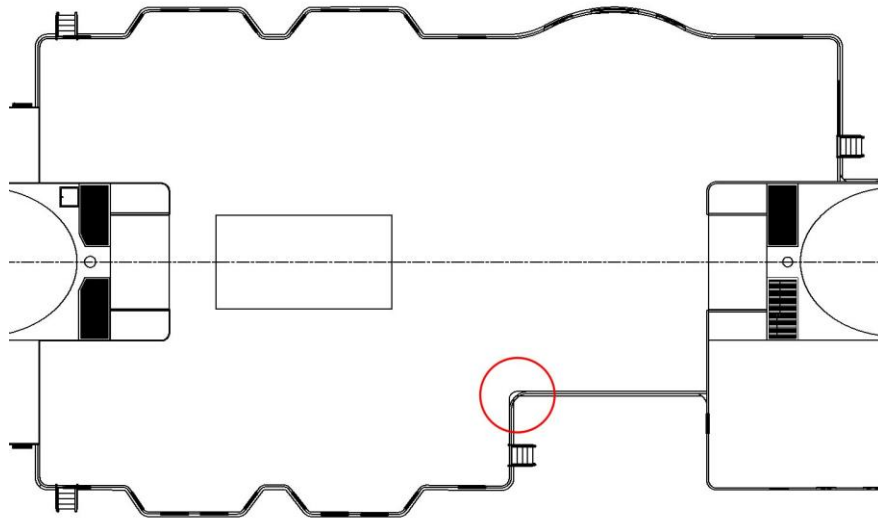
Every right angle corner of the roof over *Titanic's* first class lounge has a 12 inch radius except one. Figure 1 shows the location of the one corner of the roof which has a larger diameter.

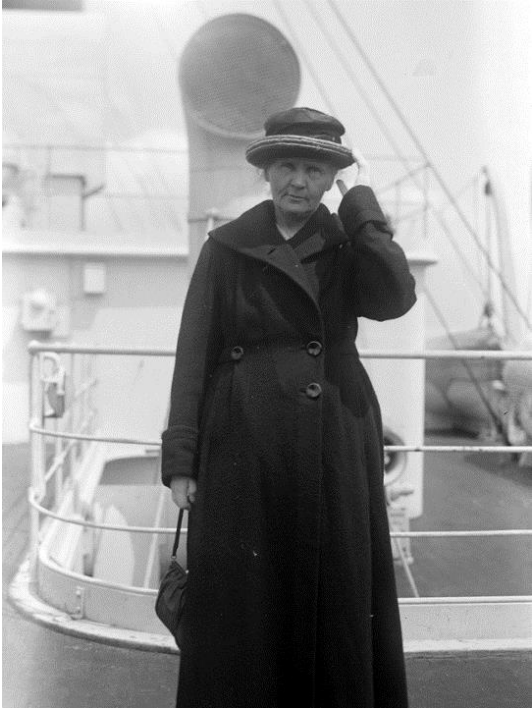
Figure 2 and Figure 3 are photos which show this particular corner of the first class lounge roof.

This larger radius corner involves only the steel decking and wood sheathing of the roof. The bulkheads of the lounge form the conventional 12 inch diameter corner. The photos above don't really give much of a clue as to the radius of the corner. Figure 4 is the one photo which gives us a more accurate representation of the radius of the corner.

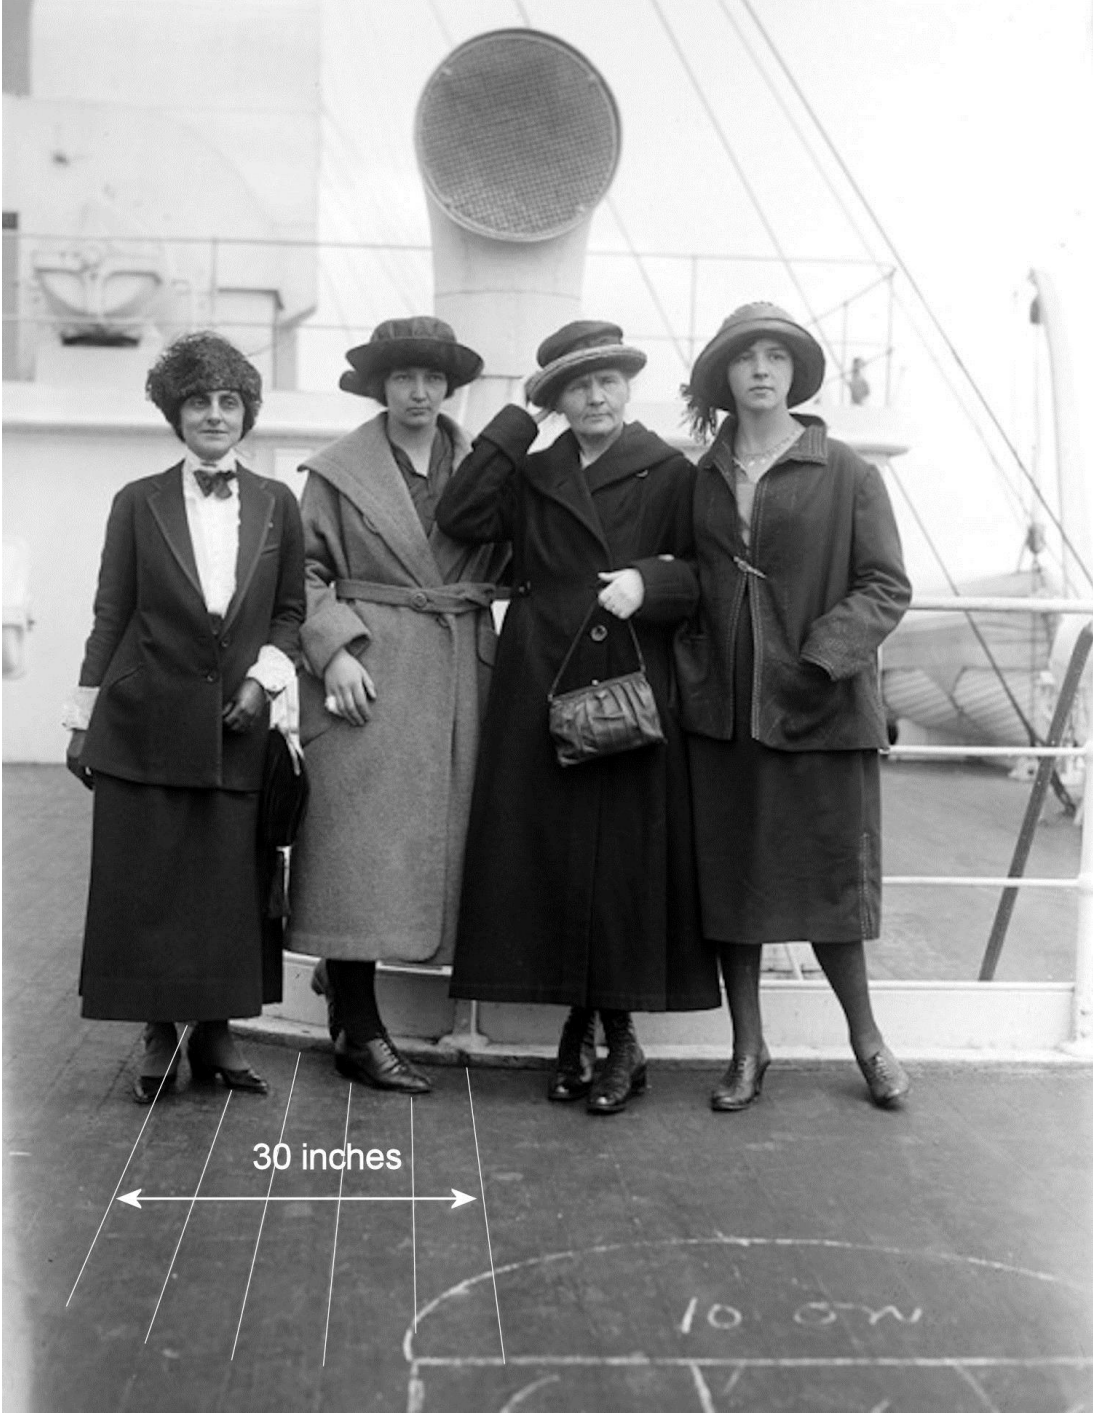
We can see in Figure 4 the individual sheathing plank boundaries. The planks are 5 inches wide. From the photo we can see that the radius corner begins where the outboard railing stanchion begins. Counting the number of planks to the inboard boundary of the radius we can see that the radius is 30 inches.

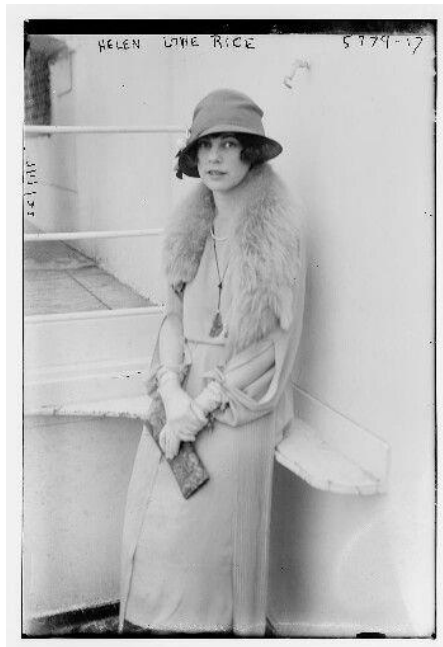
Figure 6 shows a passenger sitting on top of this knee.

The original corner which was discussed also has a reinforcement knee in the corner of the raised roof bulkhead. The difference in this location is that the steel decking which forms the roof of the first class lounge is extended to cover the knee. This allows a greater radius corner to be formed by the roof. Figure 2 shows how the waterway around the base of the raised roof retains the 12 diameter radius of the deck house while the roof has a larger diameter.

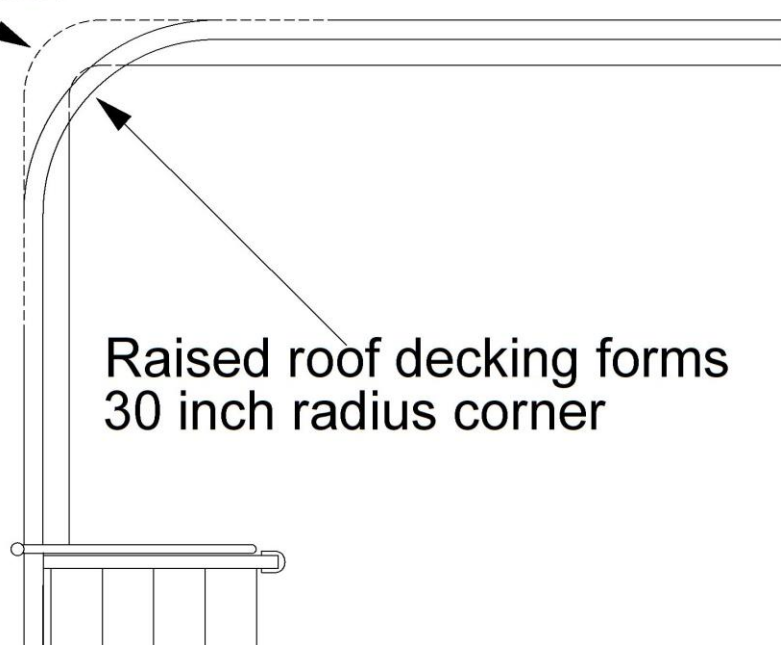
Figure 7 shows an enlarged drawing of the large radius corner of the lounge roof. The dashed lines show the 12 inch diameter corner of the deck house.

Deckhouse (dashed line)
12 inch radius corner

The roof of starboard right angle corner of the first class lounge aft of the gymnasium forms a 30 inch radius corner while the deckhouse below retains a 12 inch radius. The larger radius of the roof is formed because a reinforcing knee is placed directly below the steel decking of the roof and the roof follows the radius of the supporting knee below it. This feature was not a modification made to *Titanic*. This feature was a feature on *Olympic* as built.
