Titanic's Mystery Whistles

by Bob Read, D.M.D.

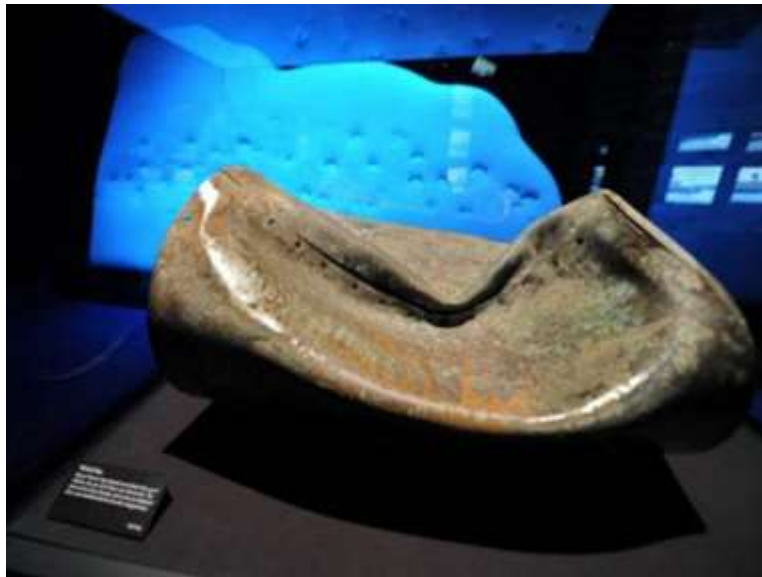
Figure 1

The only evidence we have that there was a difference between the forward two funnels and the aft two funnels is one of the whistle dome recovered from one of the aft two funnels. This dome is shown in Figure 1.

The difference in the appearance of the two whistles is striking. The reason the aft whistle is deformed is because it was constructed of a wrought metal which was riveted. Wrought materials bend under stress. The forward whistle has no deformation because it is cast metal. Cast metals fracture under stress rather than bending. The appearance of the two whistles also suggests that they are made from different metal alloys. The aft whistle is probably a less expensive type of metal known as Muntz metal.

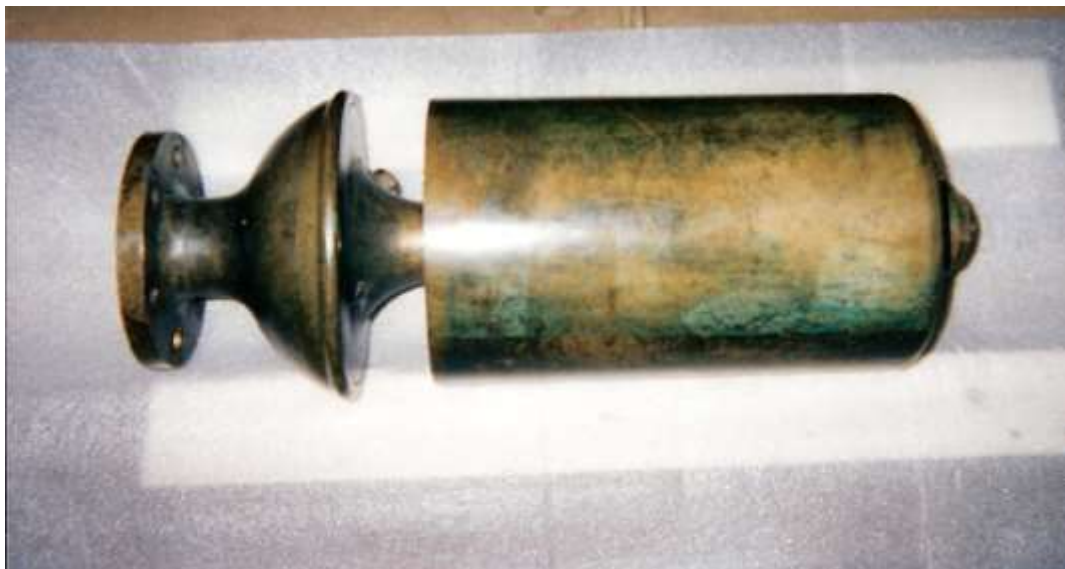
Figure 2

One of the whistle domes recovered from one of the forward two funnels is shown in Figure 2.
